Agenda Item Number: R 2-15

Re: Public Hearing - Repairs to the Thomas G. Walton Building

Inspection Report

**Energy Conservation Assessment for
Chamber Of Commerce/
Convention and Visitors Bureau/
Office of Cultural Affairs
Thomas Walton Building
300 South Providence Road
Columbia Mo**

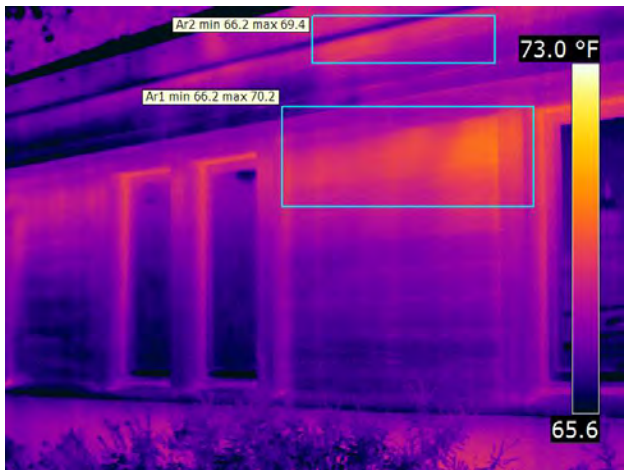
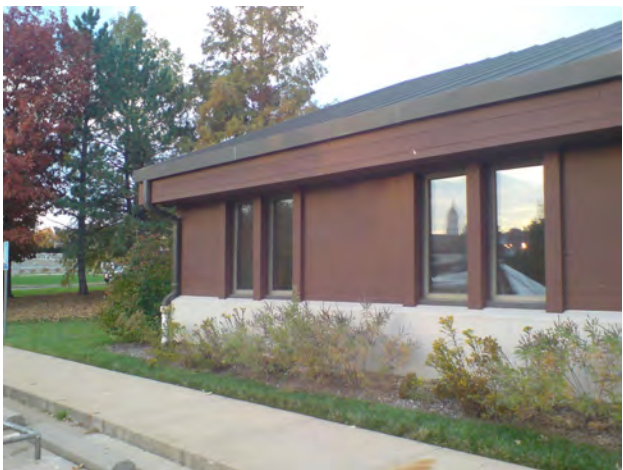
Location: east side of building. Image showing moisure where indicated. See page 2.

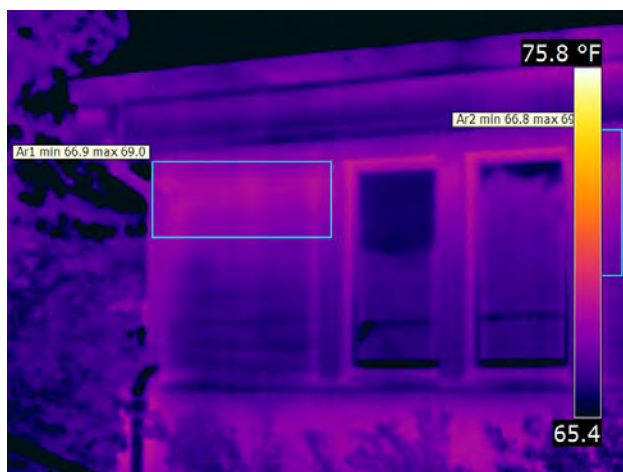
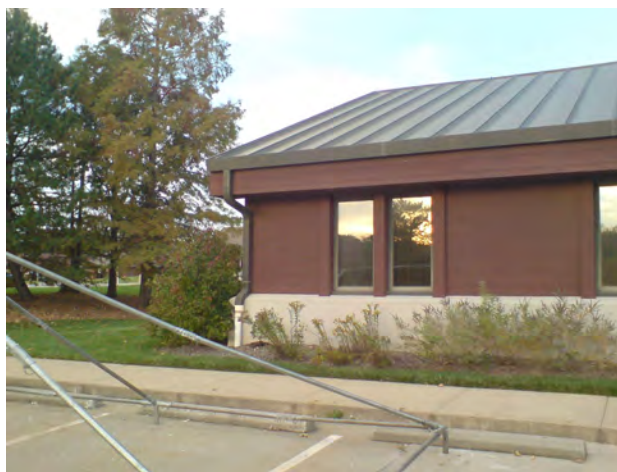
Location: east side of building. Image showing presence of moisture where indicated. See page 3.

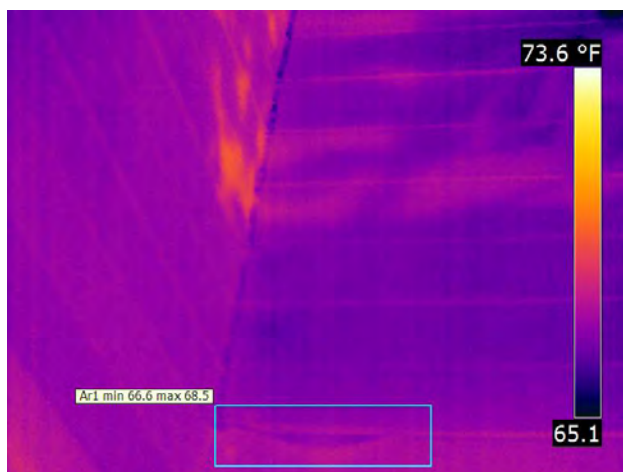
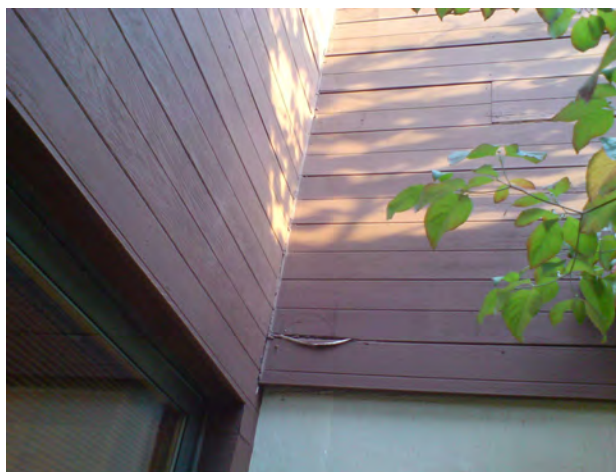
Location: east side of building. Caulking has deteriorated and allowing moisture to enter.

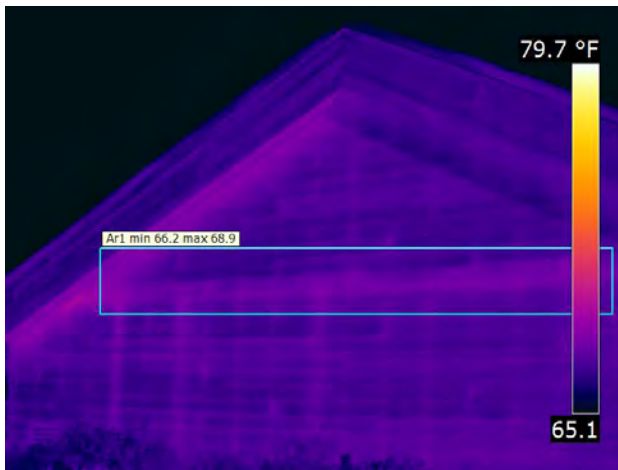
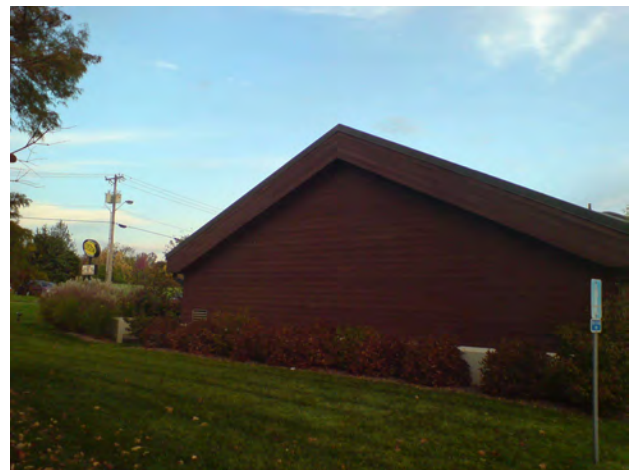
Location: south side of building. Image idicating moisture infiltration.

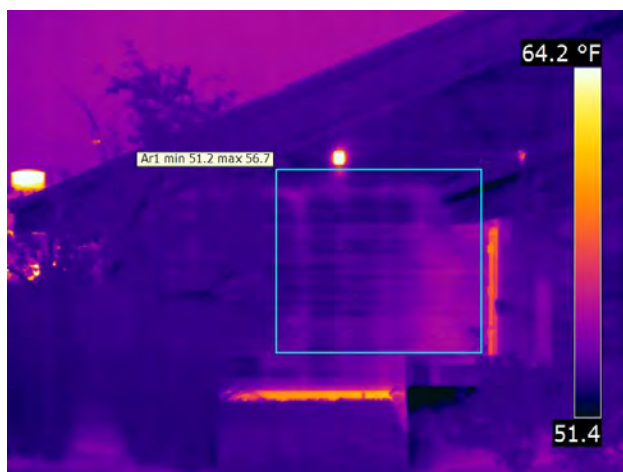
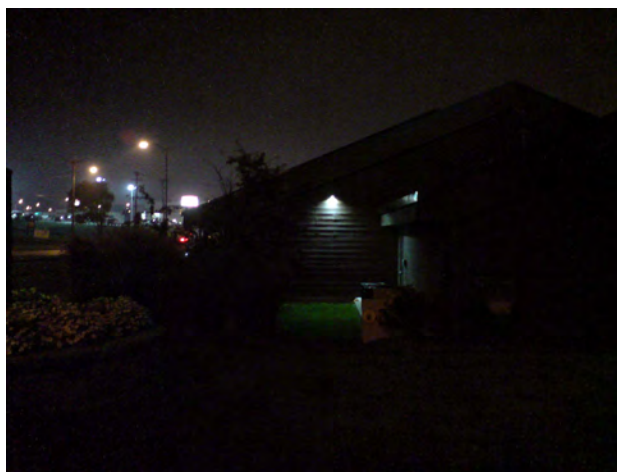
Location: west side of building. Image indicating areas of moisture inside walls. See page 2.

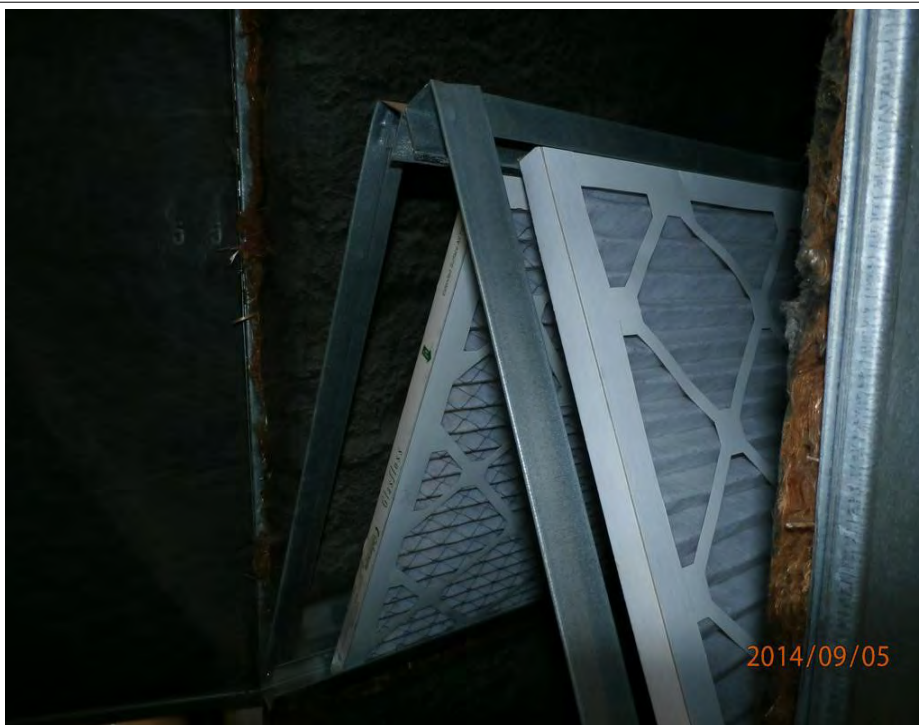
Many air handlers had improperly sized filters installed. These ill-fitting filters allow dust to bypass the filter, fouling coils. Cooling coils fouled with dust reduce efficiency and could cause freeze-up, resulting in expensive service calls. All air handlers should have coils professionally cleaned, and correct filters should be installed. The correct filter size for all units is 25X20X1. Many 22X20X1 filters were observed.

Maintenance Issue: Many air handlers had incorrectly sized filters, allowing coils to collect dirt.

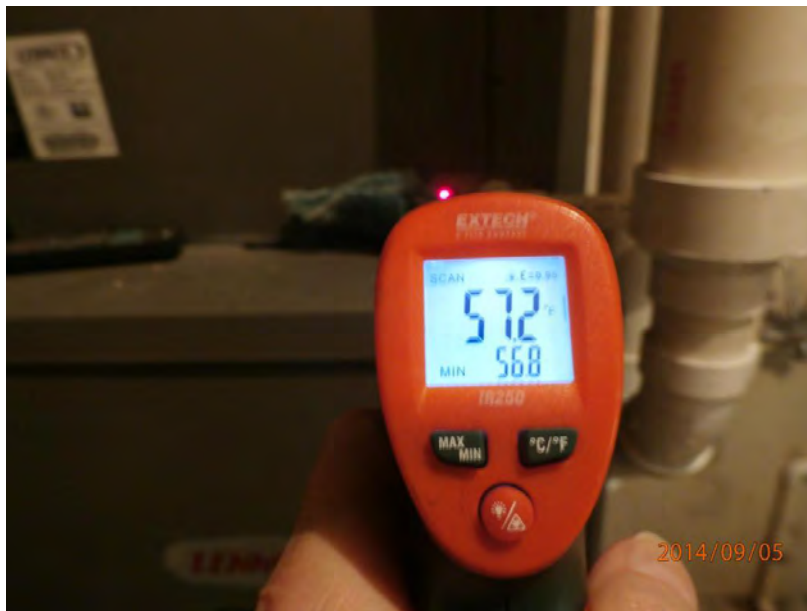
Almost every air handling unit we inspected had air leakage at the evaporating (cooling) coil. This is due to missing screws and gaskets at covers to these units. Air leakage at this point wastes cooled air, causes condensation and could grow mold. We do not calculate a payback for this ECM, but it should be relatively inexpensive to repair and should increase comfort and efficiency of the HVAC system.

Photo shows evaporator coil cabinet at HVAC unit serving the boardroom leaking 60 degree air. Gaps around much of the edge of this access panel were leaking on almost every unit.

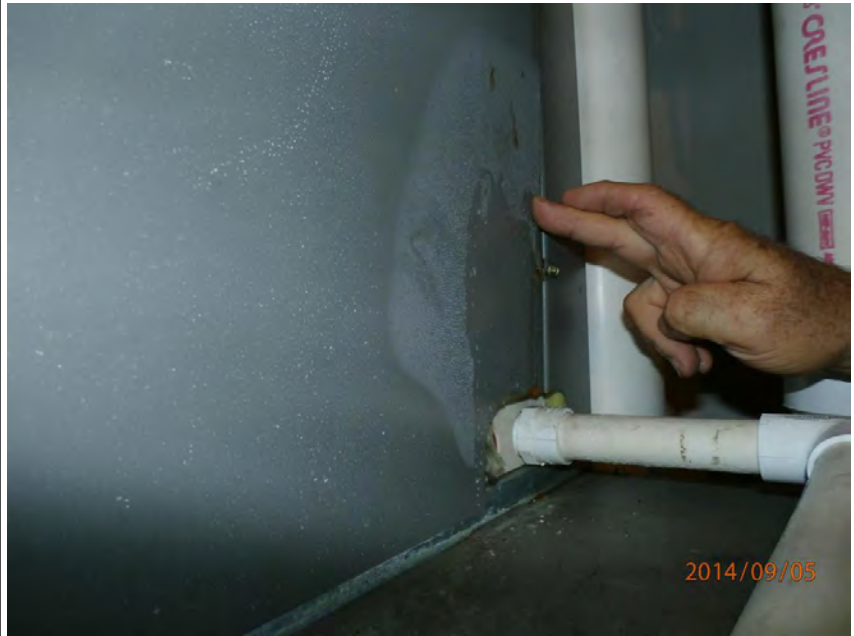
Condensation on air handler cabinet results from leaking cold air. Nearly every air handler showed air leaks in the area indicated. These should be sealed using the same techniques as are used on ductwork, including extra screws, gaskets, duct mastic and good quality tape.

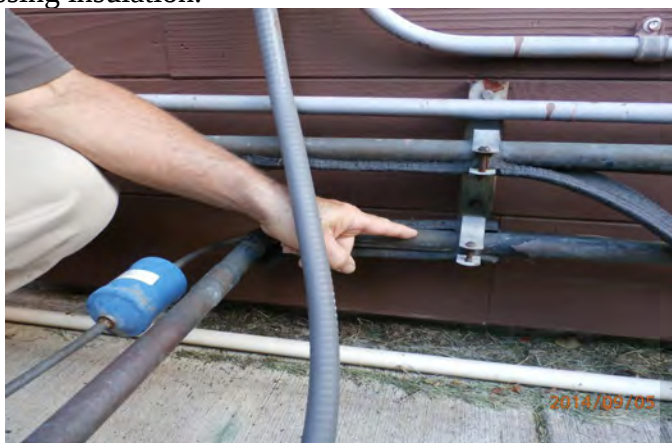
Much of the insulation on exterior refrigeration piping is damaged, which means that the efficiency of the HVAC is reduced. Sunlight deteriorates this kind of plastic. Have this damaged insulation replaced, and then have the insulation covered with a barrier that resists deterioration by sunlight. We estimate there is about 70 feet total of missing insulation.

Much of the insulation is damaged or missing from refrigeration lines.

It is estimated that about 800 KWHr per cooling season is being wasted by these uninsulated pipes, and they also rob the HVAC of capacity. This means the HVAC cannot deliver full cooling where it is needed. An estimate of the annual energy cost of the uninsulated pipes is about \$87. Repairing the pipes when the serviceman is already on the job doing a seasonal check would cost about \$70, making the payback on this measure 0.8 years or one cooling season. The technician should install a cover on the insulation that will resist sunlight.

ECM #4: Repair damaged refrigeration insulation and install a weather- and sunlight-proof covering. Cost: \$70. Annual Energy Savings: \$87. Payback: 0.8 years.

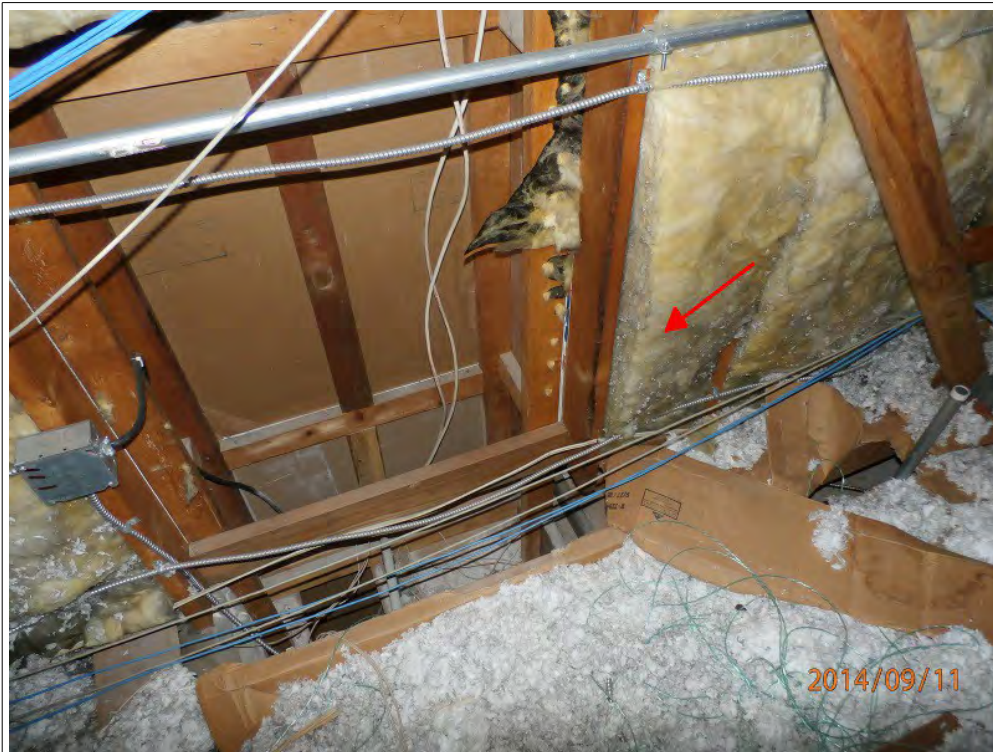
Attic insulation has been removed from walls around the central lobby causing energy loss and uncomfortable temperatures. Note black areas in fiberglass (arrow) which could be signs of excessive air movement (dirt accumulation) or possible mold growth. There is no air barrier in this area resulting in excessive infiltration. This area can function as a chimney, pumping out conditioned air.

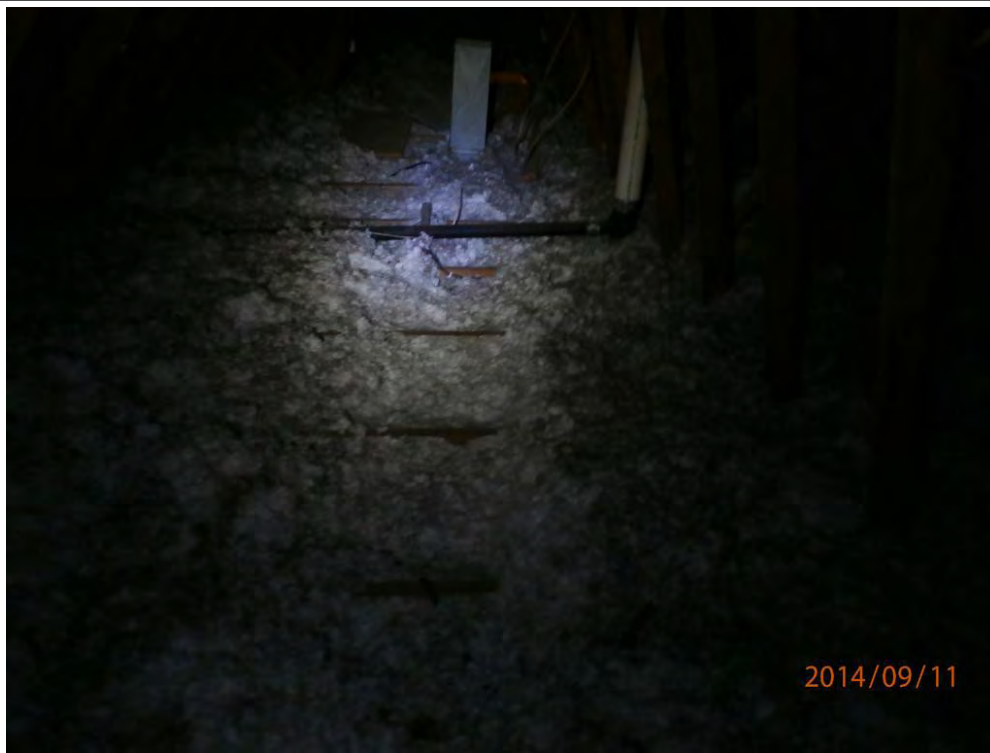
Insulation has been walked down in many areas of the attic by repeated foot traffic. Permanent walk boards should be installed above the insulation level to allow IT wiring changes.

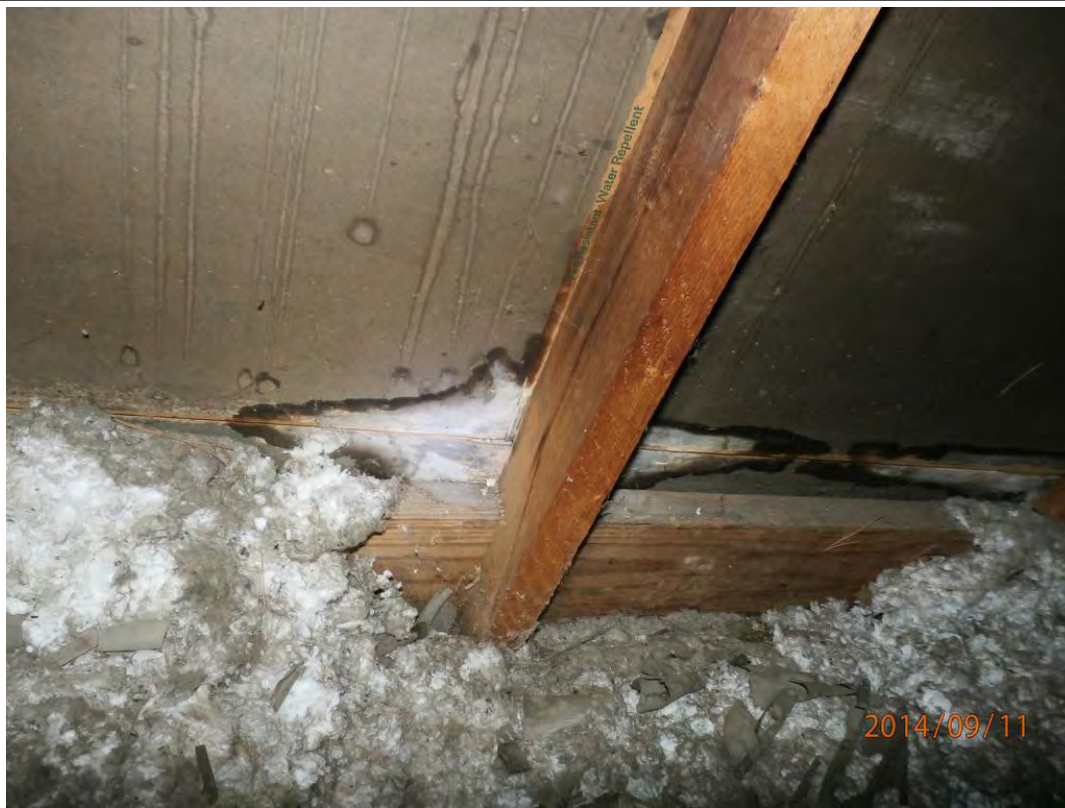
Evidence of water damage in the attic area behind the North wall. There was evidence of water damage inside the attic essentially everywhere we looked along all vertical outside walls. When exterior siding is replaced, weatherproof layers should extend to the eaves.

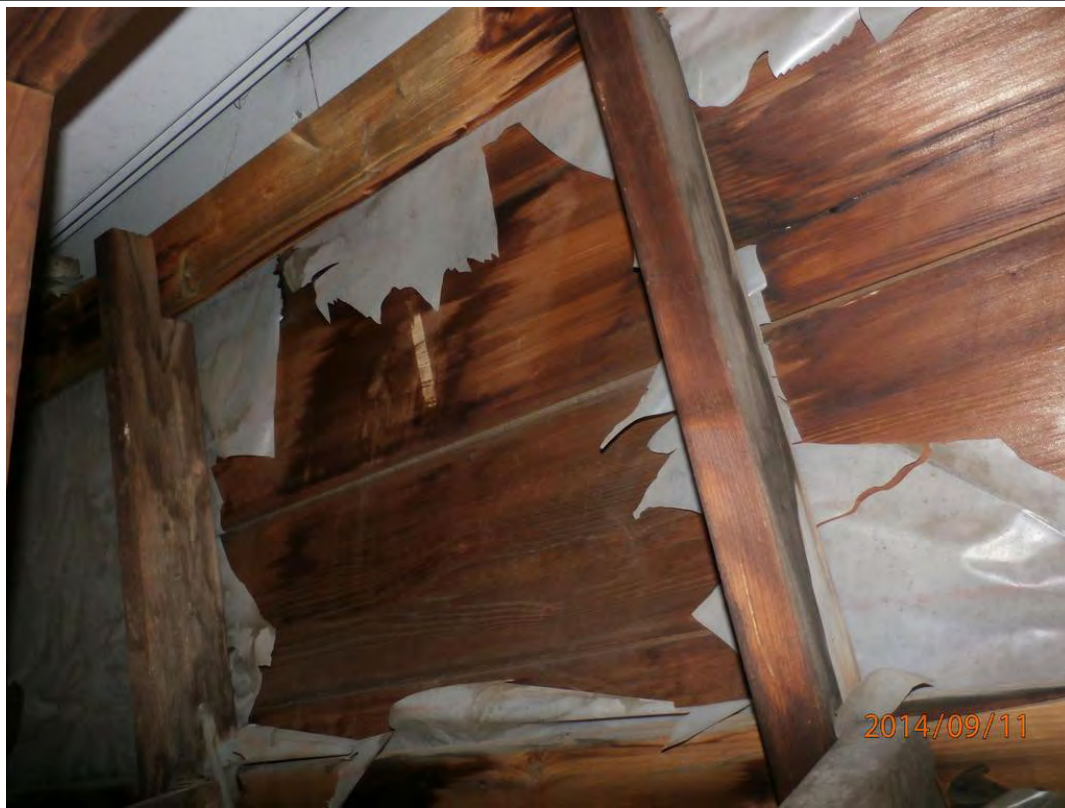
Polyethylene sheets were originally used behind wood siding in the attic for a weather barrier. This poly sheeting is deteriorated, only shreds remain because it does not stand freezing, thawing, heat and movement. The exposed wood siding is an ineffective water barrier, leaving the attic open to windblown rain entry.

Polyethylene was used as a weather barrier in the attic, and has completely deteriorated. Cedar siding is visible, an ineffective weather barrier. Water stains show evidence of water penetration.

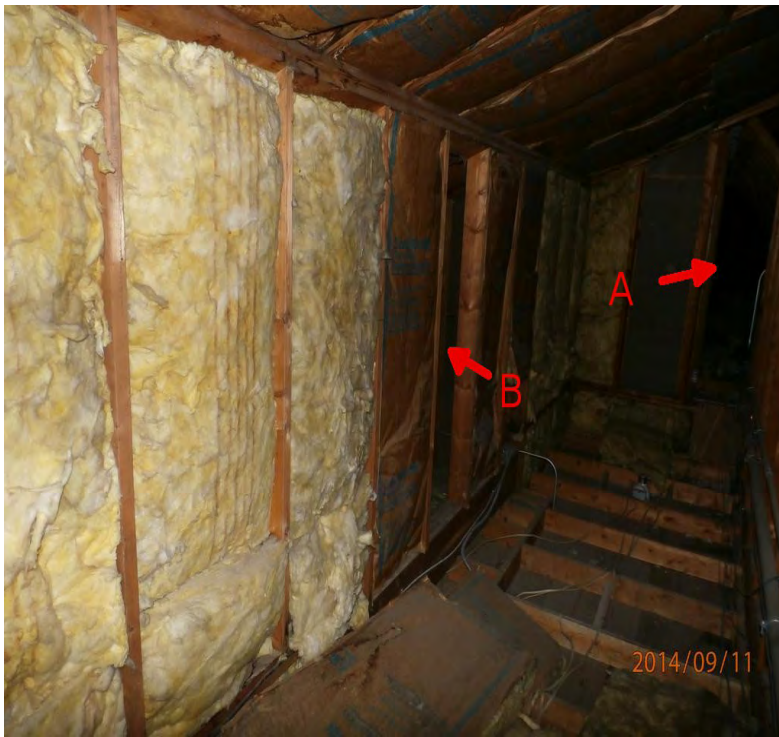
Attic above east vestibule entry has completely compromised insulation. Instead of insulating the ceiling below, vertical walls were insulated, but this insulation has now been taken down. Lobby ceiling is directly exposed to outdoor air. This space has served as a pathway from the north to south attics for IT wiring. Insulation at arrows A and B, plus the spot we are looking from, has been taken down. Bare gypsum on the Lobby ceiling can be seen at the bottom of the photo. This area should be insulated using blown-in insulation on the bottom, and walkboards should allow access for IT wiring changes.

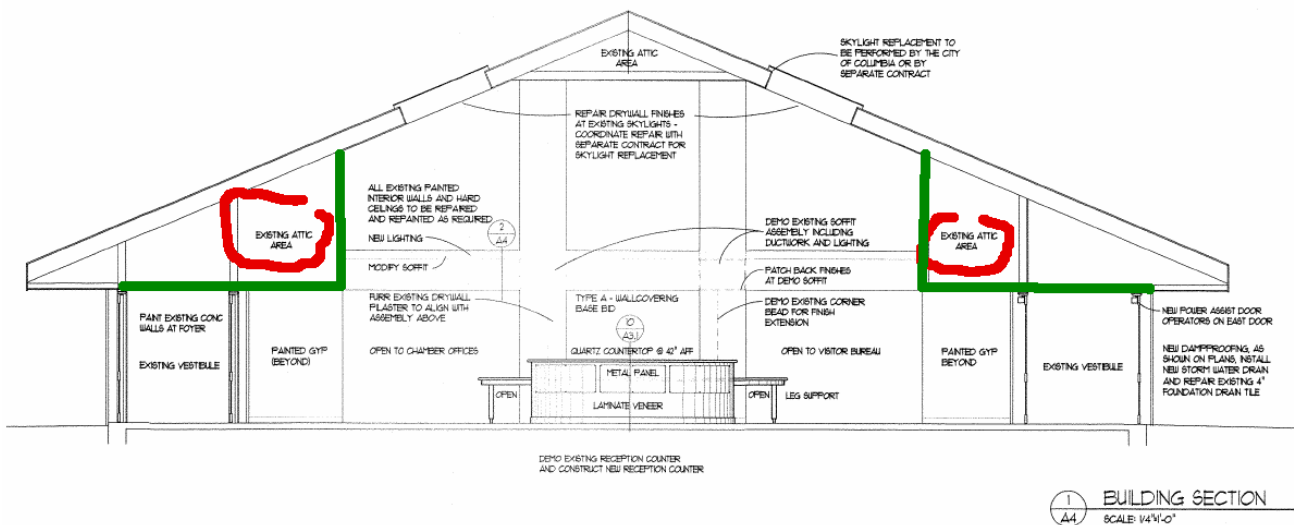
Attic area in previous photo is shown on this building section in red. Areas shown in green should be insulated, and walkboards should allow maintenance access. Current insulation for this area is ineffective and does not allow access.

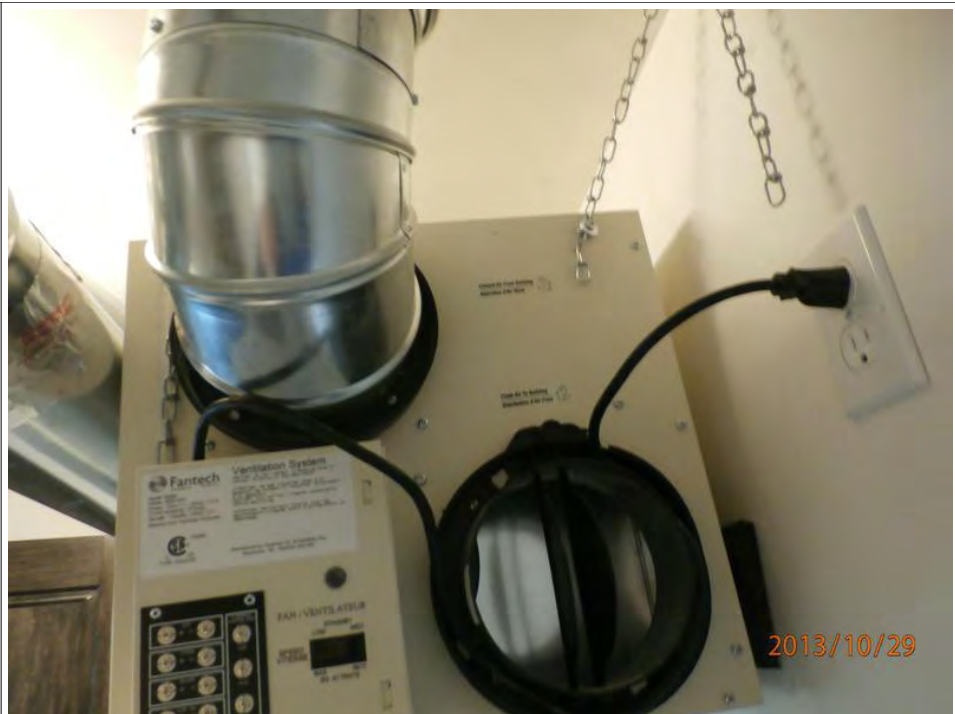
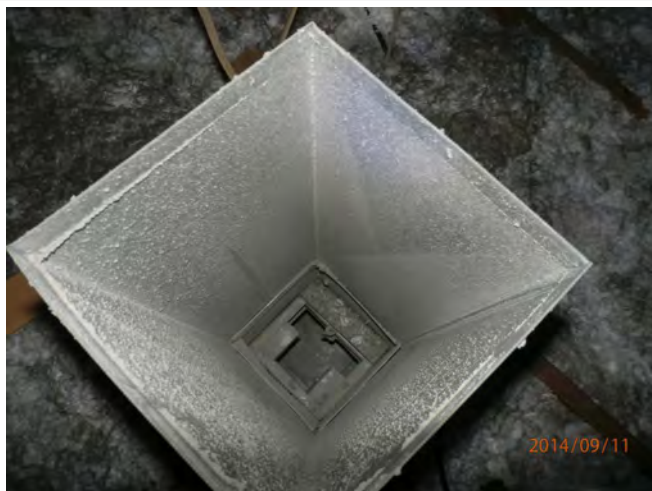
Relief vents flow directly into the attic, instead of being directed outdoors. Air continuously blows out these relief vents while the fans are running. This air is wasted, and risks creating condensation in the attic, which could promote mold. This is an opportunity to use energy recovery ventilators to capture this energy and use it to temper incoming fresh air.

Energy recovery ventilators can be used to capture waste heat from relief air.

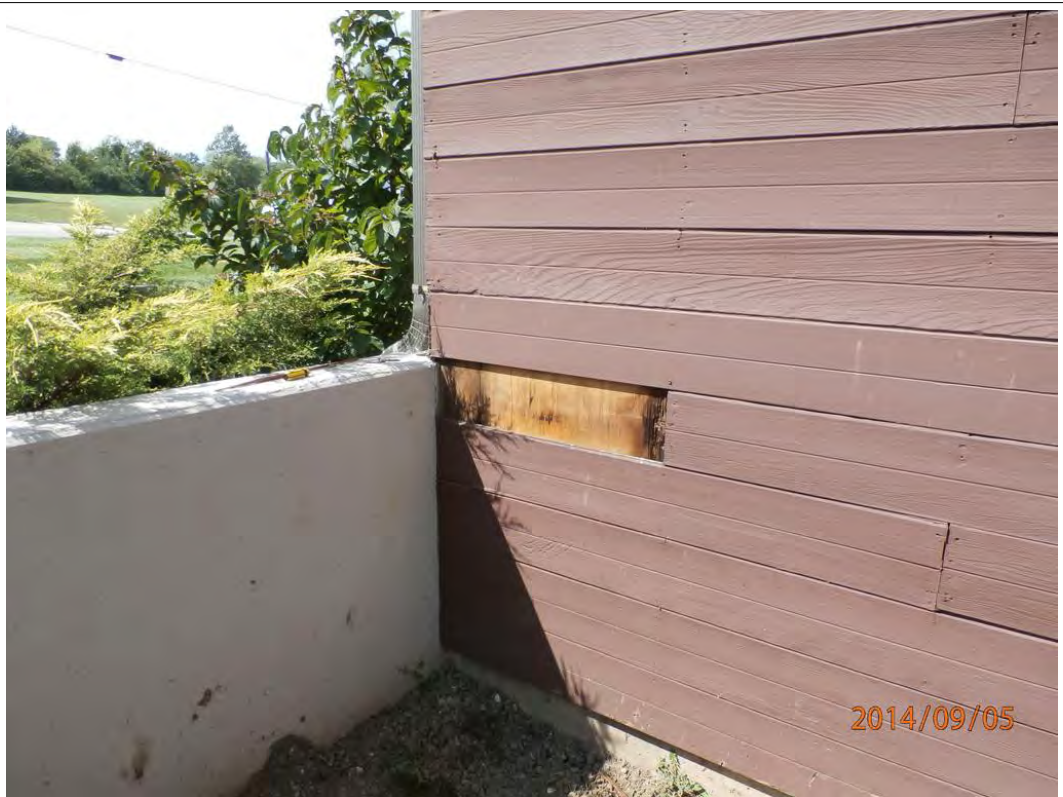
Much evidence of leaking building envelopes were observed during inspection. Rot was observed in the plywood sheathing where a piece of siding was removed on the southwest wall. There were many areas in the attic that showed evidence of past water damage, and there is currently new water damage in the ceiling of the board room near the west wall, as well as on the south wall near the floor. Outside the boardroom south wall is a concrete pad which does not slope properly away from the building. An attempt to fix this problem with spray foam was observed, an ineffective measure. This pad should be demolished and a pad properly installed at a level lower than the building floor, properly sloped away from the building.

A piece of siding was removed on the South West corner of the building. The plywood sheathing below shows evidence of rot. There is no continuous water-and-air barrier in the existing wall. However, the plywood sheathing and wood siding do allow the wall to dry to the exterior.

ECM #9: Upgrade continuous water-and-air barrier and cladding. Do not use continuous foam insulation. Cost: \$6400. Annual Energy Savings: \$679. Payback: 9.43 years.

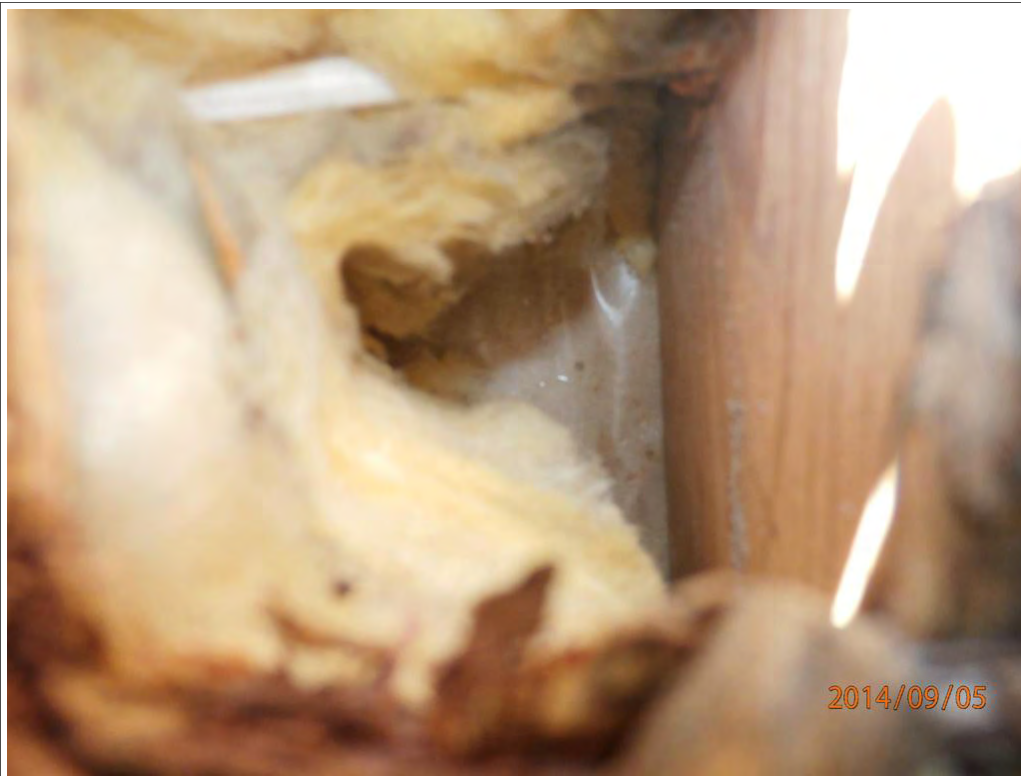
Rotted plywood sheathing was removed for inspection. A view inside shows fiberglass batts and a polyethylene barrier behind the gypsum wallboard inside. Moisture can be seen condensing on the poly sheeting, which increases the potential for mold. Poly sheeting is no longer recommended as an air barrier by building scientists because of its potential to trap moisture.
