Re: Public Hearing - Repairs to the Thomas G. Walton Building

WALTON BUILDING EXTERIOR RENOVATION DESIGN OPTIONS

Inspection Report

**Energy Conservation Assessment for
Chamber Of Commerce/
Convention and Visitors Bureau/
Office of Cultural Affairs
Thomas Walton Building
300 South Providence Road
Columbia Mo**

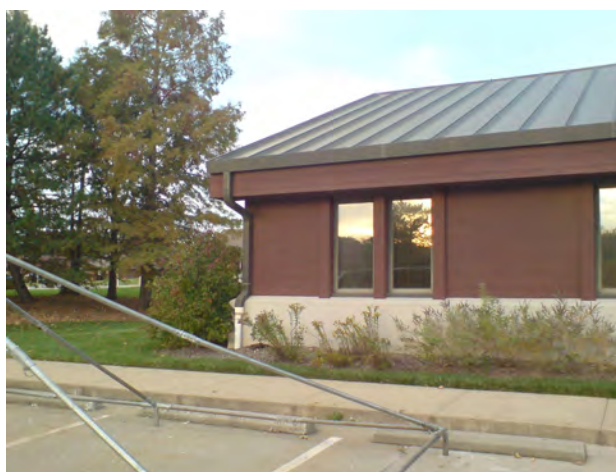
Location: east side of building. Image showing presence of moisture where indicated. See page 3.

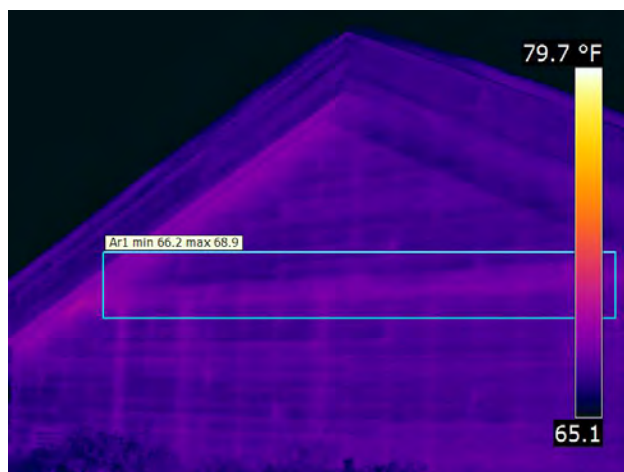
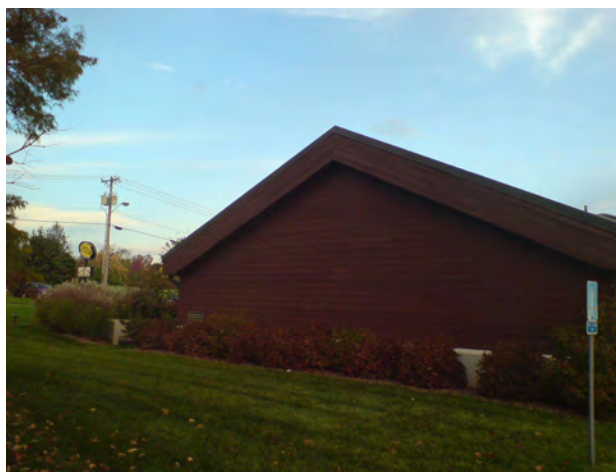
Location: south side of building. Image idicating moisture infiltration.

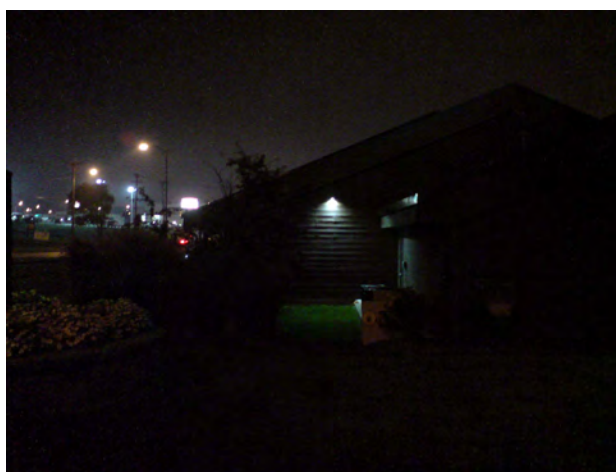
Location: west side of building. Image indicating areas of moisture inside walls. See page 2.

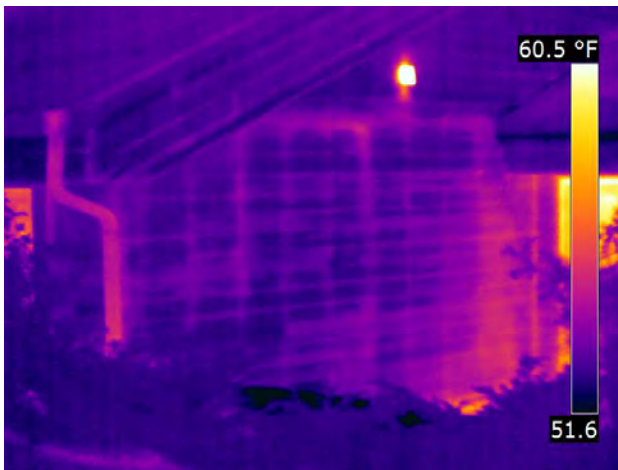
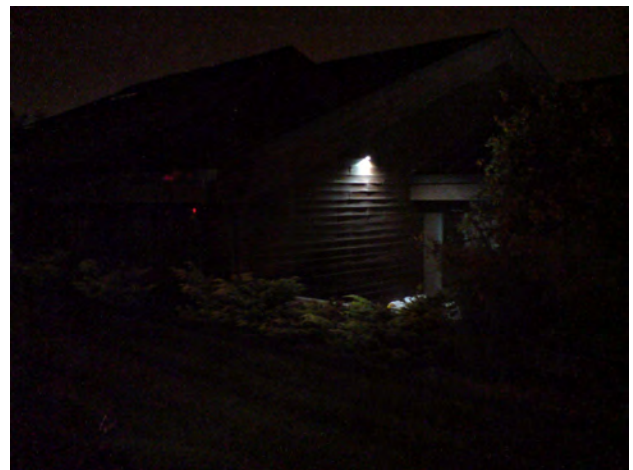
Location: west side of building. Image showing areas with wet insulation.

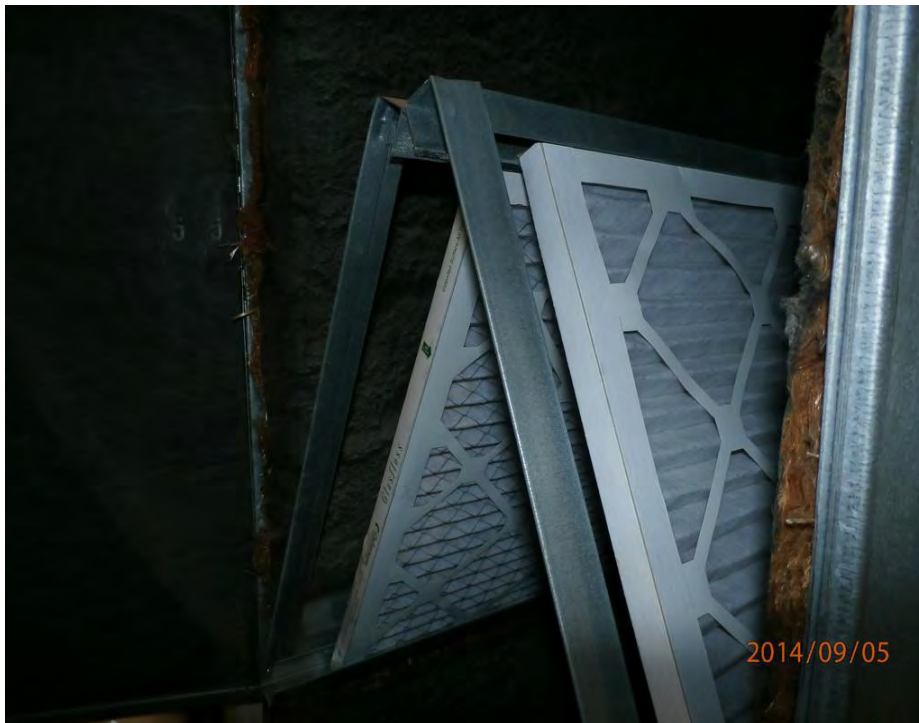
Many air handlers had improperly sized filters installed. These ill-fitting filters allow dust to bypass the filter, fouling coils. Cooling coils fouled with dust reduce efficiency and could cause freeze-up, resulting in expensive service calls. All air handlers should have coils professionally cleaned, and correct filters should be installed. The correct filter size for all units is 25X20X1. Many 22X20X1 filters were observed.

Maintenance Issue: Many air handlers had incorrectly sized filters, allowing coils to collect dirt.

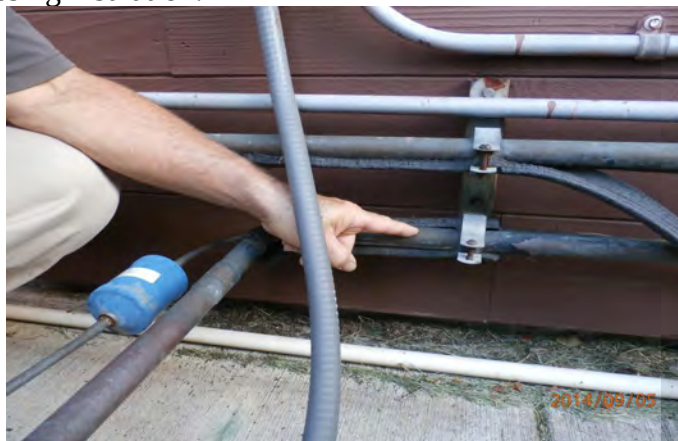
Much of the insulation on exterior refrigeration piping is damaged, which means that the efficiency of the HVAC is reduced. Sunlight deteriorates this kind of plastic. Have this damaged insulation replaced, and then have the insulation covered with a barrier that resists deterioration by sunlight. We estimate there is about 70 feet total of missing insulation.

Much of the insulation is damaged or missing from refrigeration lines.

It is estimated that about 800 KWHr per cooling season is being wasted by these uninsulated pipes, and they also rob the HVAC of capacity. This means the HVAC cannot deliver full cooling where it is needed. An estimate of the annual energy cost of the uninsulated pipes is about \$87. Repairing the pipes when the serviceman is already on the job doing a seasonal check would cost about \$70, making the payback on this measure 0.8 years or one cooling season. The technician should install a cover on the insulation that will resist sunlight.

ECM #4: Repair damaged refrigeration insulation and install a weather- and sunlight-proof covering. Cost: \$70. Annual Energy Savings: \$87. Payback: 0.8 years.

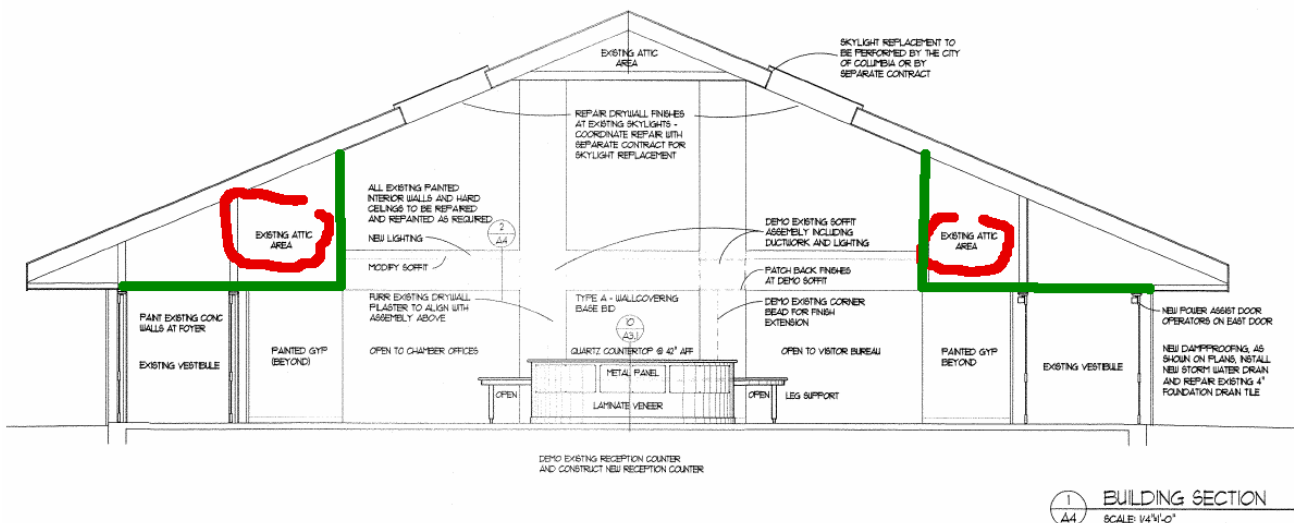
Attic area in previous photo is shown on this building section in red. Areas shown in green should be insulated, and walkboards should allow maintenance access. Current insulation for this area is ineffective and does not allow access.
