Agenda Item Number: REP 90-15

Re: Hazardous Tree Removal Report: Stephens Lake Park

Basic Tree Risk Assessment Form

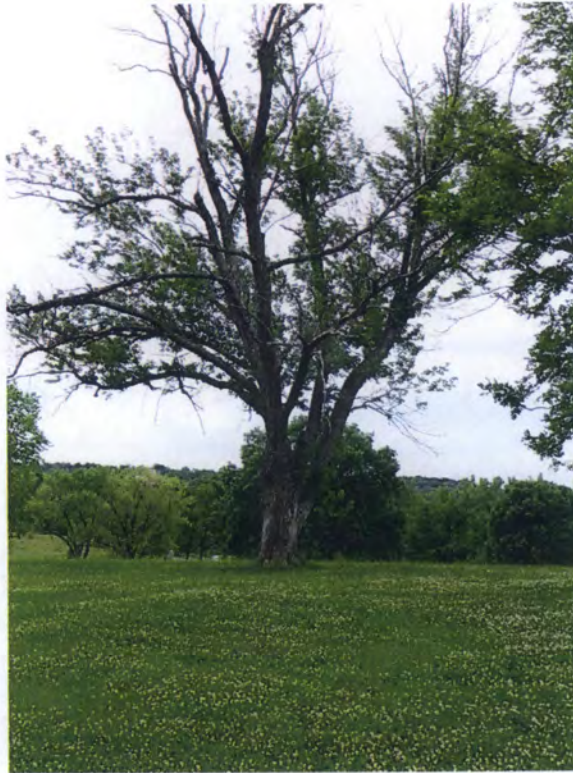
Vigor Low ☒ Normal ☐ High ☐ Foliage None (seasonal) ☐ None (dead) ☐ Normal 70 % Chlorotic _____ % Necrotic 30 %
 Pests _____ Abiotic _____
 Species failure profile Branches ☒ Trunk ☐ Roots ☐ Describe Tree has major dieback in canopy and has begun shedding large limbs

Significant amount dead/dying limbs

Mitigation options Tree should be removed and new plantings installed in its place.

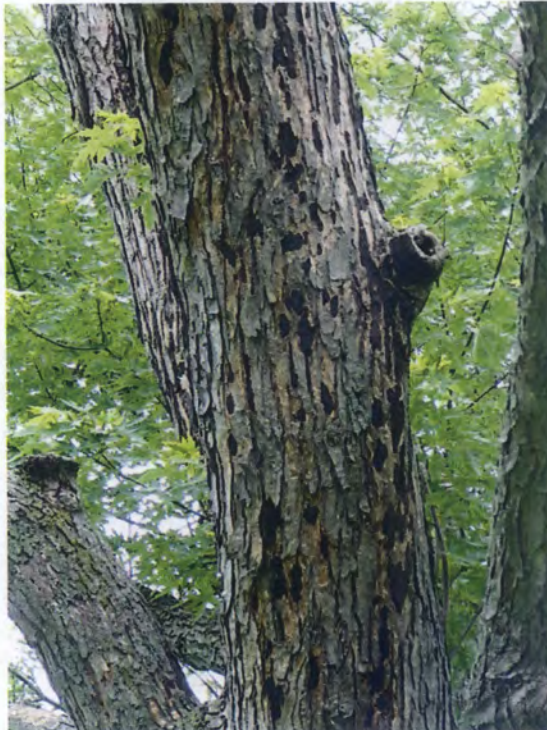
Dead/Missing bark ☒ Abnormal bark texture/color ☐
 Codominant stems ☒ Included bark ☒ Cracks ☐
 Sapwood damage/decay ☐ Cankers/Galls/Burls ☐ Sap ooze ☐
 Lightning damage ☐ Heartwood decay ☐ Conks/Mushrooms ☐
 Cavity/Nest hole _____ % circ. Depth _____ Poor taper ☐
 Lean _____ ° Corrected? _____
 Response growth _____
 Main concern(s) potential for dead/dying codominant stems to split out
 Load on defect N/A ☐ Minor ☐ Moderate ☐ Significant ☒
 Likelihood of failure Improbable ☐ Possible ☐ Probable ☒ Imminent ☐

Significant bark loss/decay on main trunks

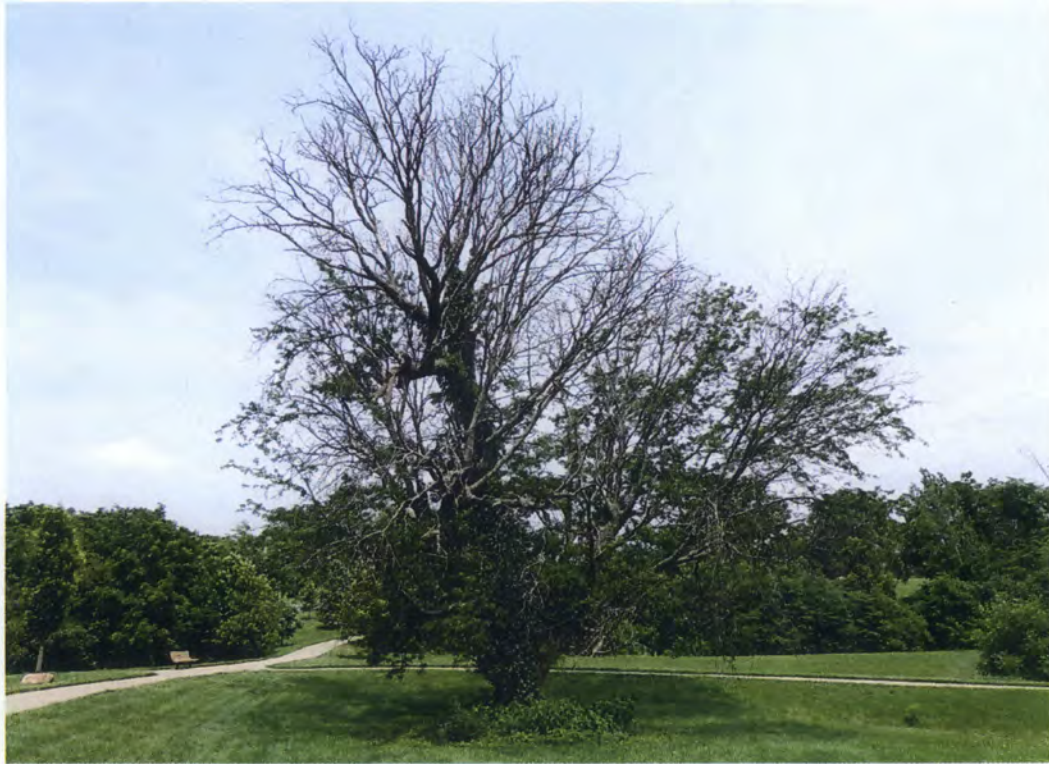
Existing Conditions – Honeylocust Tree
Stephens Lake Park – Adjacent to fitness trail and lake trail

The second tree recommended for removal is a Honeylocust tree located on the north side of Stephens Lake Park along the hard surface trail. The Honeylocust tree has grown to a mature height of 65 feet with a 49-inch Diameter at Breast Height. The tree has approximately 30% living crown and has shown visible signs of rot, decay and cavity in the branches and root crown. The visual signs of rot at the branch attachments is a clear sign of branch failure. Forestry staff has observed falling limbs and deadwood in the tree over the last 2 years and blame the decline over the past year due to the severe drought of 2012. Staff is requesting permission to remove the failing tree due to the risk of failure and public safety due to the proximity to the Stephens Lake Park fitness trail.

Notes, explanations, descriptions The majority of this tree's canopy is dead and the branches are rapidly decaying. Failure of these branches is imminent. Several of the larger live branches have advanced heartwood decay from previous failures. This tree not only looks bad but is also a large threat to park users.

Only 30% of tree canopy is still alive / large amounts of deadwood

Mitigation options No options due to condition and age

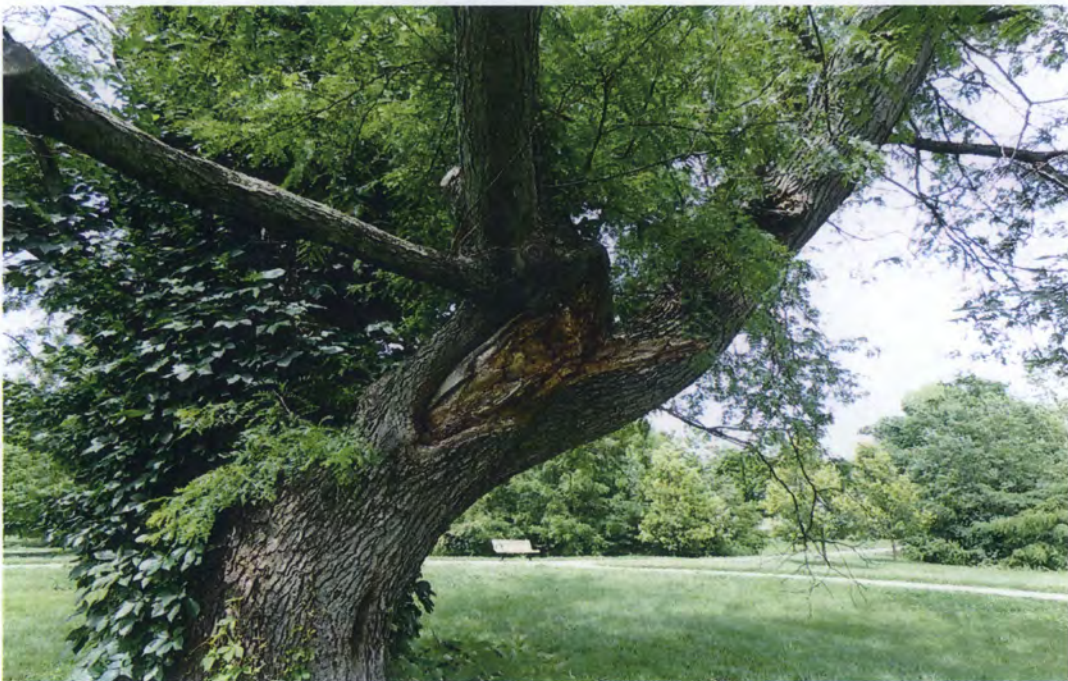
Dead/Missing bark ☒ Abnormal bark texture/color ☒
 Codominant stems ☒ Included bark ☒ Cracks ☒
 Sapwood damage/decay ☒ Cankers/Galls/Burls ☐ Sap ooze ☒
 Lightning damage ☐ Heartwood decay ☒ Conks/Mushrooms ☐
 Cavity/Nest hole _____ % circ. Depth _____ Poor taper ☐
 Lean _____ ° Corrected? _____
 Response growth _____
 Main concern(s) _____
 Load on defect N/A ☐ Minor ☒ Moderate ☐ Significant ☐
 Likelihood of failure Improbable ☒ Possible ☐ Probable ☐ Imminent ☐

Large wound with decay at base of tree / entry point for disease and fungus

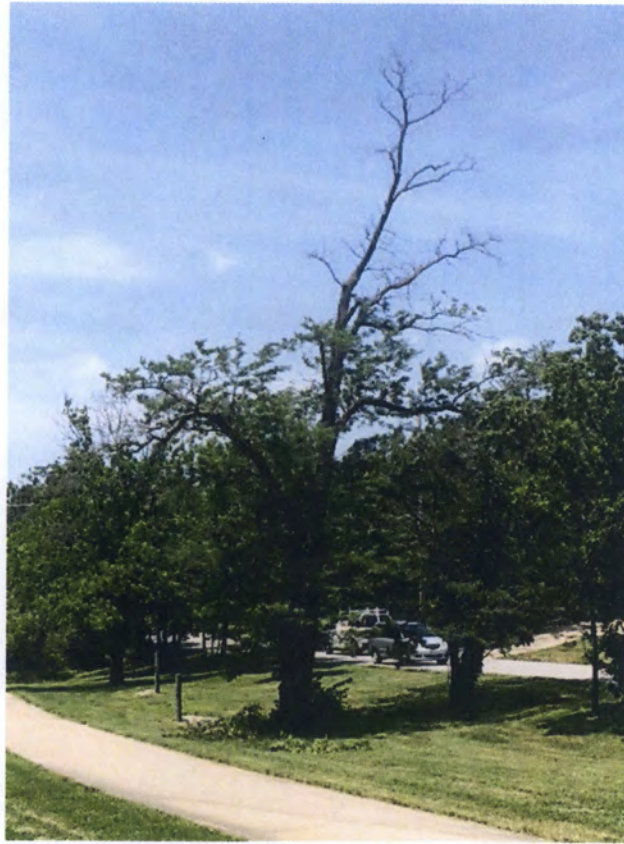
Existing Conditions – Honeylocust
Stephens Lake Park – Adjacent to Fitness Trail and Amphitheater

The final tree recommended for removal by Forestry staff is a mature Honeylocust tree located in the northwest corner of Stephens Lake Park. The tree has a 32-inch diameter at breast height and a total height of 40 feet. The Honeylocust currently has signs of complete decline in the upper 40% of the tree and has undergone multiple pruning cycles in which significant amounts of deadwood were removed. The continued dieback in the canopy continues to pose a hazard to East Walnut Street and park patrons utilizing the hard surface trail and amphitheater. The tree has shown previous signs of branch and major stem failure and will continue to drop large, dead limbs if it is not removed. The removal of the tree is necessary due to the weakened state of the tree and safety issues for park patrons.

Response growth _____
 Main concern(s) Tree has been in a long term cycle of decline. Yearly dieback has been routinely pruned and removed. Over 65% of original canopy has been removed or is currently dead and threatening a roadway and fitness trail
 Load on defect N/A ☐ Minor ☒ Moderate ☐ Significant ☐
 Likelihood of failure Improbable ☐ Possible ☐ Probable ☒ Imminent ☐

Significant limb loss over past three years/Removal of large amount of canopy

Mitigation options Tree has undergone multiple pruning cycles where significant amounts of dead wood were removed. Tree has continued to decline, and only a small percentage of the original canopy is still living. I believe it is time to remove the entire tree, as the dieback in the canopy continues to pose a hazard to the roadway and fitness trail below. Residual risk _____
 Residual risk _____
 Residual risk _____
 Residual risk _____

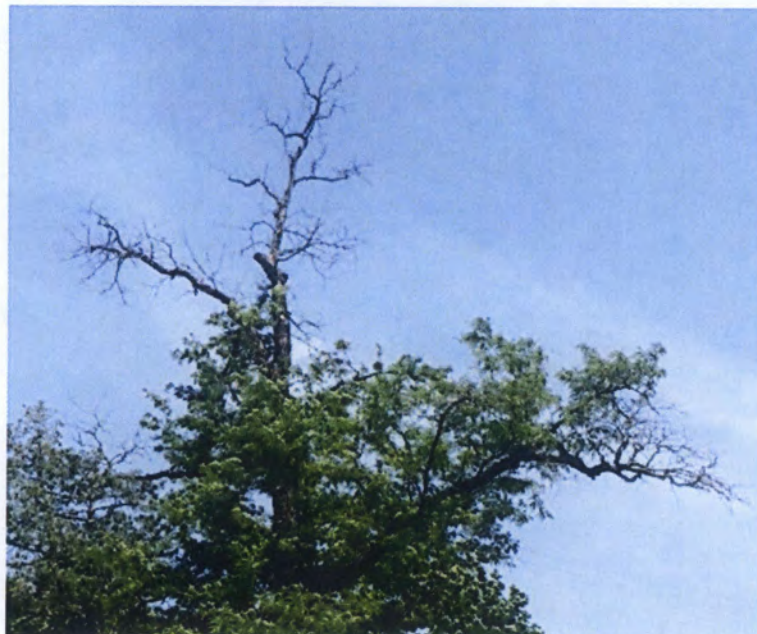
Dead limbs hanging over East Walnut Street and fitness trail
