Re: Setting a Public Hearing for Improvements to the Historic Maplewood Home at Nifong Park

MAPLEWOOD HOUSE

3701 Ponderosa St.

BUILDING SURVEY, July 2015

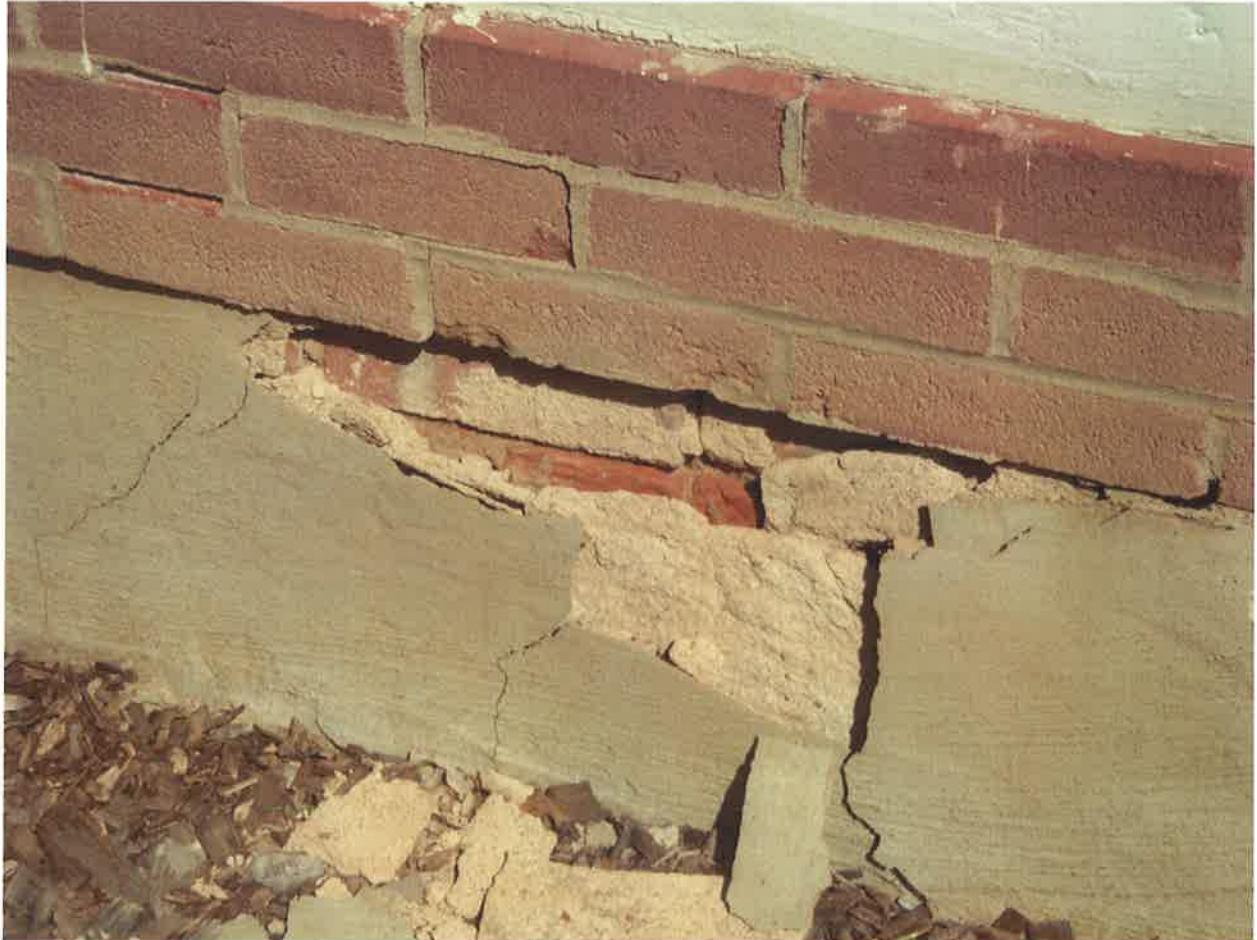
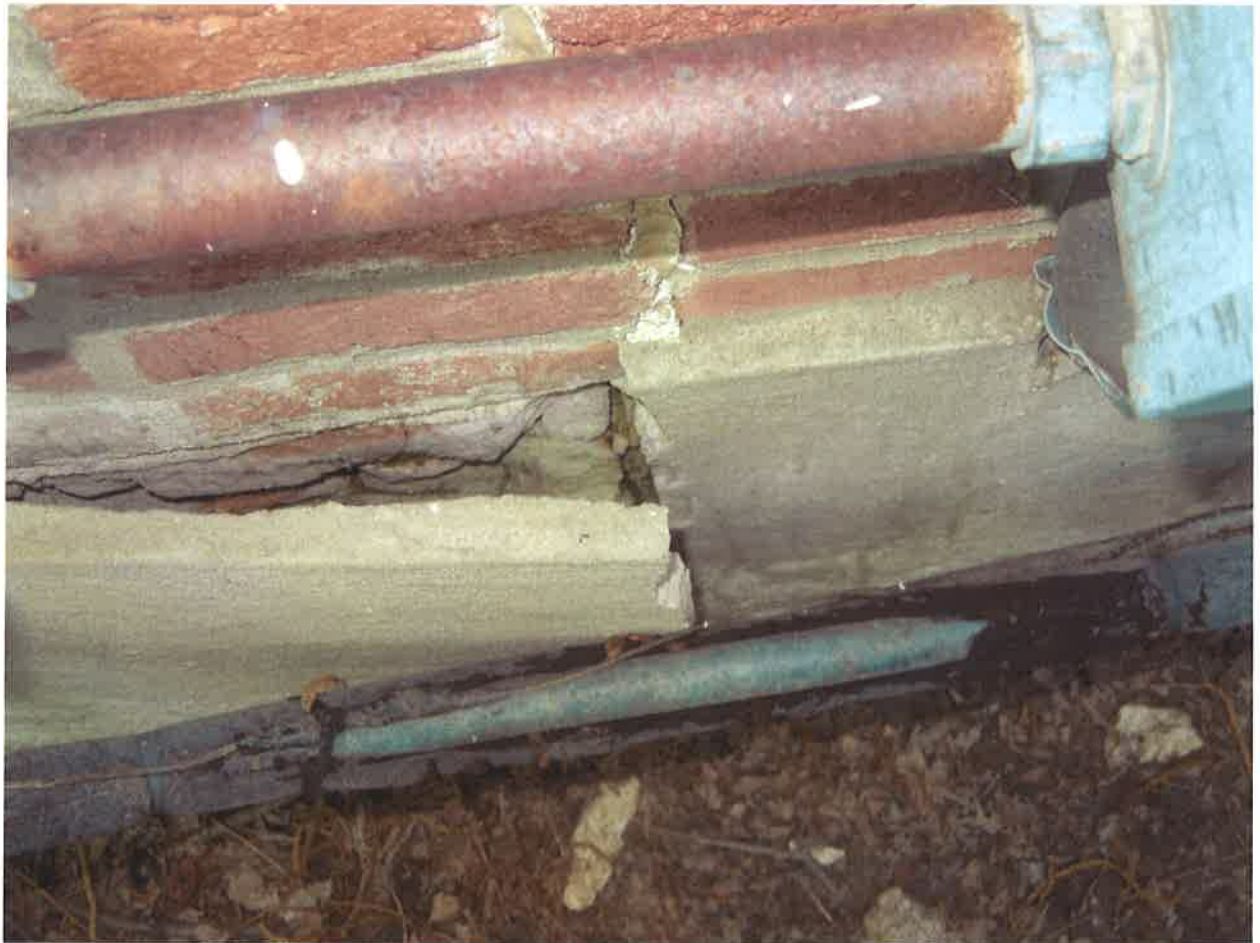
Foundation Parging

The building sits on a brick foundation which appears to be the same brick the above grade exterior walls are constructed. A parging coat of mortar covers the foundation brick. The parging extends below grade and I assume terminates at the foundation footing. The above grade foundation parging is damaged / deteriorated in several locations. Due to the weathering effect of the soil and moisture, and the likely movement of the foundation it is credible the below grade parging is in poorer condition explaining basement ground water infiltration and excessive crawl space moisture.

It is my experience the most effective method for waterproofing / damp-proofing a foundation is done on the exterior. The process begins by excavating along the wall, all the way down to the footings. Dirt, loose mortar, brick dust and parging are removed from the foundation wall and a "parge" coat of mortar is applied over the entire wall that provides a more uniform and above grade decorative surface.

Once the parge coat has cured, an exterior waterproofing membrane consisting of asphalt-modified polyurethane is applied to the below grade wall. Next install a foundation drain tile system with a sump pump. The excavated trench is filled to within two feet of the final grade with a granular backfill such as 1" clean rock. The remaining portion of the ditch is backfilled with clean soil and graded causing positive surface water drainage away from the foundation.

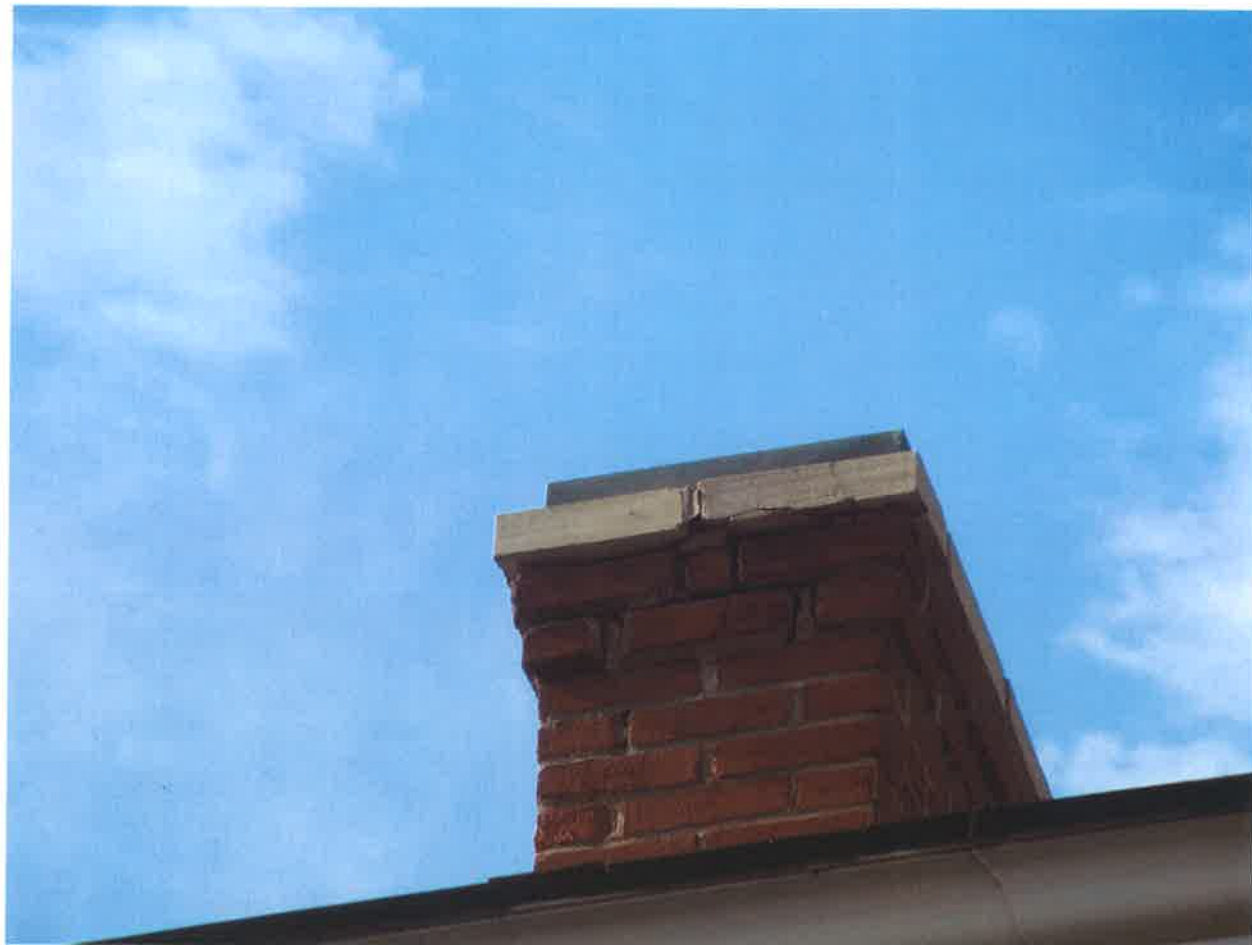
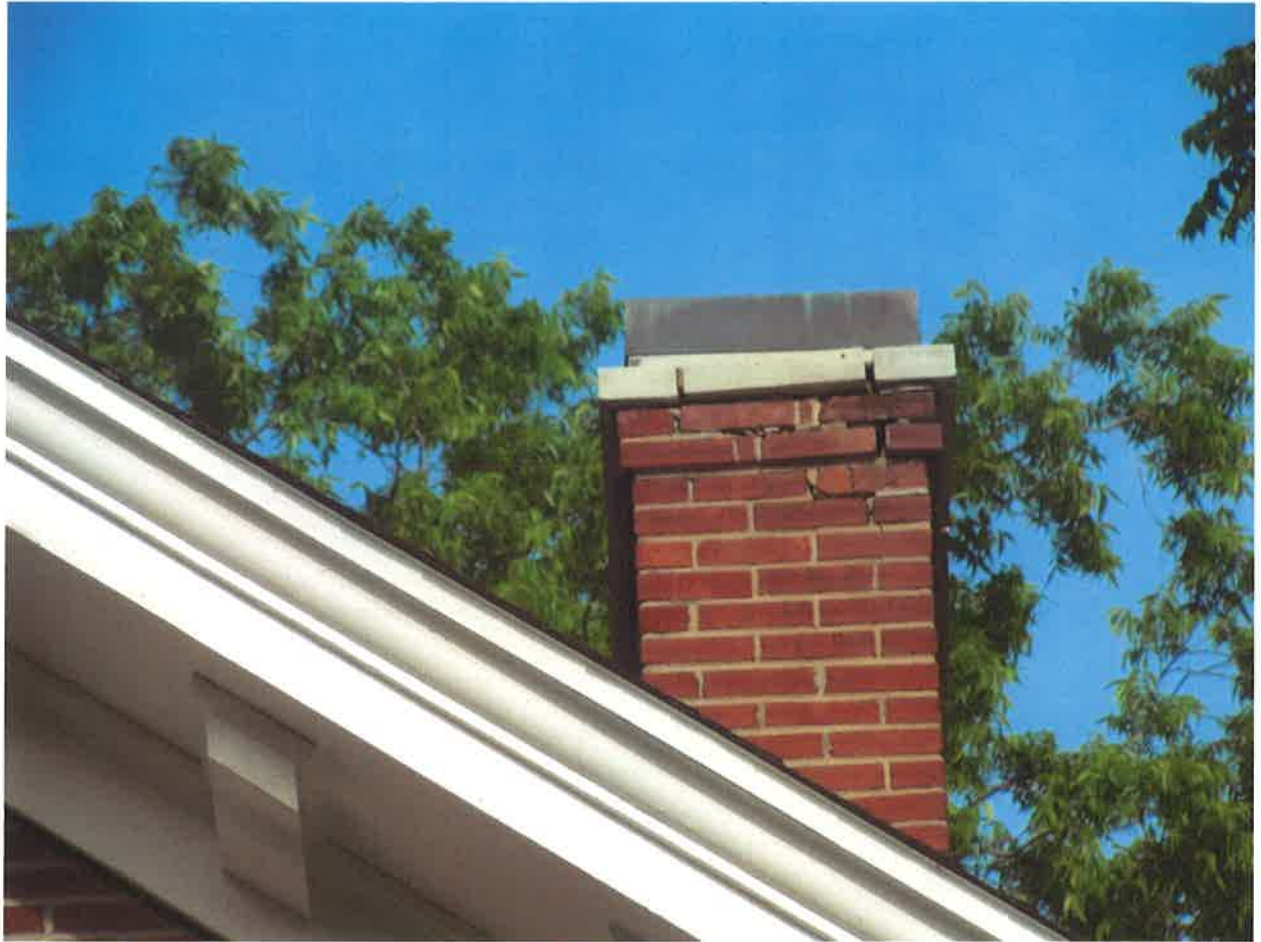
Brick Chimney

There are four brick chimneys, three are nonfunctional, one is used as a metalbestos furnace flu chase. All four brick chimneys need repointing, and portions of three chimneys needed to be rebuilt above the roof line. All sheet metal chimney caps are not properly secured and sealed.

As a general rule conditions which require repointing include: (1) mortar erosion equal to or greater than one quarter (1/4) inch (2) crumbling mortar, (3) hairline cracks in the mortar, and (4) cracks between the brick and mortar. As shown in the attached photos (BrickChimney1-7) portions of the Maplewood House chimneys' mortar deterioration exceeds the above guidelines warranting a partial rebuild.

The occasional repair of the mortar joints is expected over the life of the brick masonry. Unfortunately the occasional repair of the brick chimneys' mortar joints has not occurred. That is why portions of the chimneys are deteriorated to the point warranting a partial rebuild.

An imperative reason for repointing brick masonry is to improve water penetration resistance and maintain structural integrity. Repointing mortar joints is one of the most effective and permanent ways of decreasing water entry into brickwork. This is because the most common means of water entry into brick masonry is through deboned, cracked or deteriorated mortar joints.

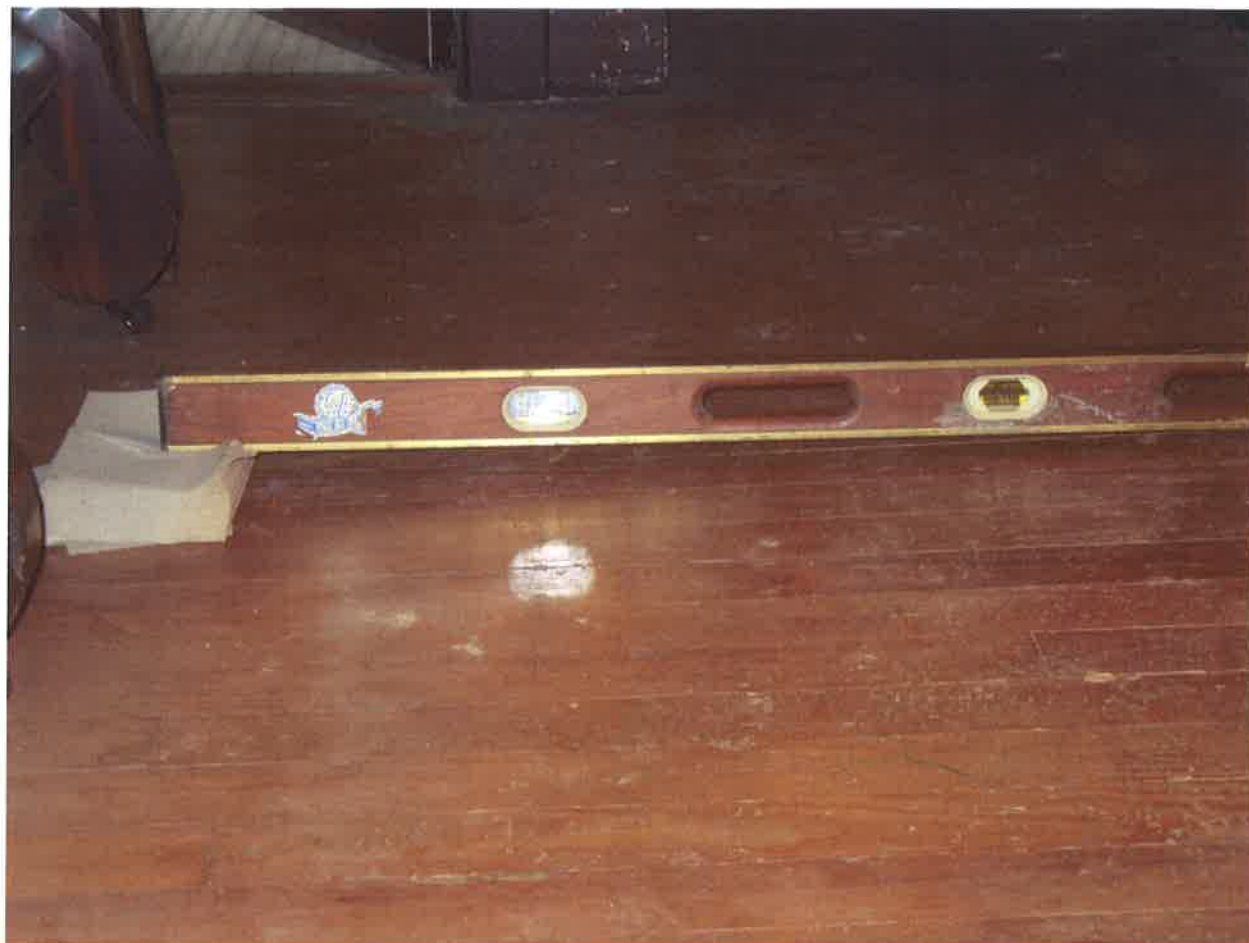
Unlevel Floor

The down stair bathroom, the adjoining utility room and the adjoining hall way floor assemblies have failed. These floors are out of level three quarters of an inch (3/4") in three (3) feet meaning a 2% slope. The down stair bathtub is falling through the subflooring. These conditions are due to improperly support floor joists and beams, rotting/damaged floor joists and rotting subflooring. Defective conditions include improper bearing and support, termite damage and dry/wood rot due to excessive moisture.

The observed structural deficiencies are limited to the kitchen, the adjacent hallway, first floor bathroom and the utility room floor assemblies (beams, beam supports, floor joist and subflooring). The majority of this area is above a crawl space which I was unable enter. My assessment is based upon visual observations from the basement, an access opening in the basement to the adjoining crawl space and the finished spaces above. Though I did not inspect every framing member for material damage, fatigue, bending, bearing, etc., I did note conditions such as floor slope and specific deficiencies such as wood decay and improper support to warrant my recommending a compressive structural analysis of these areas and subsequent repairs.

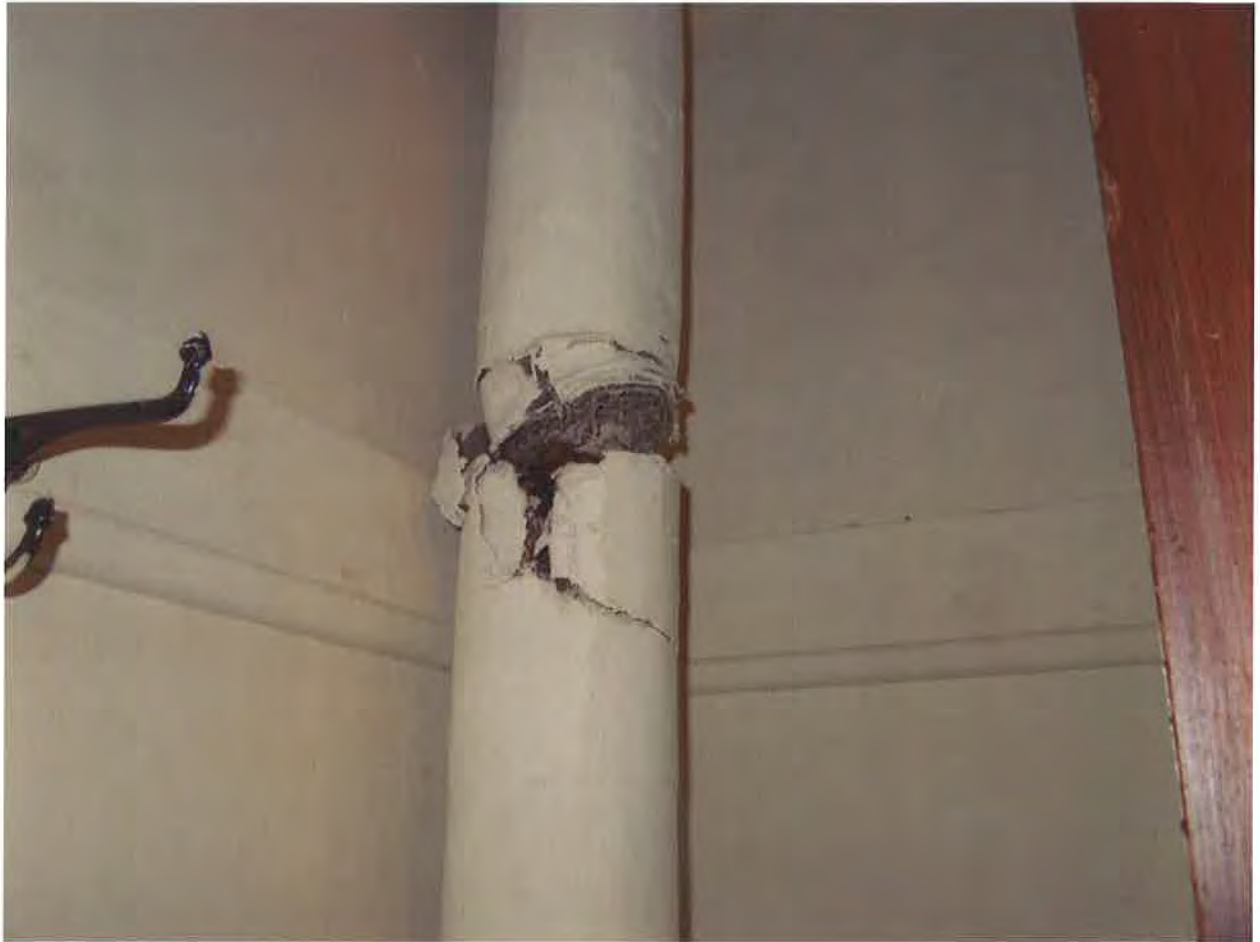
Asbestos

There is evidence the Maplewood house was heated by a steam boiler, supply and return piping and radiators. I am unable to determine when that heating system was installed or removed. There is a remaining supply circulation line in a closet located in what I call the living room. This room is located on front southeast corner of the structure. This line is wrapped with what I believe to be asbestos insulation. I believe the material is asbestos based upon its appearance and the common use of asbestos insulation for many decades.

Due to its age and appearance it is prudent the abandoned insulated boiler piping be tested for asbestos and abated based upon the reports finding. The City has a Term and Supply Contract with ARSI for asbestos testing and abatement. Due to the nature of this possible hazard I recommend the City go forward with the testing and possible abatement of this material as soon as possible.

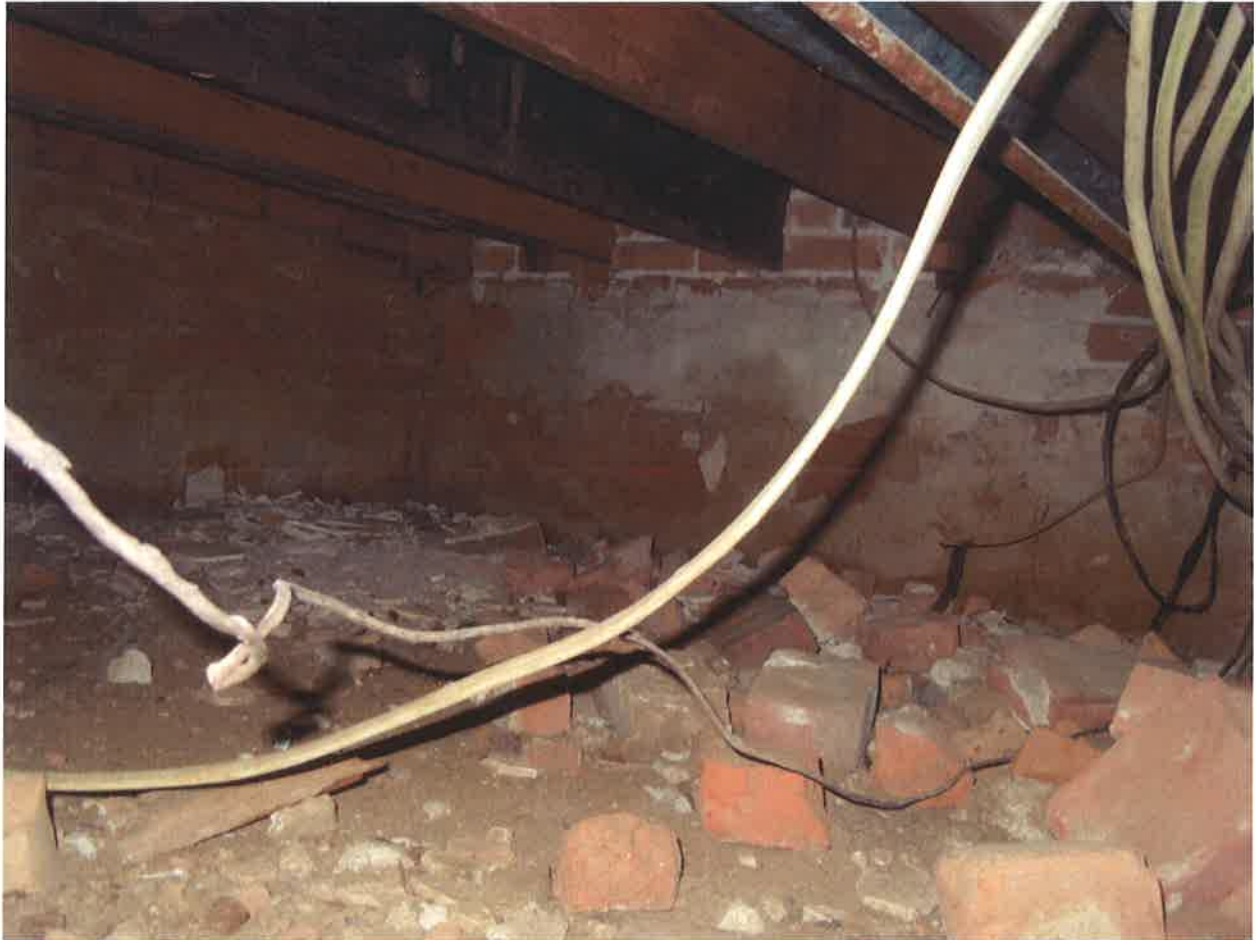
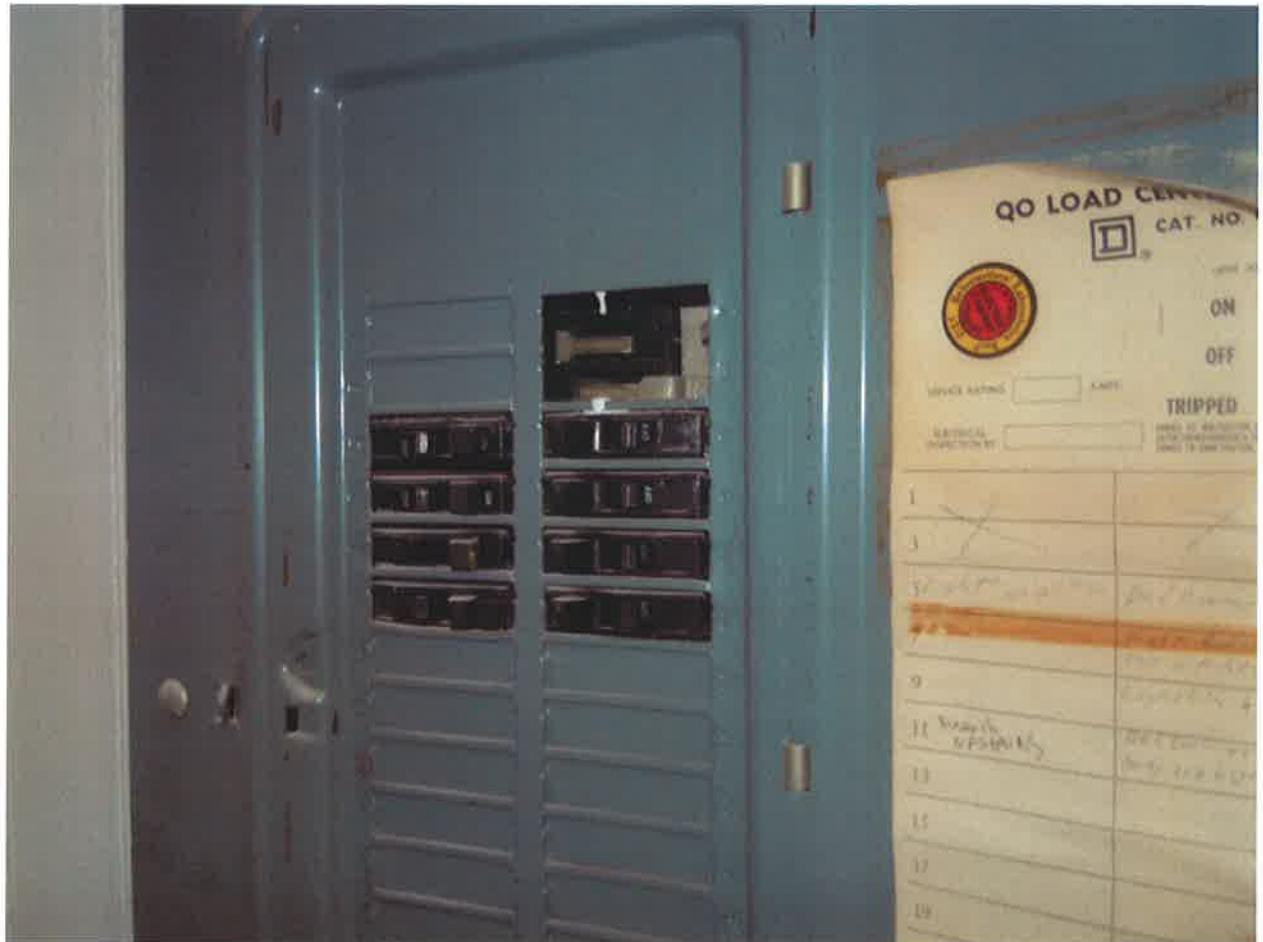
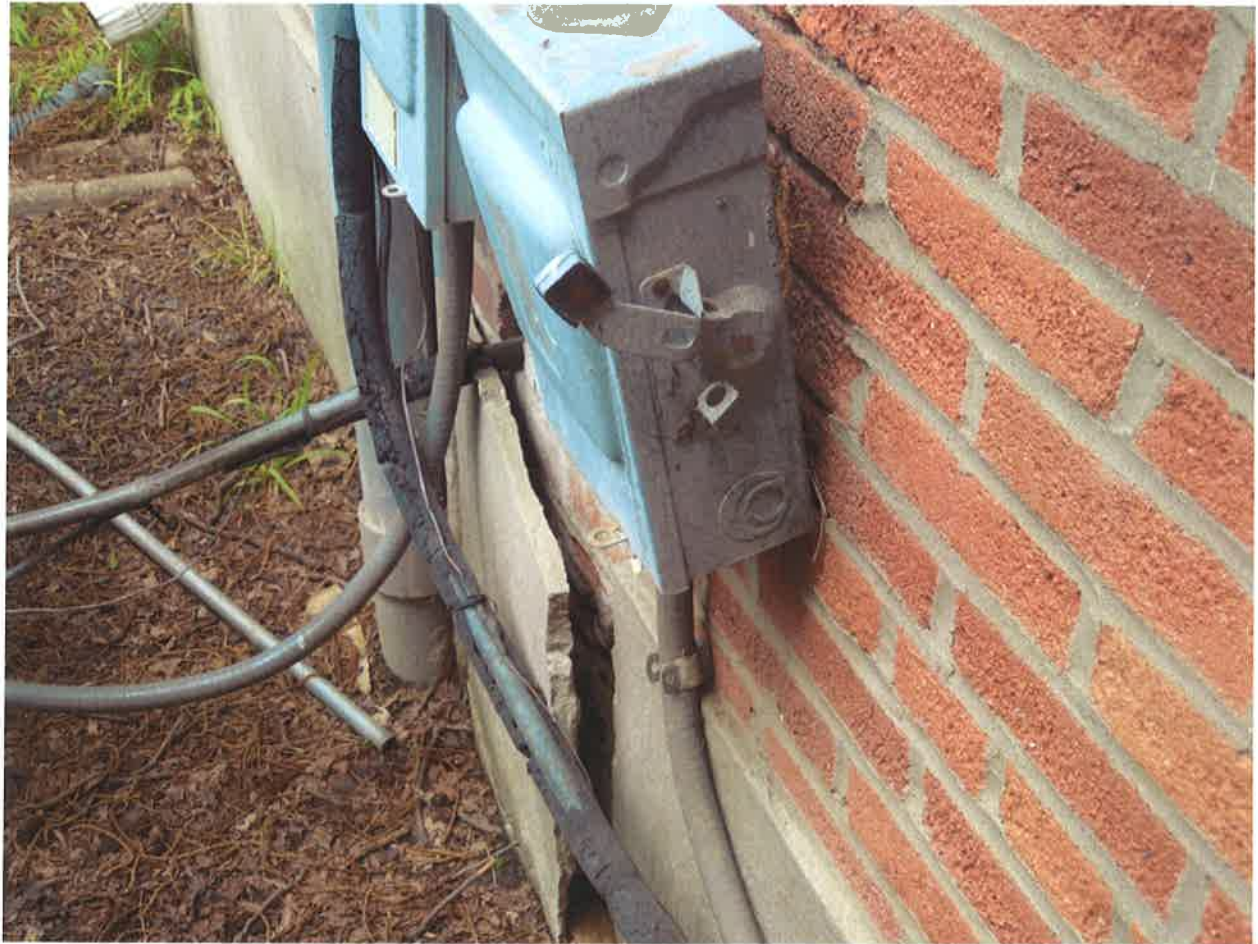
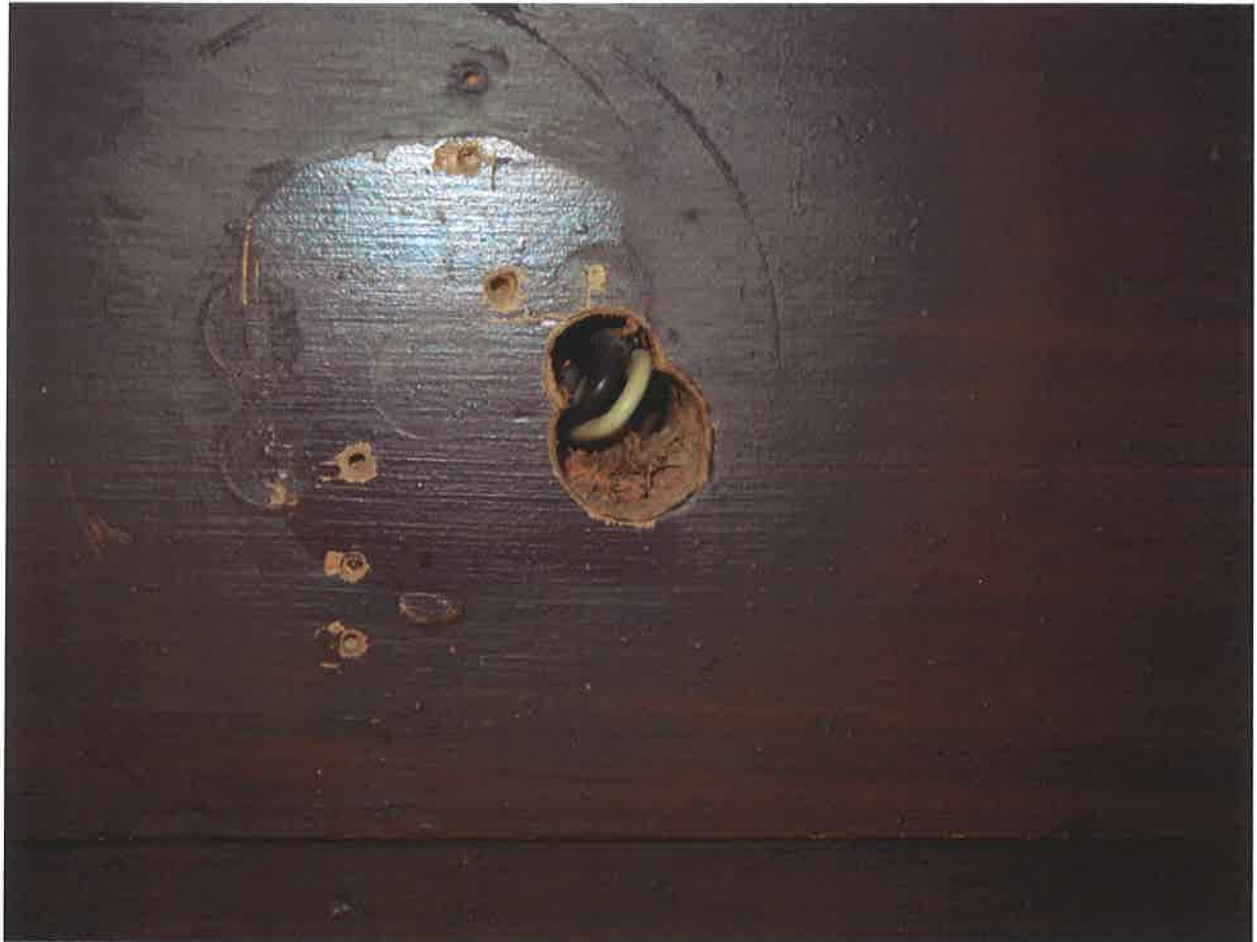
1. Pinched wire in basement light.
2. Improperly supported / secured non-metallic cable in basement and crawl space.
3. Coils of non-metallic cable in basement improperly terminated.
4. Eliminate use of extension cord in basement.
5. Exposed electrical wires and open j-boxes.
6. Electrical surface raceways improperly strapped / secured.

7. Exterior AC disconnect box not secured to the structure.

The electrical system is a potential fire hazard in any structure if the integrity of the system's electrical service, distributions panels, controls, wiring, fixtures, equipment, devices and appurtenances are not properly maintained. There are a number of conditions, which I have previously listed, which qualify for classification as unsafe or hazardous. A thorough inspection and testing by a licensed electrician of the structures electrical system is needed. The inspection and testing should include:

1. Continuity
2. Bonding Conductors Continuity
3. Polarity
4. Earth Electrode Resistance
5. Wiring Methods
6. Boxes and Conduit Bodies
7. Cabinets and Cutout Boxes
8. Switches, Receptacles and Fixtures
9. Replace circuit breakers AFCI breakers

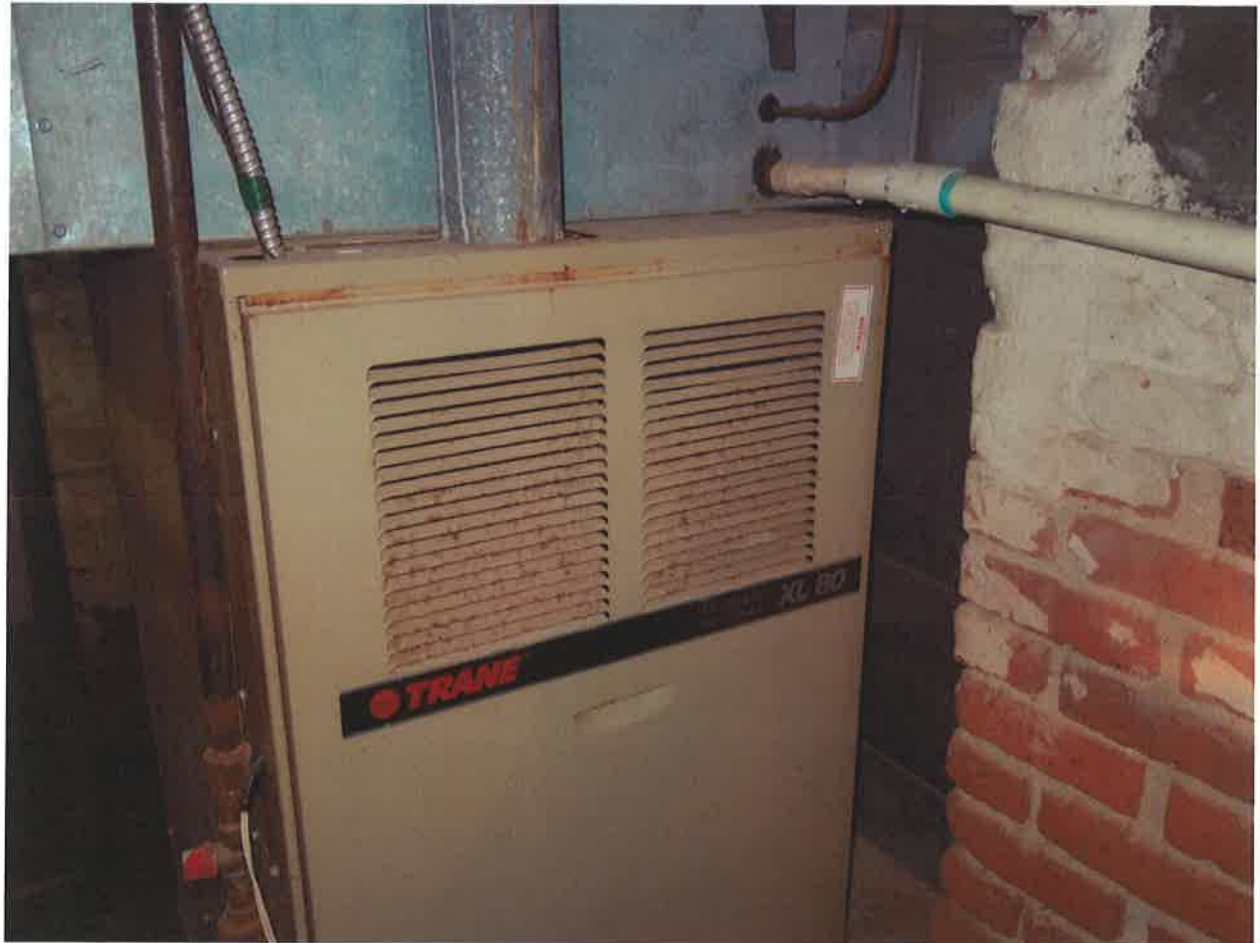
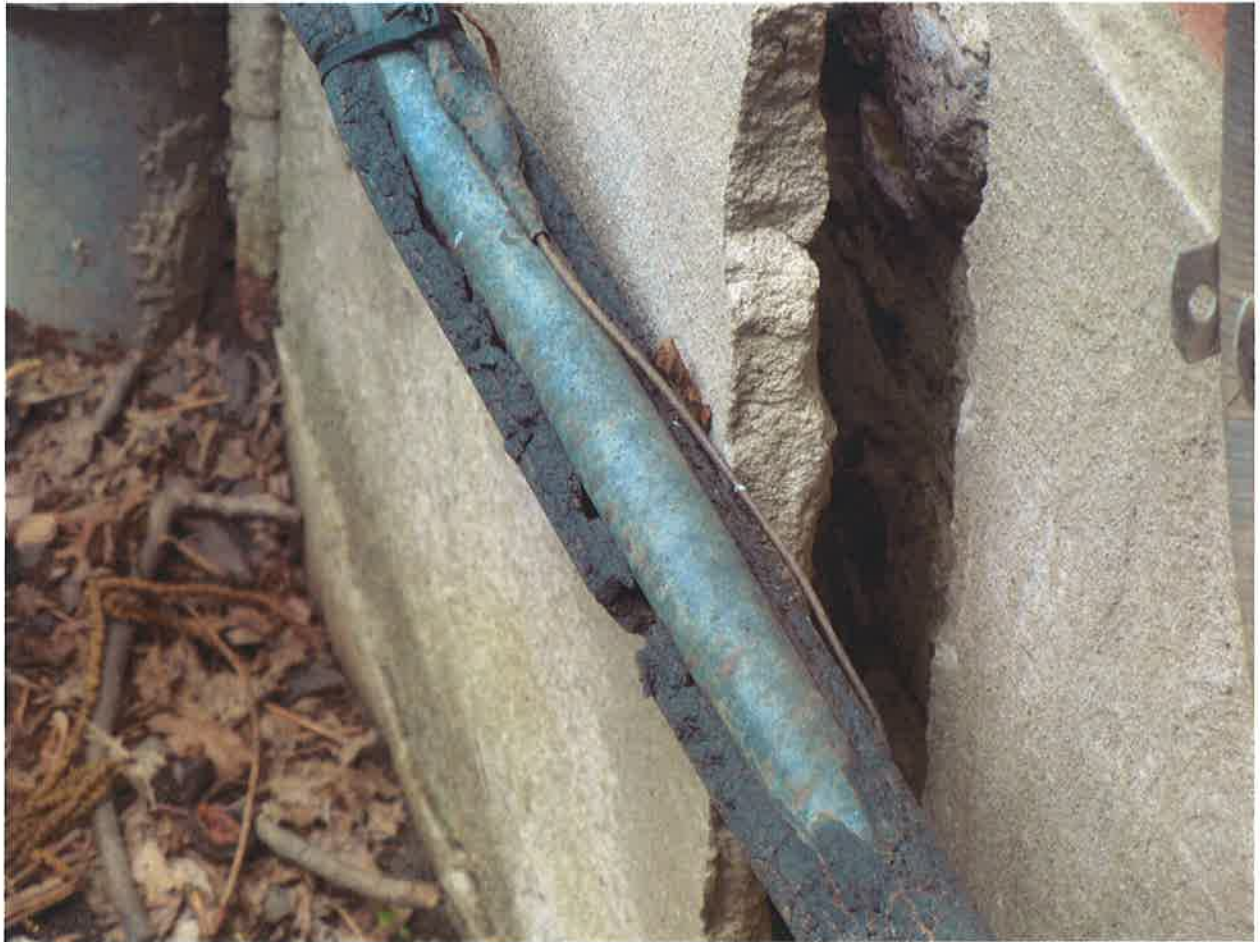
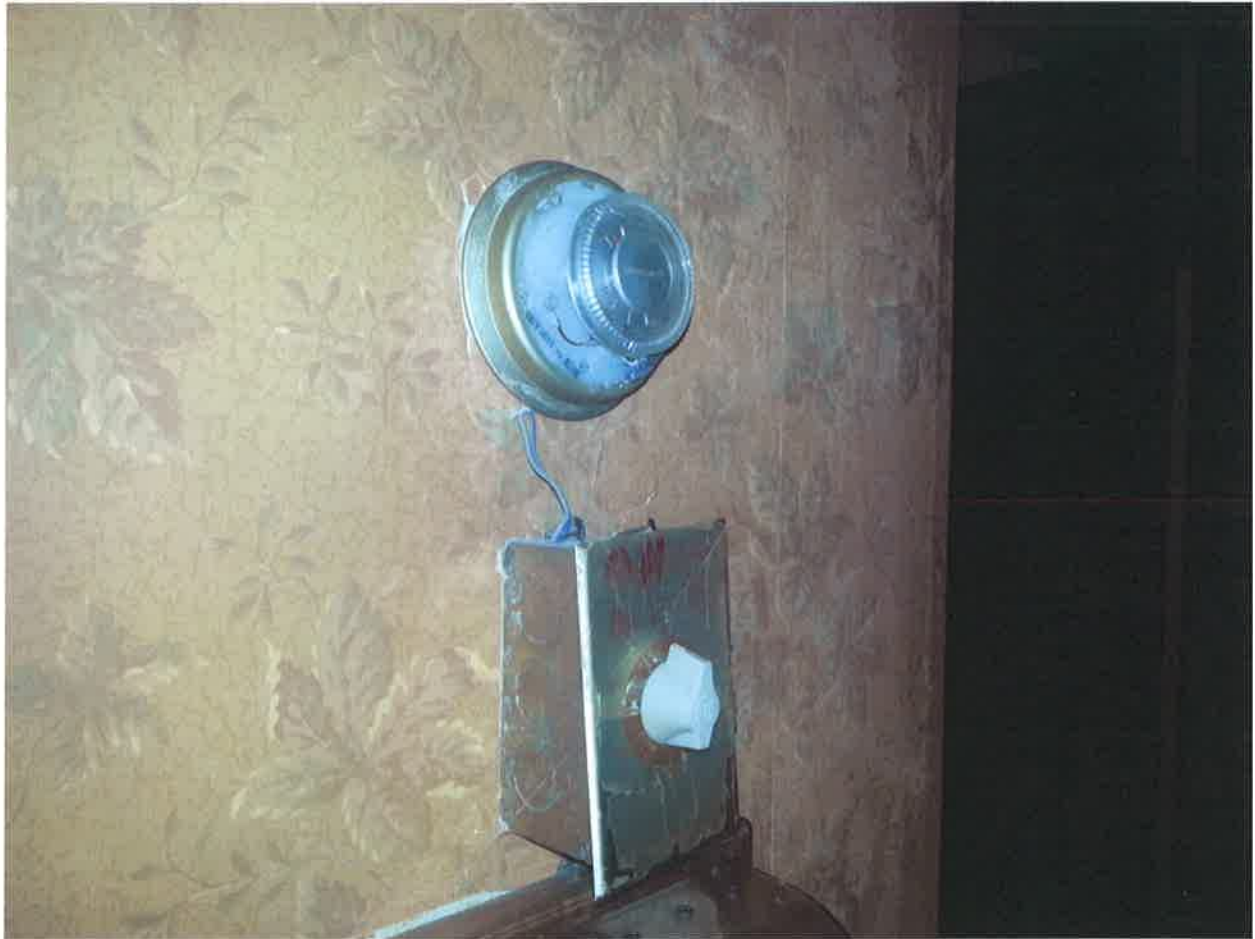
1. The first floor air handling unit (furnace) located in the basement is dated, inefficient and possibly unsafe. Due to basement ground water infiltration the furnace is rust damaged. Of greatest concern is the integrity of the heat exchanger, and the real possibility the heat exchanger rust has caused pitting and the potential release of carbon monoxide. The manufacturer's equipment plate is illegible so I am unable to determine the manufacturing date and the unit's designed efficiency based upon BTU input and output. In looking at the furnace cabinet, the gas valve, limit switch etc.; I estimate this unit was manufactured in the late seventies or early eighties at best. For equipment of this age the designed thermo-efficiency is typically around 76% under optimum conditions.

2. The two air conditioning units are at least 20 years old. Equipment of this age typically has a SEER Rating (BTUs of Cooling per watt) of 10. All equipment becomes less efficient with time, and Water & Light Energy Services staff estimates the unit's efficiency to be 7-8 SEER. The current model energy code specifies a minimum SEER rating of 13.

4. The thermostat controls are dated analog bimetallic strip controls, and probably out of calibration. These controls are inefficient, they require manual temperature setting and regulation providing minimal operational control and information such as humidity levels, when it's time to change filters and alerts when there are problems with the system.

I am recommending the replacement of the first floor air handling unit and the two air conditioning condensing units with high efficiency equipment with humidifying capabilities and smart Wi-Fi thermostats. The existing HVAC equipment and controls are inefficient and lack the capability of creating and regulating the needed interior climate.

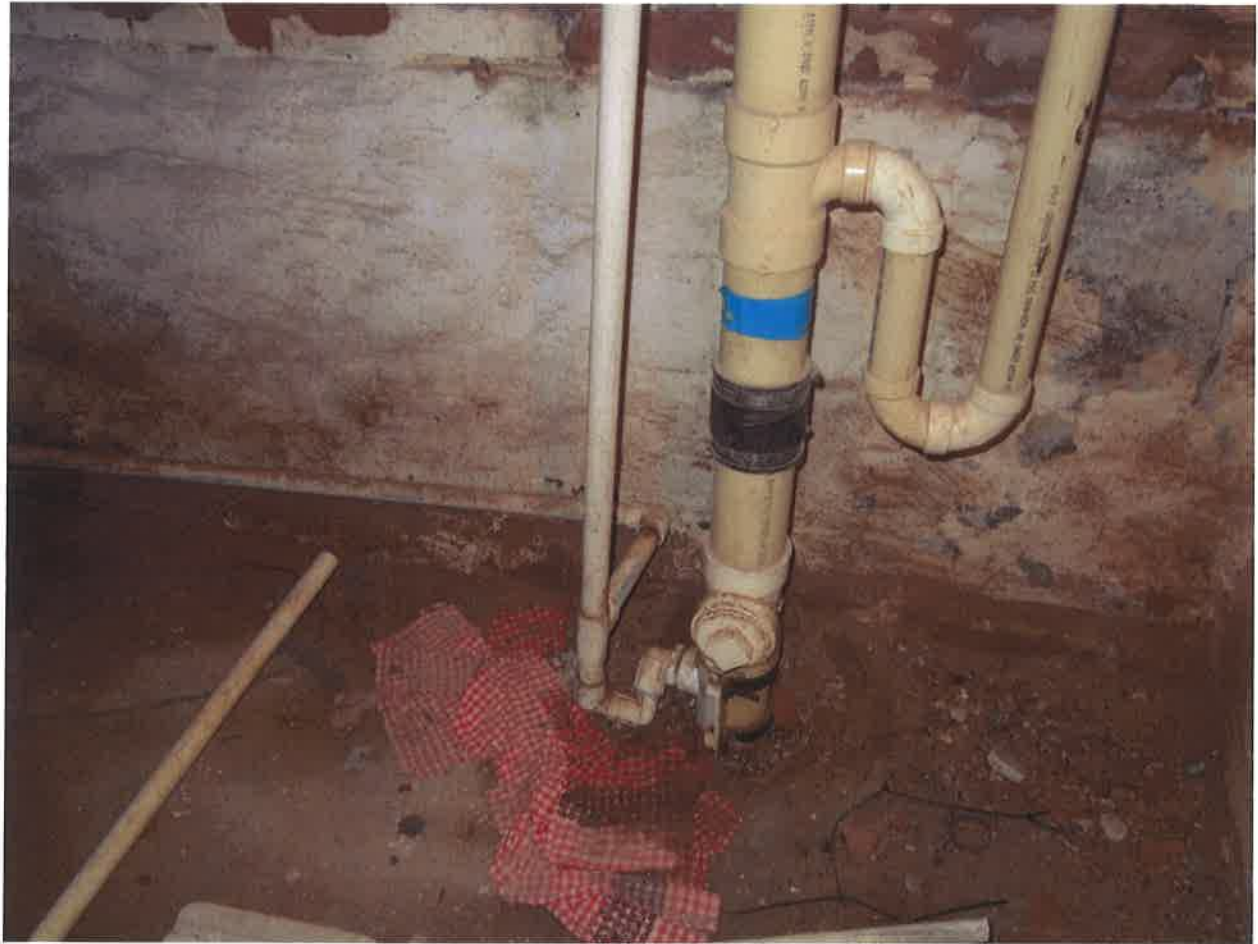
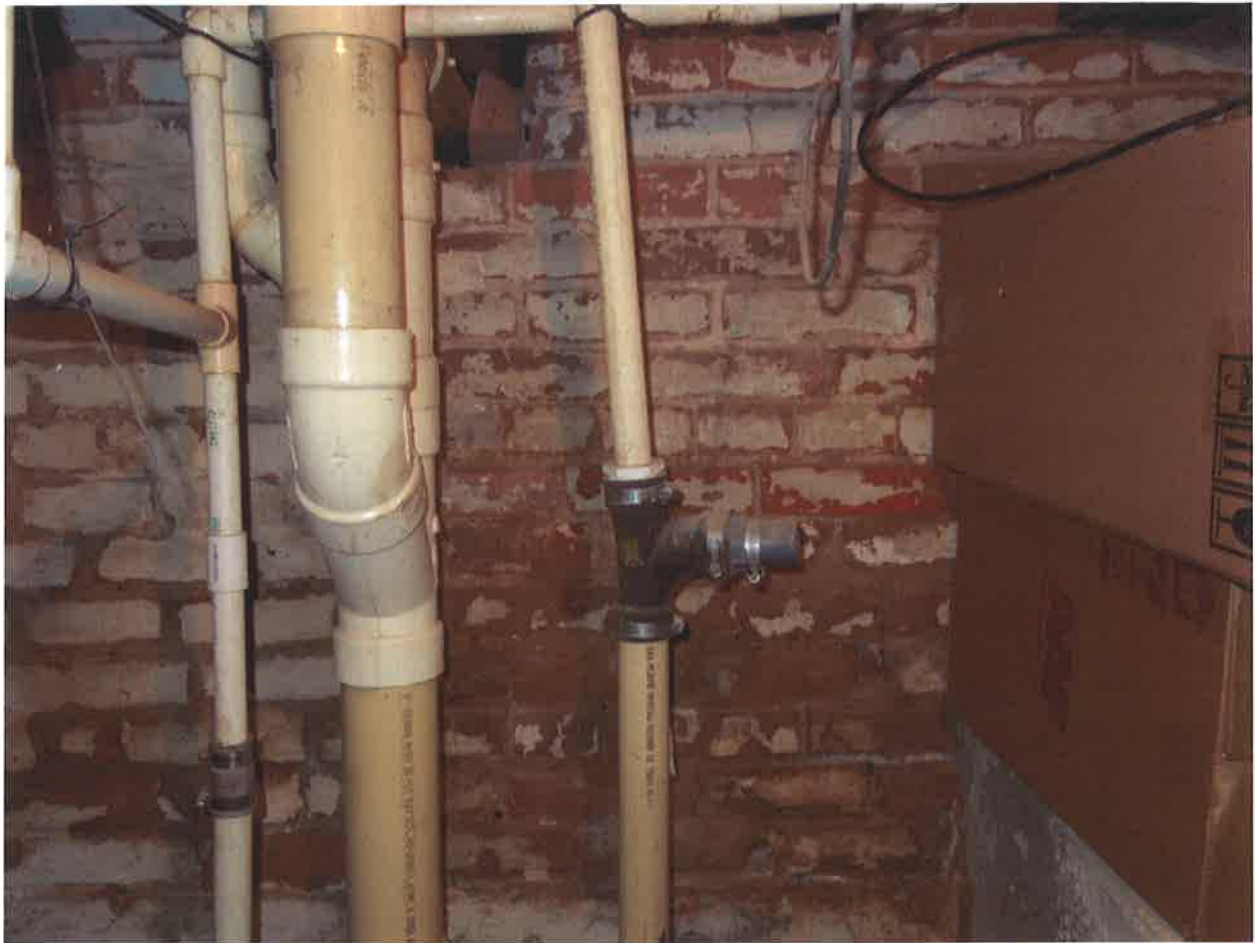
Plumbing

There are no working plumbing fixtures in the structure. The abandoned plumbing piping is unsanitary. There are four DWV unprotected openings meaning sewer gas can pass into the structure.
