Re: Setting a Public Hearing for Improvements to the Historic Maplewood Home at Nifong Park

MAPLEWOOD HOUSE

3701 Ponderosa St.

BUILDING SURVEY, July 2015

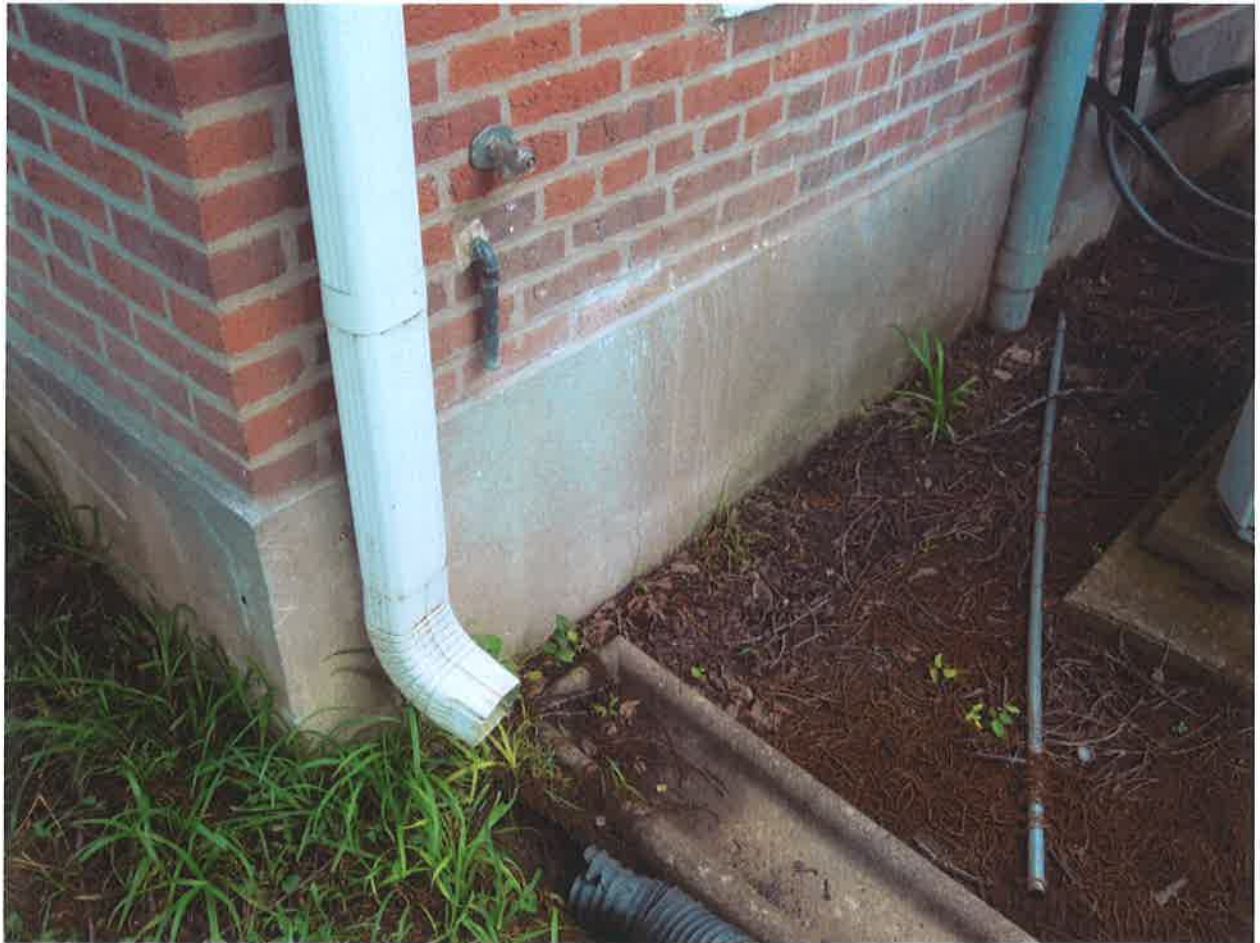
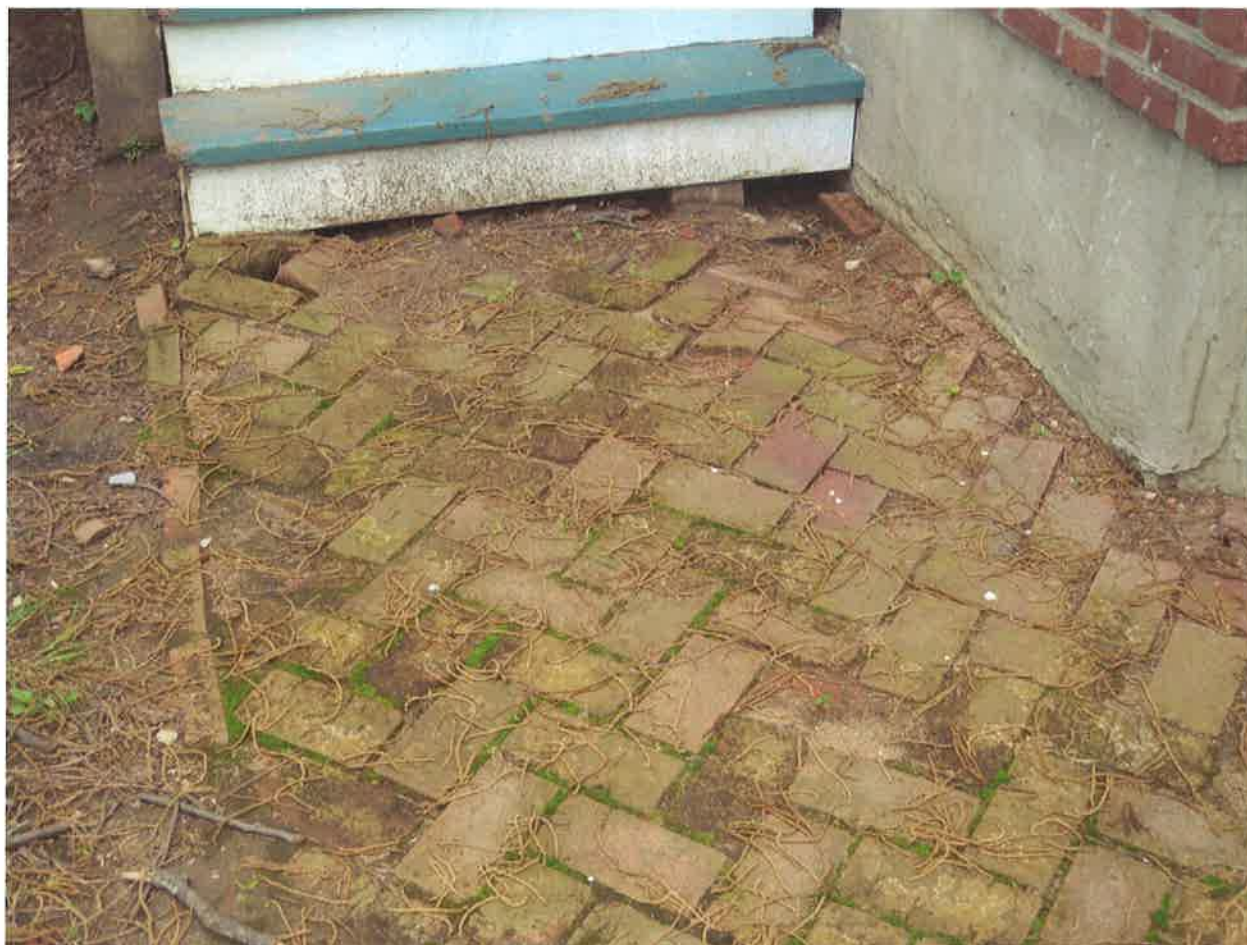
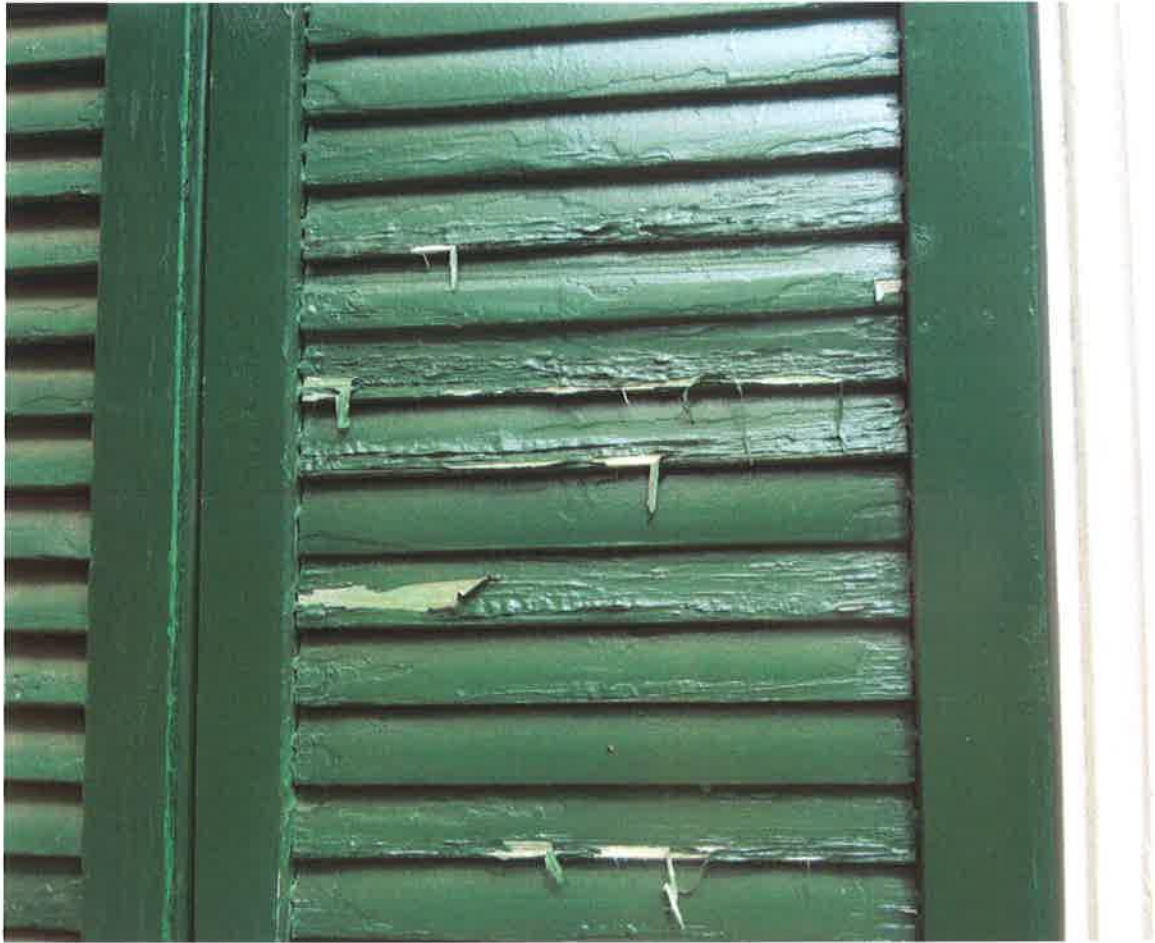
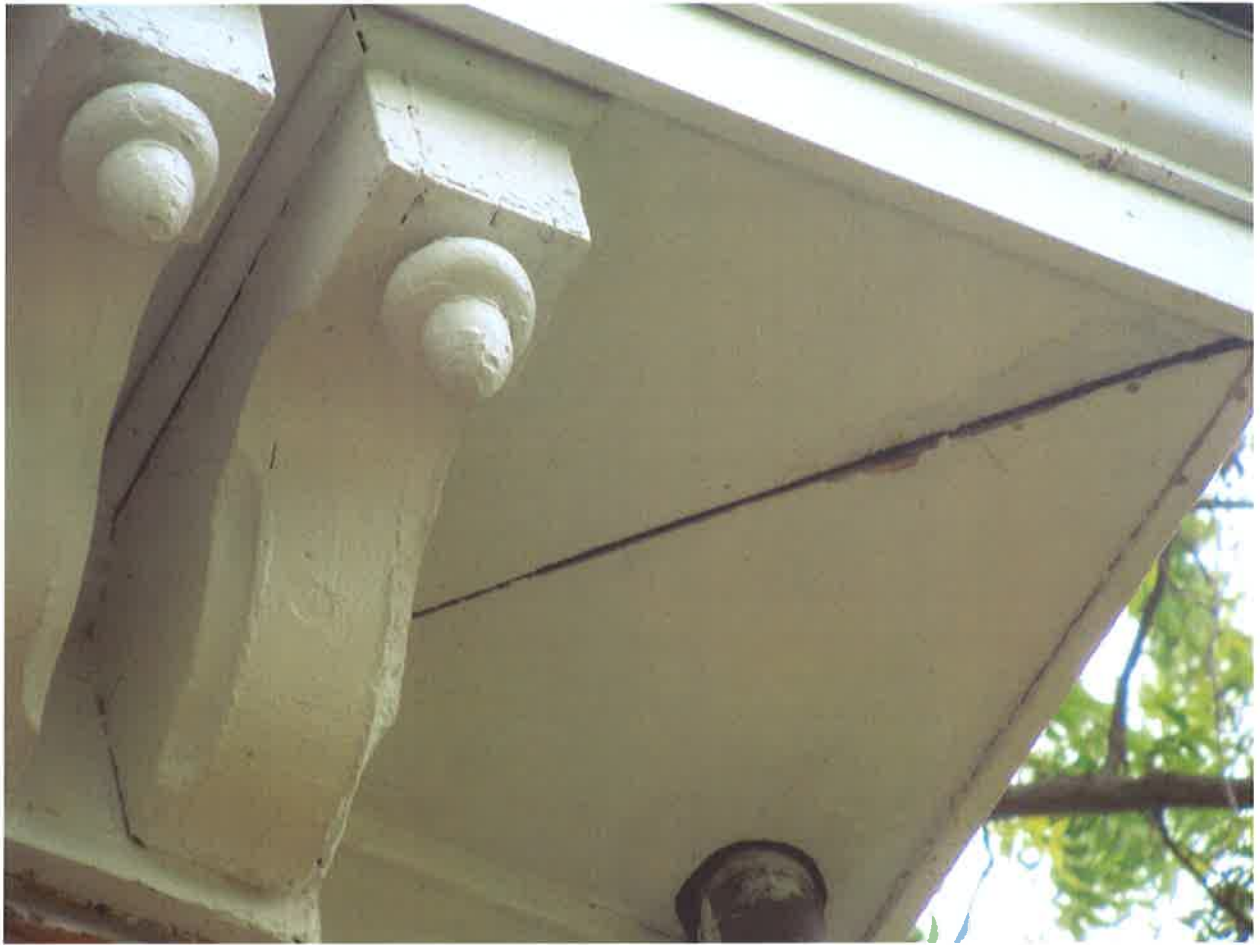
Maintenance

1. There are a few exterior masonry wall locations where repointing is needed.
2. Window wells are filling with debris and some plant growth.
3. There are several exterior locations where the paint is bubbling or peeling.
4. Several window shutter metal hinges are experiencing surface rust.
5. The guttering down spout horizontal piping is not properly connected and need cleaning.
6. A brick landing/walkway on the southwest corner of the structure is in bad repair. The bricks have settled causing storm water accumulation. Several of the bricks are damaged in addition to the settlement creating an irregular walking surface and a trip hazard.
7. There are several unsealed exterior penetrations such as the air conditioning condensing unit's set line penetrations.
8. There are several locations where the wood finish butt and mitered joints are gapped and need caulking.

9. There is a one (1") inch gap between the bottom of the kitchen's exterior door leaf and the threshold flooring. Obviously this condition allows for air infiltration and exfiltration and the entry of insects and vermin.

1. Repoint exterior masonry walls as needed. Repointing needs should be based upon the following; mortar erosion equal to or greater than one quarter (1/4) inch, crumbling mortar, hairline cracks in the mortar, and cracks between the brick and mortar.
2. Clean and remove debris and plant life from the window wells.
3. Scrap, prime and repaint bubbling or peeling exterior paint.
4. Wire brush, coat with a rust inhibitor and finish paint rusting window shutter hinges.
5. Cleaning and securely connect guttering down spout horizontal piping.
6. Rebuild the brick landing/walkway on the southwest corner of the structure.
