Agenda Item No: REP 89-13

**Re:** Hazardous Tree Removal Report: Columbia Cosmopolitan Recreation Area & Stephens Lake Park

Parks Services Natural Resources  
Tree Hazard Evaluation Form

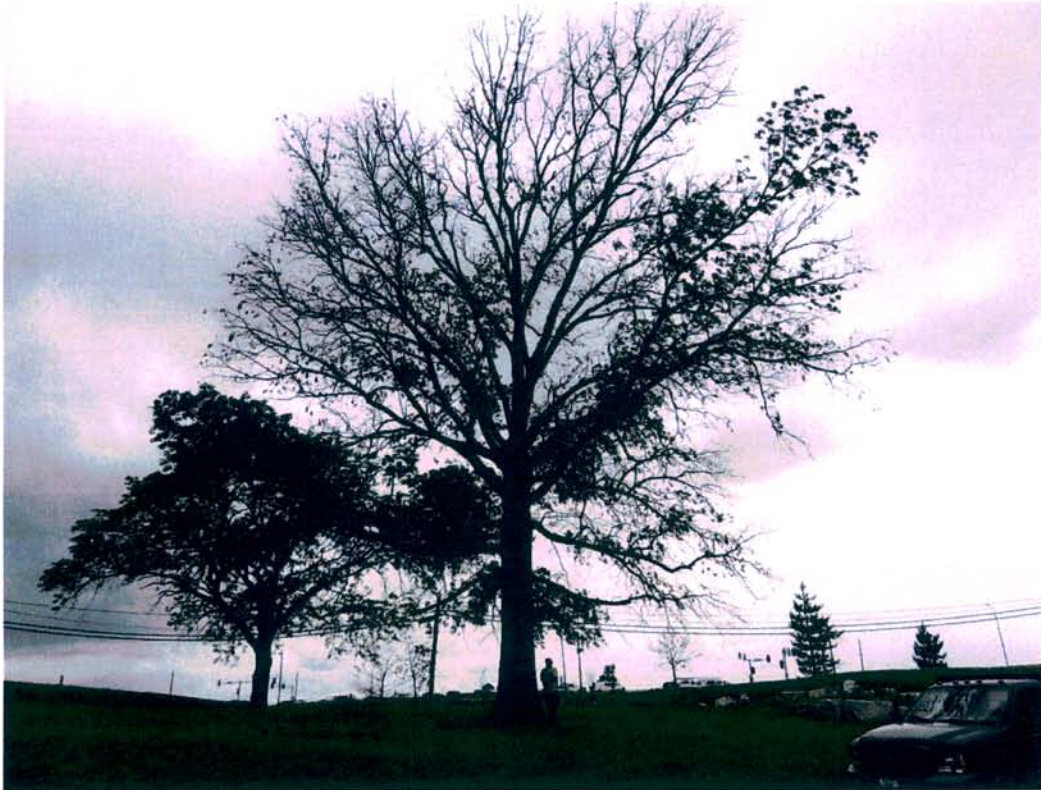
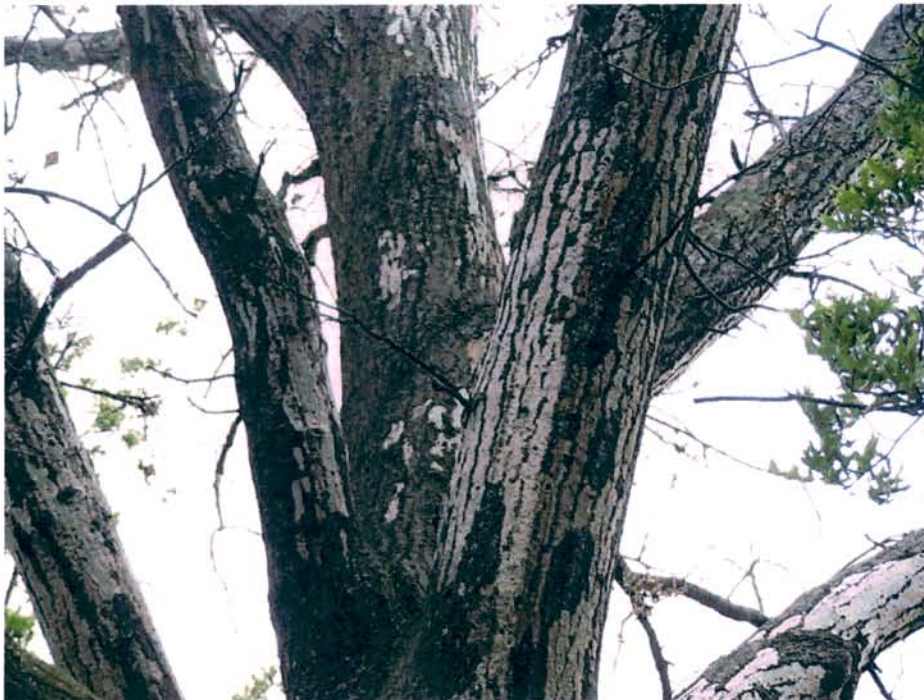
The Pin Oak tree that the Parks and Recreation Forestry staff is proposing to remove is located in Columbia Cosmopolitan Recreation Area in the parking lot next to Harris Shelter. The 41-inch DBH tree has visible signs of Hypoxylon Canker and has a live crown of less than 25% possessing a high potential for falling scaffolding branches and dead limbs from the crown and canopy. The mature Oak tree has had previous branch failures and final failure of the tree was due to drought conditions in the summer of 2012. Forestry staff has determined that the potential for failure is the key factor for the determination of removal due to the location of the tree near pedestrians and automobiles.

Major pests/diseases: Hypoxylon Canker

Part most likely to fail: Large Branches

Has the potential to start dropping very large limbs.

Pin Oak tree at Columbia Cosmopolitan Recreation Area  
at the Harris shelter parking lot

Prune: ☐ remove defective part ☐ reduce end weight ☐ crown clean ☐ thin ☐ raise canopy ☐ crown reduce ☐ restructure ☐ shape  
 Cable/Brace: \_\_\_\_\_ Inspect further: ☐ root crown ☐ decay ☐ aerial ☐ monitor  
 Remove tree: ☒ Y ☐ N Replace? ☒ Y ☐ N Move target: ☐ Y ☒ N  
 Other: \_\_\_\_\_

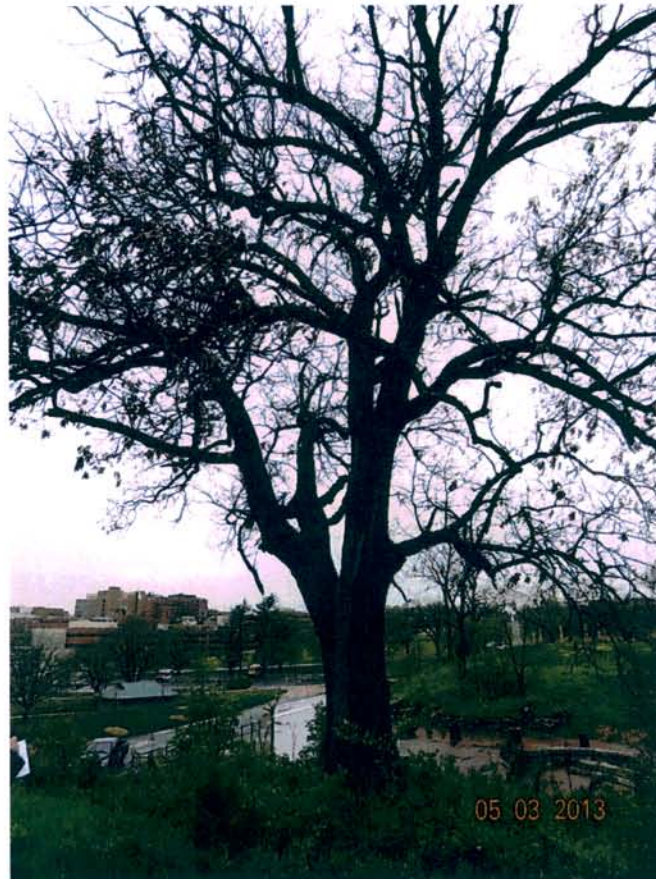
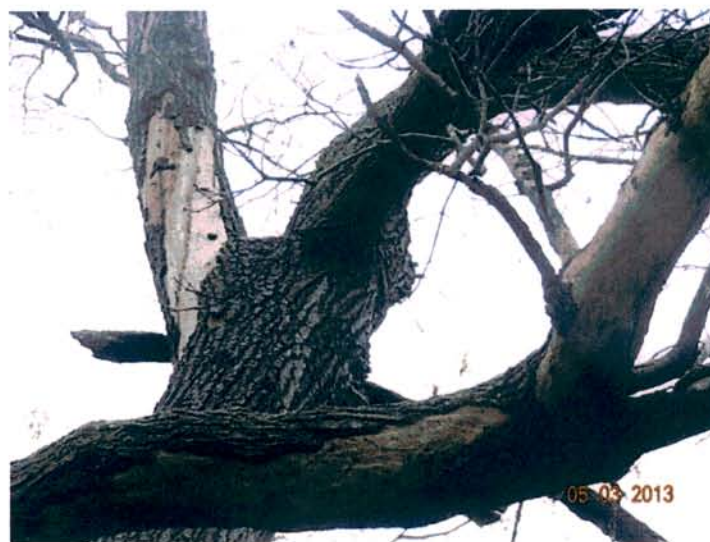
The final tree recommended for removal by Forestry staff is a mature Black Oak tree located on the hillside east of the amphitheater at Stephens Lake Park. The tree has a 37" diameter at breast height and a total height of 50 feet. The Black Oak currently has a live crown of approximately 10% and exhibits signs of wounds and decay throughout the trunk and main scaffolding branches. The canopy loss of this Oak tree is due to a previous lightning strike and drought stress from the summer of 2012. The dead canopy has shown previous signs of failure and will continue to drop large, dead limbs if it is not removed. The removal of the tree is necessary due to the weakened state of the tree and the potential for the tree or large branches to fall on park patrons.

Part most likely to fail: Large limbs breaking off, possible failure due to lightening strike

The canopy of this tree is over 90% dead due to a previous lightening strike and drought stress from the summer of 2012. This dead canopy has shown signs of previous failure and will continue to drop large dead limbs. We recommend the removal of this tree as soon as possible to prevent injury to park users.

Black Oak tree at Stephens Lake Park  
on the hills east of the amphitheater

Prune: ☐ remove defective part ☐ reduce end weight ☐ crown clean ☐ thin ☐ raise canopy ☐ crown reduce ☐ restructure ☐ shape  
 Cable/Brace: \_\_\_\_\_ Inspect further: ☐ root crown ☐ decay ☐ aerial ☐ monitor  
 Remove tree: ☒ Y ☐ N Replace? ☒ Y ☐ N Move target: ☐ Y ☒ N  
 Other: \_\_\_\_\_

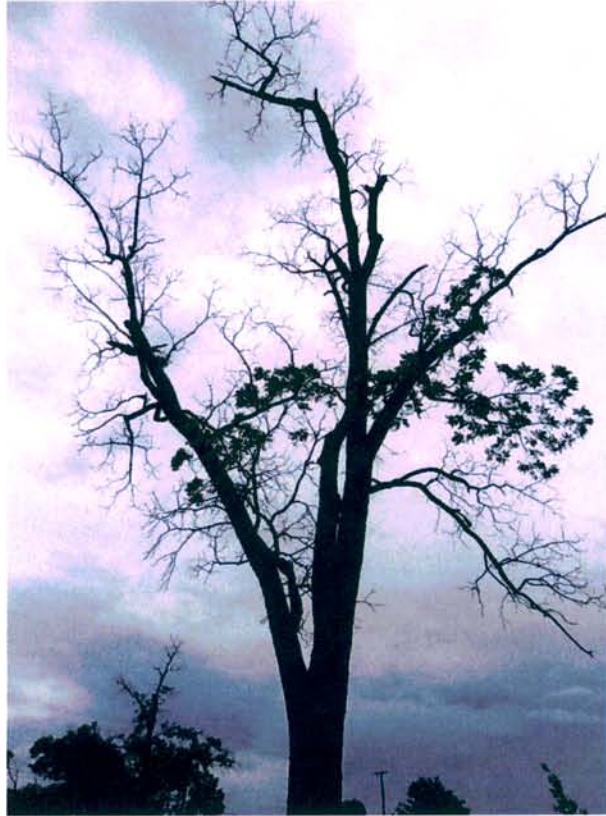
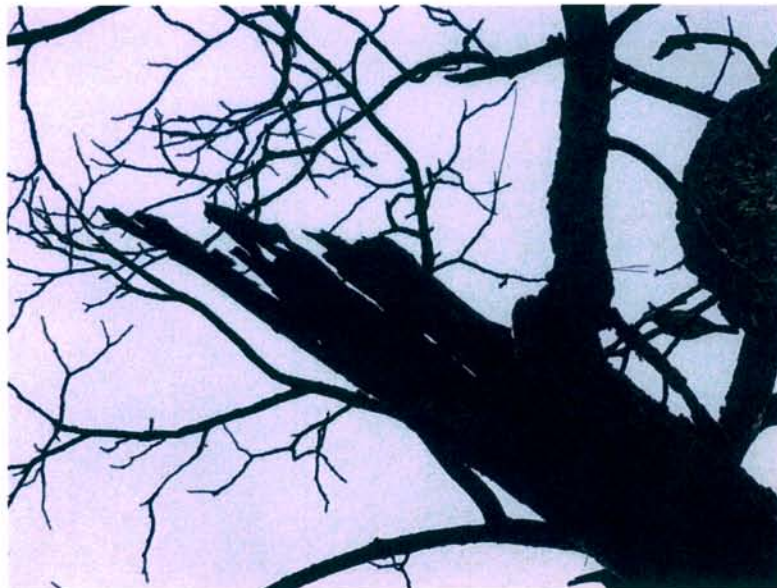
The second tree recommended for removal is a Black Walnut located in the northwest corner of Stephens Lake Park along the hard surface trail. The Walnut tree has grown to a mature height of 64 feet with a 30.5 inch diameter at breast height. The tree has approximately 10% living crown and has shown visible signs of wounds, decay and cavity in the branches and root crown. Forestry staff has observed falling limbs and deadwood in the tree over the last 2 years and blame the severe decline over the past year due to the severe drought of 2012. Staff is requesting permission to remove the failing tree due to the risk of failure and public safety due to the proximity to the Stephens Lake Park fitness trail.

Part most likely to fail: Dead branches in canopy.

This tree has shown pervious limb failure and has a high potential for dropping large limbs onto a high use recreation trail.

Black Walnut tree at Stephens Lake Park in the northwest corner of park along the hard surface trail

Prune: ☐ remove defective part ☐ reduce end weight ☐ crown clean ☐ thin ☐ raise canopy ☐ crown reduce ☐ restructure ☐ shape  
 Cable/Brace: \_\_\_\_\_ Inspect further: ☐ root crown ☐ decay ☐ aerial ☐ monitor  
 Remove tree: ☒ Y ☐ N Replace? ☒ Y ☐ N Move target: ☐ Y ☒ N  
 Other: \_\_\_\_\_
