Facility: Activity & Recreation Center

Address: 1701 W. Ash Street

Date of Survey: 03/05/10 & 03/09/10

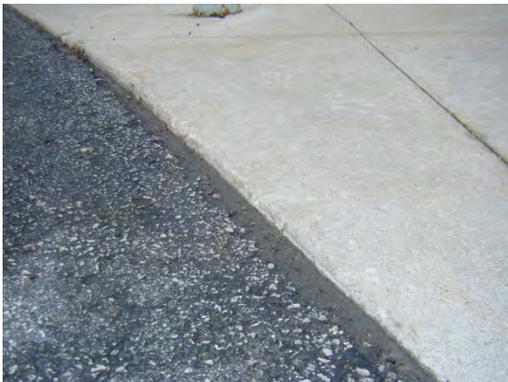
Photo 1

- Patch/repair approximately 30 linear feet of asphalt drive lip where it intersects with the concrete sidewalk at main drop-off area at west building entrance area (see photo 1). **Estimated Cost: \$53.00**

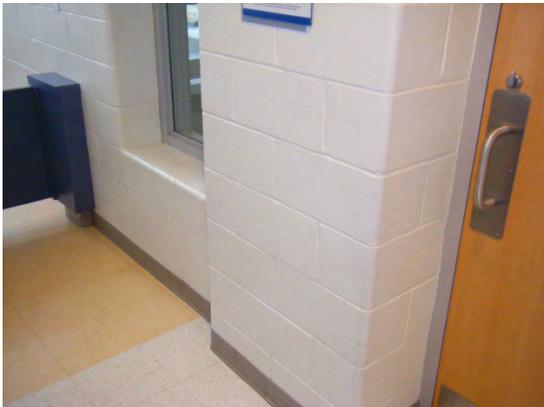
Photo 2

- Door into Baby-Sitting Room 156 does not provide minimum required latch side clearance of 18" per ADAAG 4.13.6. The latch side clearance at the door is blocked by a concrete masonry unit pilaster that protrudes 13" into the required clear area (see photo 2). Remove in-swinging door and re-install as an out-swinging door. **Estimated Cost: \$291.00**

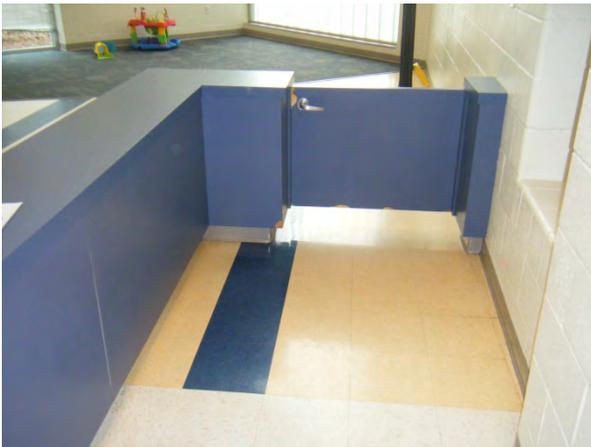
Photo 3

- Unless noted below, all exercise/activity rooms, meeting rooms, classrooms, and the gymnasium are wheelchair accessible.
- In the Youth Training Room (located at NW corner of the facility), the weight training equipment needs to be rearranged to allow accessible path around equipment for wheelchair users, some of the equipment may need to be adjusted or temporarily modified to be accessible to wheelchair users and a shelf unit near the entry door needs to be moved to allow proper wheelchair clearance at the door.
- In Baby-Sitting Room 156, the half-door leading from entry-counter into the main baby-sitting area (see photo 3) does not provide proper latch side clearance of at least 18" and therefore, that door should also be removed and rehung to swing into the baby-sitting area to gain required latch side clearance.

Estimated Cost: \$347.00

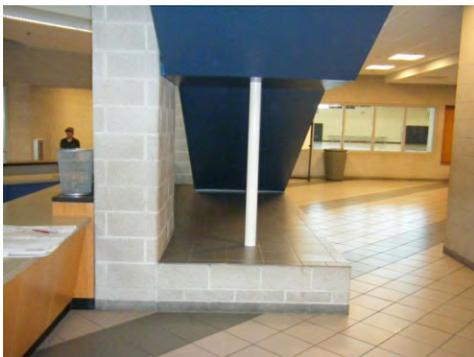
Photo 4

- The exposed underside of Stair 123B measures 75" above the floor just beyond the concrete masonry platform below it (see photo 4). Therefore, that portion of the underside of the stair that is less than 80" above the floor is considered a protruding object per ADAAG 4.4.2. Extend the existing platform approximately 12" to the south such that it can be detected by blind or visually-impaired persons using a cane and so that no portion of the underside of the stair is lower than 80" above the floor.

Estimated Cost: \$600.00

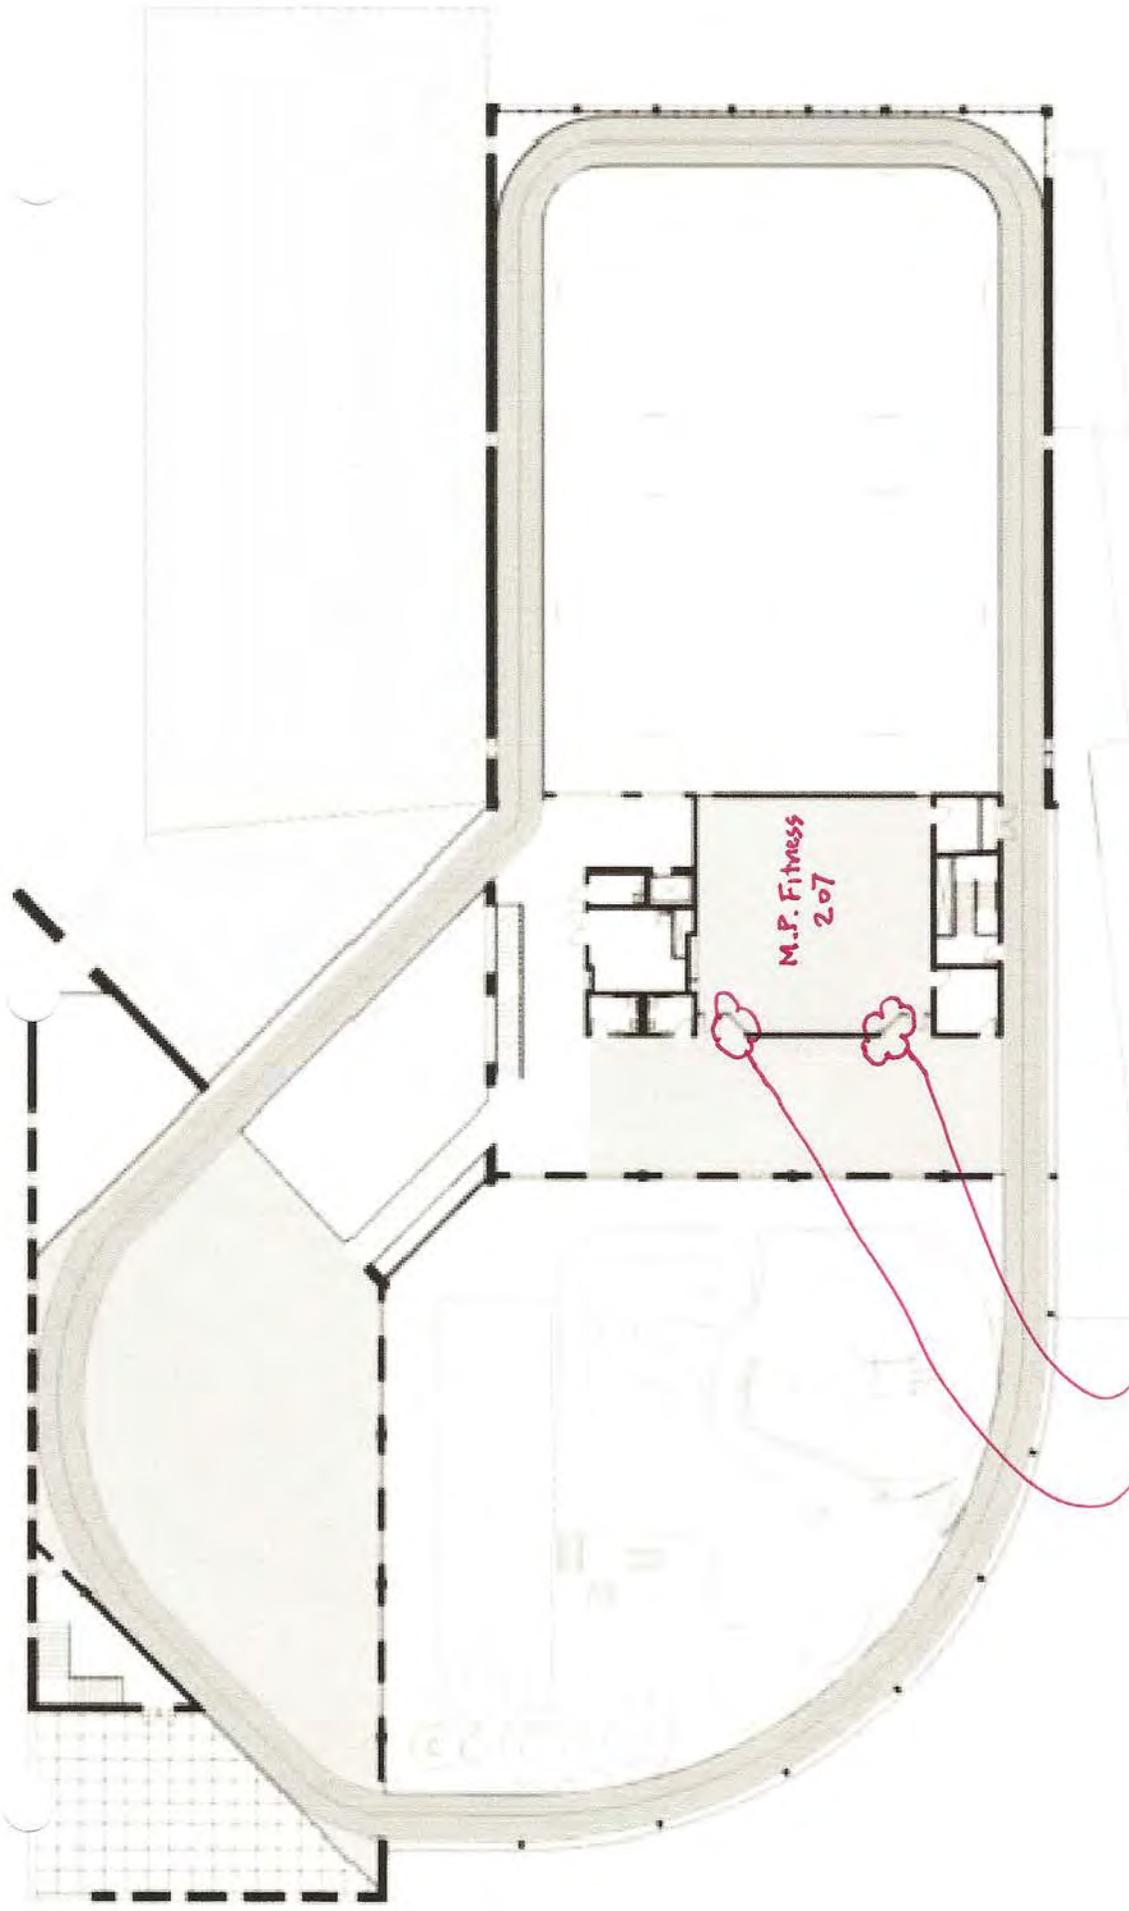
ARC – Second Floor Plan

- Two doors at Multi-Purpose Fitness Room 207 do not provided minimum required latch side clearance of 18" per ADAAG 4.13.6 (16" provided). At least one of those doors should be modified to either provide the required 18" latch side clearance or install an automatic door opener. **Estimated Cost: \$489.00**

Only 16" latch side clearance provided @ these doors (min. 18" reqd.)
