# Facility: Columbia Cosmopolitan Recreation Area

Address: 1615 Business Loop 70W      Date of Survey: 04/19/10 - 05/04/10

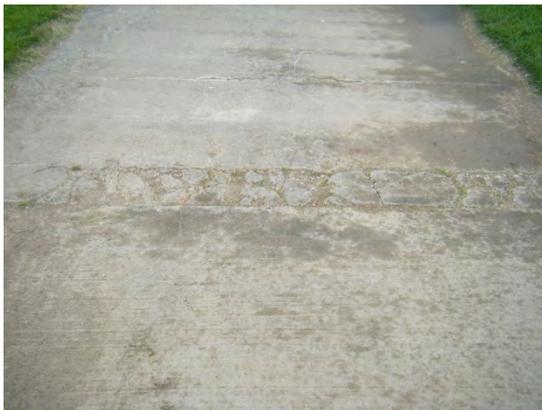
Photo 1

- Refer to site plan included with this report: (2) At the asphalt path leading to and between the six Rainbow Softball Complex fields, there are various areas of deteriorated and/or settled asphalt pathway that needs to be repaired for proper and safe access. **Estimated Cost: \$5,000.00**
- Refer to site plan included with this report: (3) Install a 4' wide concrete access path from existing sidewalk over to the edge of the volleyball court. Sidewalk will be ~28 linear feet long and should have a max. slope of 5% as much as is feasible and a max. cross-slope of 2%. **Estimated Cost: \$1,130.00**
- Refer to site plan included with this report: (4) Repair area of sidewalk (~50 s.f. area) that leads from the west parking lot over to Antimi ball fields (see photo 1 below). **Estimated Cost: \$1,104.00**

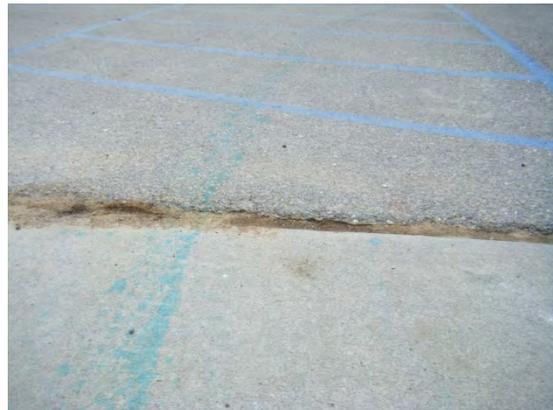
Photo 2

- Refer to site plan included with this report: (5) Patch/smooth out transition from south Antimi parking asphalt to sidewalk (see photo 2 above). **Estimated Cost: \$200.00**
- Refer to site plan included with this report: (6) Replace section of walk (~36' long x 6' wide) leading up to the T-ball bleacher area that has a cross slope of up to 6.7%. Replacement concrete walk shall have a max. slope of 5% and a max. cross-slope of 2%. **Estimated Cost: \$2,366.00**
- Refer to site plan included with this report: (7) Remove and/or replace one fixed bench at the children's batting cage to provide min. ADAAG required access path

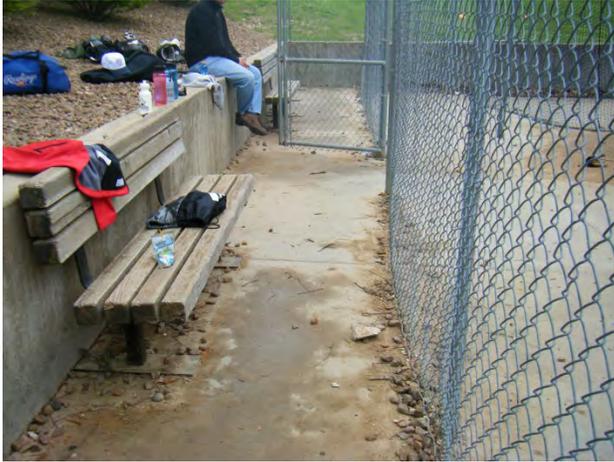
Photo 3

width of 36" clear to the batting cage entry gate (see photo 3 below).

**Estimated Cost: \$400.00**

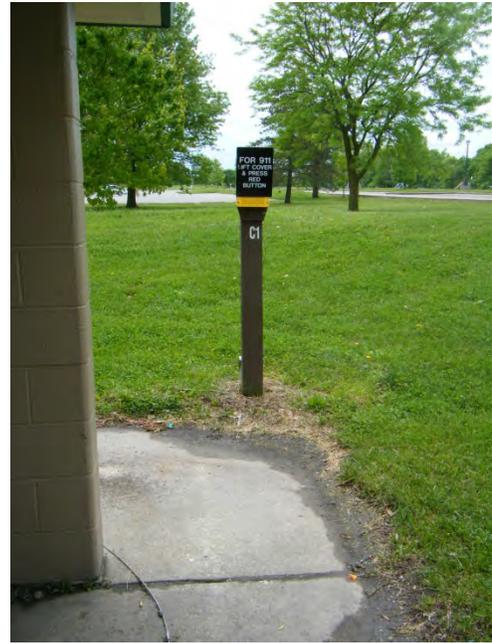
Photo 4

- Refer to site plan included with this report: (8) Install a min. 3'x4' concrete pad at the emergency phone at the Antimi Shelter (see photo 4 above) for wheelchair access. Concrete pad shall have a max. slope and cross-slope of 2%.

**Estimated Cost: \$546.00**

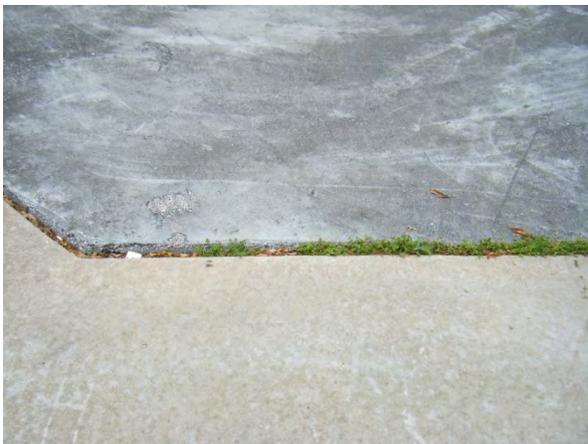
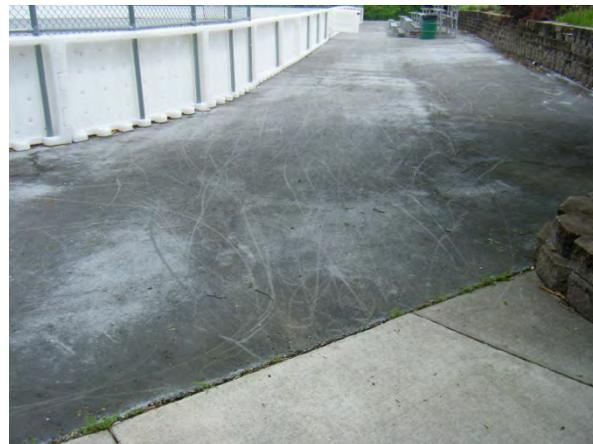
- Refer to site plan included with this report: (9) Patch/smooth/fill 2" gap between concrete and asphalt at east end of roller rink and 1" gap at west end of roller rink (see photos 5 & 6 below).

**Estimated Cost: \$250.00**

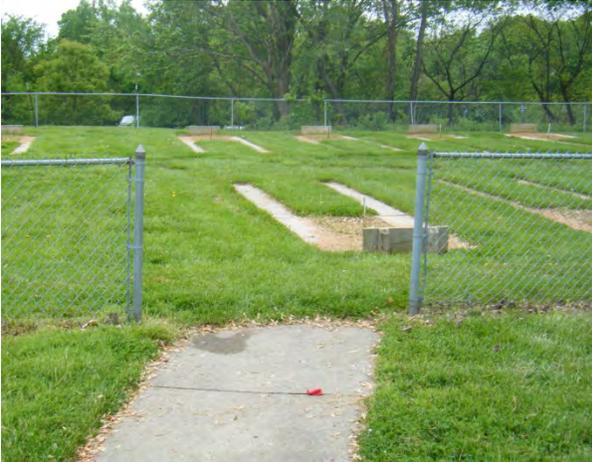
Photo 7

- Refer to site plan included with this report: (10) Install a 4' wide asphalt path from the existing sidewalk to and along the length of one of the horseshoe playing areas adjacent to the Garrison Shelter for wheelchair access. New path should have a max. slope of 5% as much as is feasible and a max. cross-slope of 2% (see photo 7 below). **Estimated Cost: \$1,292.00**

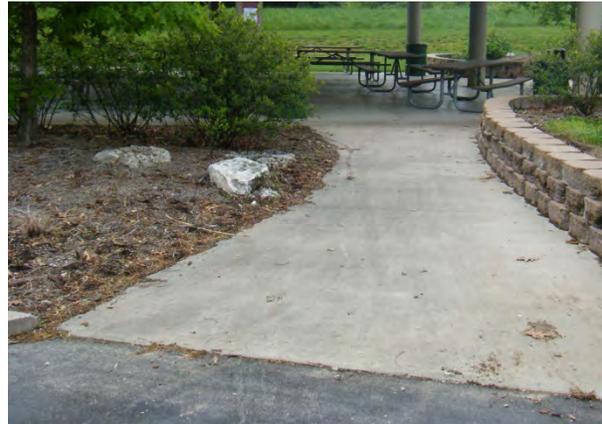
Photo 8

- Refer to site plan included with this report: (11) Patch/smooth/fill 1.5" gap between asphalt and concrete walk leading up to the Dexheimer Shelter (see photo 8 above). **Estimated Cost: \$100.00**
- Refer to site plan included with this report: (12) Replace section of walk (~29' long x 4' wide & ~26' long x 5' wide) leading from the parking area just NW of the Restroom Building over to the level concrete pad in front of the Restroom Building (see photos 9 & 10 below). Existing walk sections have cross-slopes up to 8%. Replacement concrete walk shall have a max. slope of 5% as much as is feasible and a max. cross-slope of 2%. **Estimated Cost: \$2,594.00**

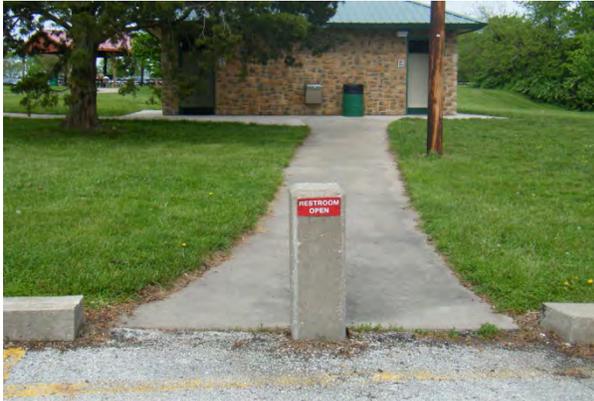
Photo 11

- Refer to site plan included with this report: (13) Patch/smooth/fill 2" gap between concrete and asphalt parking area near the Nickell – Lamb Restroom Building (see photos 11 below).  
**Estimated Cost: \$100.00**

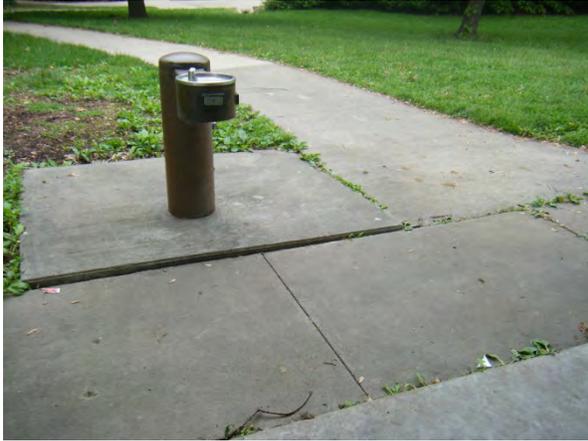
Photo 13

**Estimated Cost: \$1,802.00**
- Refer to site plan included with this report: (16) Replace ~80 s.f. of existing concrete pad that has settled at Lamb Shelter drinking fountain for wheelchair access (see photo 13 next page). Concrete pad shall have a max. slope and cross-slope of 2%.

**Estimated Cost: \$1,332.00**
- Refer to site plan included with this report: (17) Patch/repair asphalt surface at Lamb Shelter BBQ grill (see photo 14 next page) for wheelchair access. Repaired pad shall have a max. slope and cross-slope of 2%.

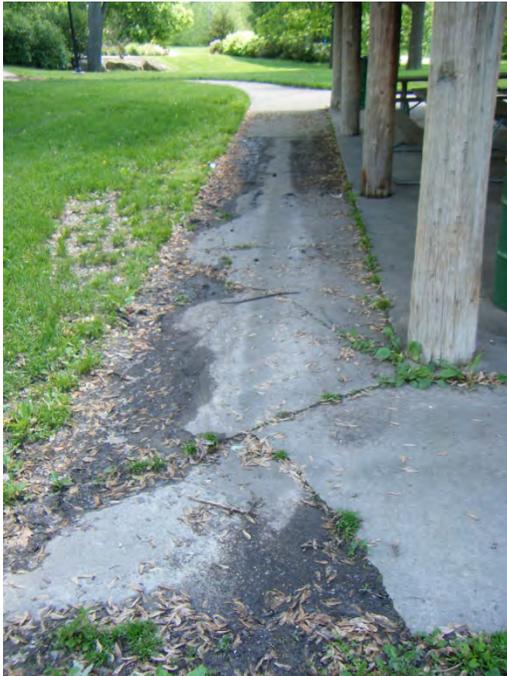
Photo 15

- Refer to site plan included with this report: (19) Replace perimeter concrete walk at the Burford Shelter (see photo 15 below) due to deterioration and settlement (~170' long x 5' wide). New path should have a max. slope of 5% and a max. cross-slope of 2%. Additionally, repair shelter slab cracking inside the shelter (see photo 16 below) with epoxy crack injection or similar repair.

**Estimated Cost: \$8,184.00**

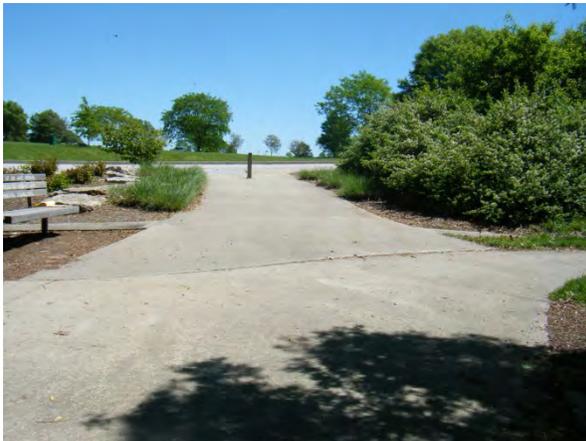
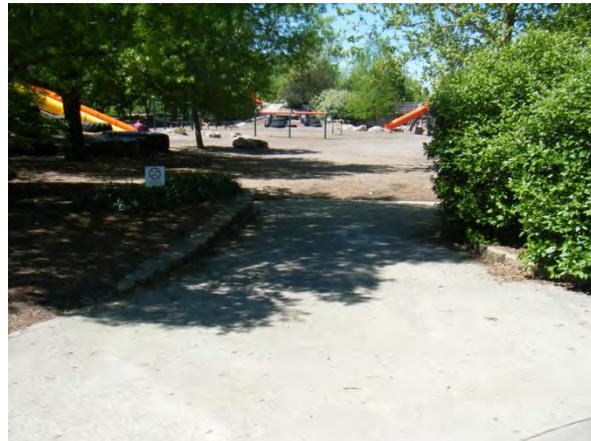
- Refer to site plan included with this report: (22) Existing concrete path from the ADA parking spaces down to the Steinberg Playground (see photos 17 & 18 below) has slopes up to 10.7%. Due to existing grade of intersecting sidewalk as well as existing grades at the parking lot and at the playground, it will likely be necessary to have this area surveyed by a land surveyor to establish the existing topography and determine how best to modify the existing grades to accommodate lesser slopes at the access paths in question. For this area, I have estimated the removal of ~894 s.f. of existing concrete pavement and installation of new concrete pavement with maximum slopes of 8.33% (land survey may find that a 5% maximum slope is possible which would then eliminate the need for handrails that will be added per Section 1.4 (37)) and maximum cross-slopes of 2%. A level landing (no more than 2% slope in any direction) will be required where this access path intersects with the existing perimeter access path that circles the playground.

**Estimated Cost: \$7,518.00**

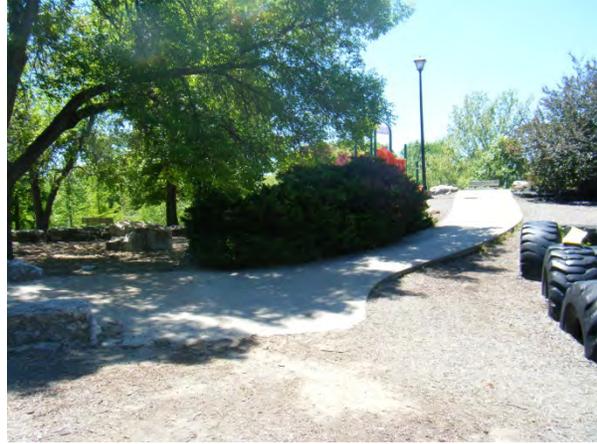
Photo 20

- Refer to site plan included with this report: (24) Replace ~400 s.f. of existing concrete walk adjacent to the sand play area to create a level landing at the entry to the sand play area and a max. 5% sloped walk down into the playground area (see photo 20 below).  
**Estimated Cost: \$3,764.00**

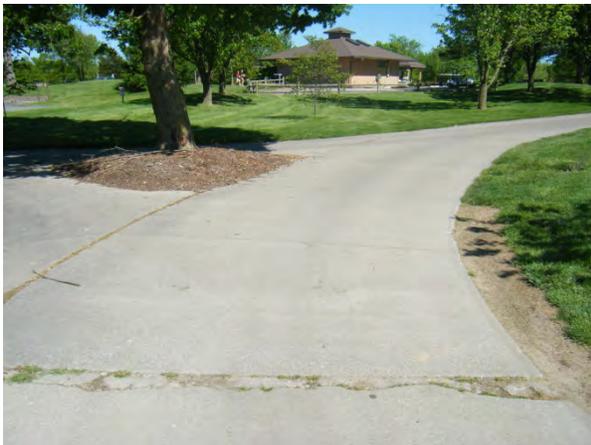
Photo 21

- Refer to site plan included with this report: (25) Replace a deteriorated section of sidewalk (~15' wide x 10' long) at access path leading from parking lot (27a. on parking map) to the clubhouse (see photo 21 below).

**Estimated Cost: \$1,864.00**

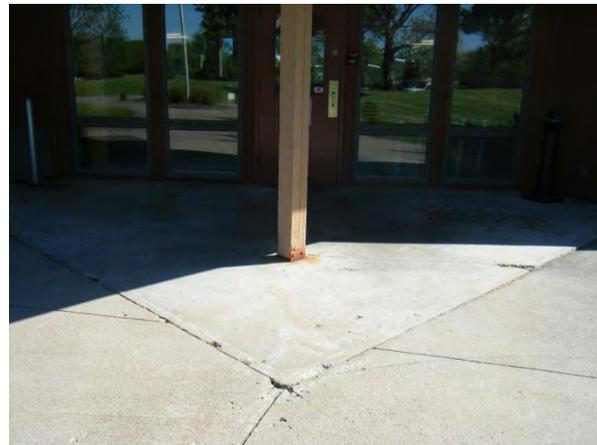
Photo 22

- Refer to site plan included with this report: (26) Misc. patch and repairs to concrete pad outside of the main (north) clubhouse entrance (see photo 22 below).

**Estimated Cost: \$1,000.00**

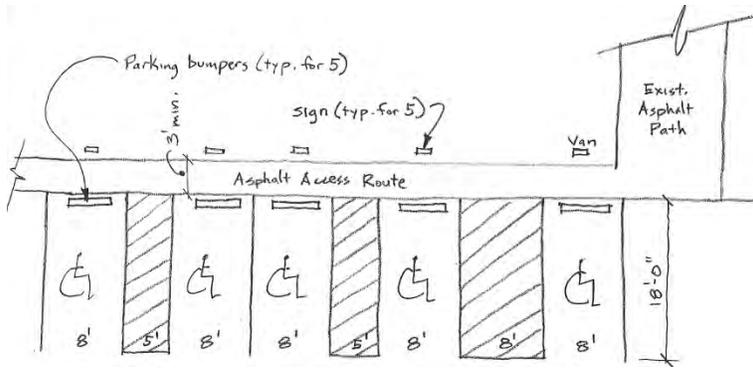
**Estimated Cost: \$4,245.00**
3. Football Fields: This parking lot has a total of 104 spaces and four are striped as accessible spaces. Per ADAAG, five spaces are required to be accessible with one of those being van accessible. At the four existing accessible spaces, there are no access aisles between spaces as required, the access route at the front of the spaces is only 2'-0" wide, the slope of the spaces is up to 5% near front of the spaces and all spaces and access route asphalt is in poor condition. Consolidate the four existing access spaces with three additional adjacent spaces, repave, restripe and install required signage as shown in the sketch on the next page. **Estimated Cost: \$4,603.00**

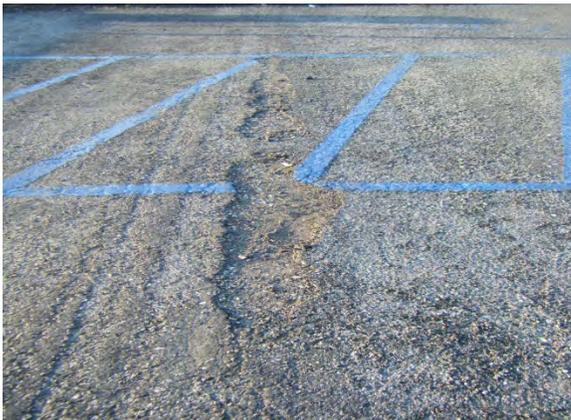
Photo 23

8. Antimi Shelter: The required number of access spaces are provided. One access space needs a sign installed. Parking spaces and access aisle asphalt is in poor condition and needs to be resurfaced (see photo 23 below). **Estimated Cost: \$1,512.00**

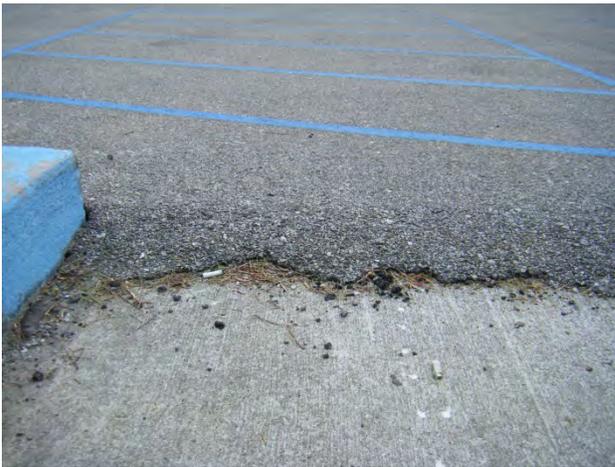
Photo 24

12. Soccer Fields: The required number of access spaces are provided. Need to smooth out the asphalt transition to concrete at the curb-cut (see photo 24 below). **Estimated Cost: \$200.00**

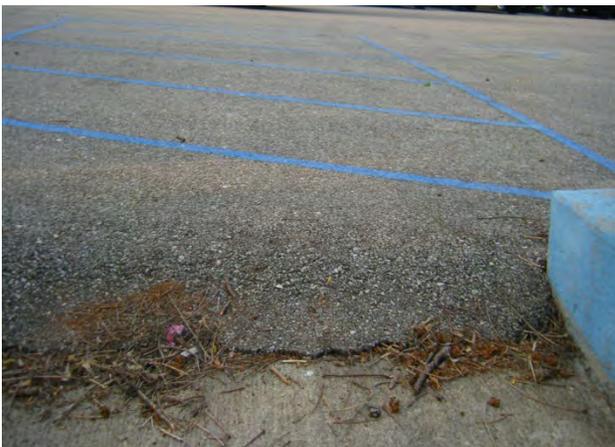
Photo 25

14. Soccer Fields: The required number of access spaces are provided. Need to smooth out the asphalt transition to concrete at the curb-cut (see photo 25 below). **Estimated Cost: \$200.00**

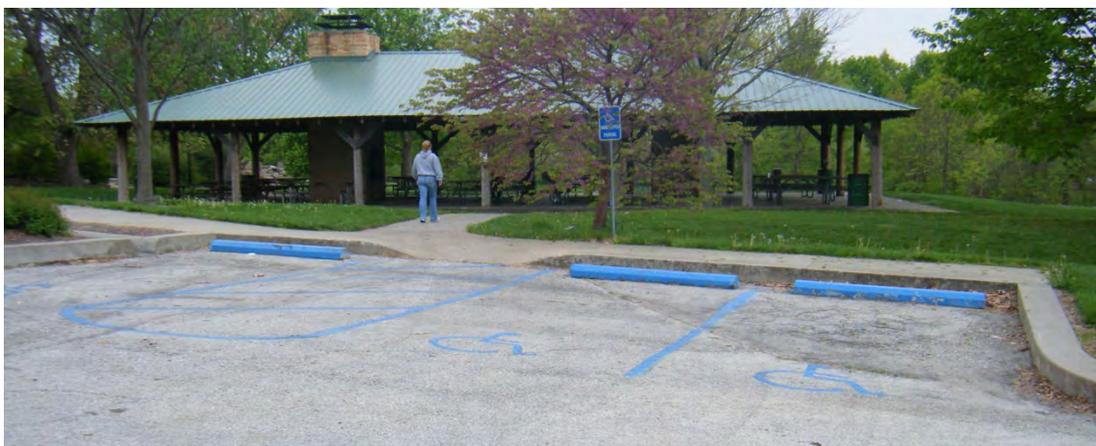
Photo 26

17. Burford Shelter: More than the required number of access spaces are provided. In this area, three accessible spaces are marked, but only two of them have an access aisle, one of them is slightly too narrow, the cross-slopes are from 4.1% to 5.8% in all spaces and access aisle and the running slope of two spaces is up to 4.8%. Because we have more than the required number of spaces in this lot, recommended solution would be to change west-most parking space to a non-access space and then repave the area to get proper slopes in the two remaining spaces and the access aisle. Only one sign exists now, so an additional sign will need to be installed at the other ADA space (see photo 26 below). **Estimated Cost: \$2,316.00**

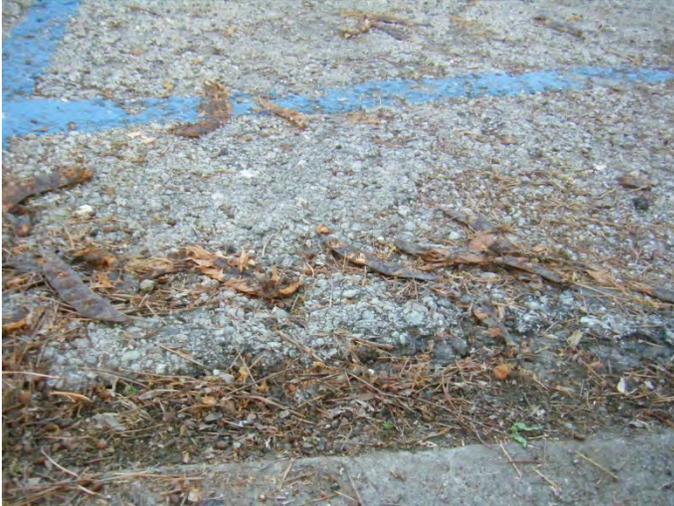
Photo 27

20. Lamb Shelter: The required number of access spaces are provided. Sign at van access space is too low – install sign on new taller post. Other access space does not have a sign, so a new sign needs to be installed. Running slopes of two spaces and shared access aisle are up to 7.7% and cross-slopes are up to 4.5%. Repave all spaces for proper slopes. Patch/smooth out asphalt transition to concrete at the access aisle (see photo 27 next page). **Estimated Cost: \$1,895.00**

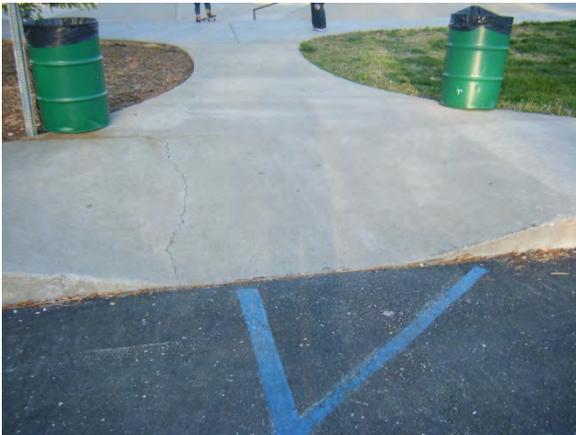
Photo 28

- Refer to site plan included with this report: (27) Curb-cut at access aisle is not tactile, does not contrast and has a slope of up to 9.5% which exceeds the maximum allowable slope of 8.33% (see photo 28 below). Replace curb-cut with a contrasting truncated dome ADAAG compliant curb-cut.

**Estimated Cost: \$4,500.00**

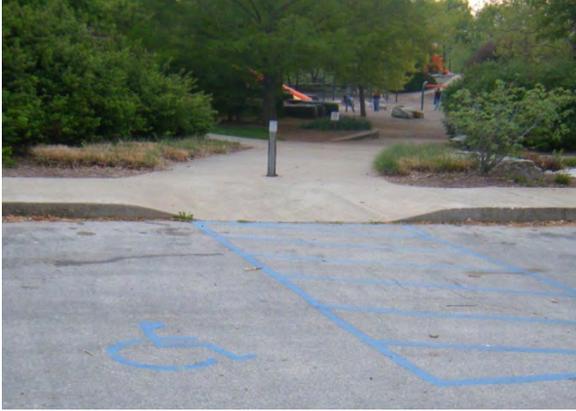
Photo 30

- Refer to site plan included with this report: (29) The existing curb-cut at the access aisle is not tactile or contrasting and the flared sides within the sidewalk are greater than ADA maximum slope of 8.33% (see photo 30 next page). Replace curb-cut with a contrasting truncated dome ADAAG compliant curb-cut.

**Estimated Cost: \$4,500.00**

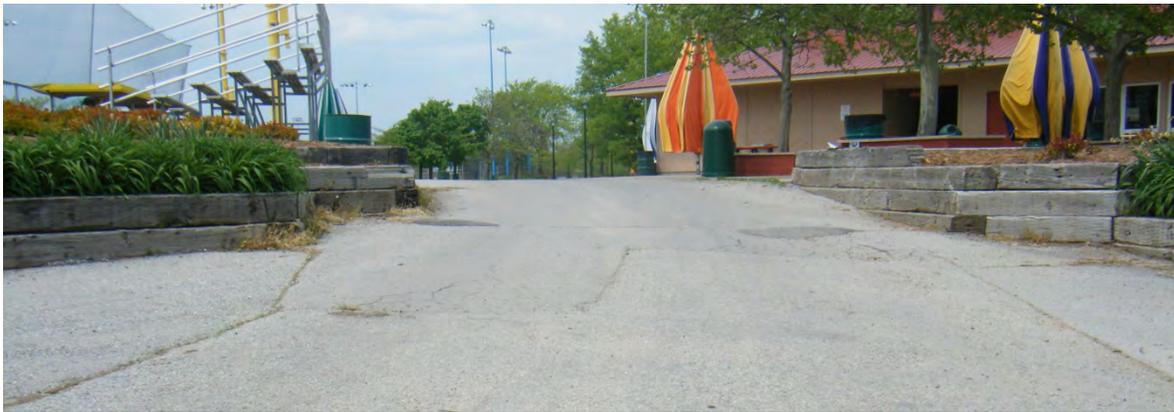
Photo 32

- Refer to site plan included with this report: (31) Install wood handrails that meet ADAAG 4.8.5 on both sides of an existing ~38' long section of asphalt path up to and between the railroad tie planters at the Rainbow Softball Complex due to slopes between 5.7% - 7.8% at this section of the path (see photo 32 below). **Estimated Cost: \$3,055.00**

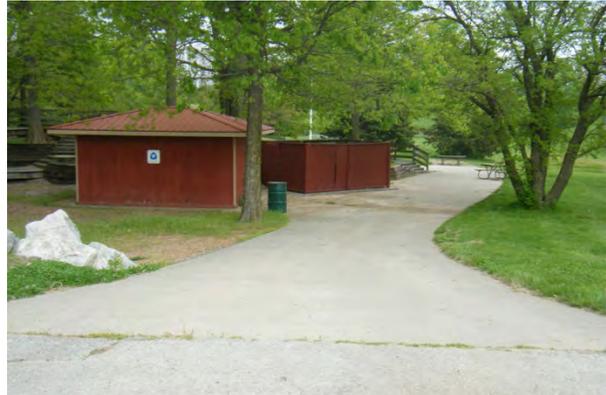
Photo 34

- Refer to site plan included with this report: (32) Install wood ramp with handrails on both sides that meets ADAAG 4.8 for wheelchair access down to the batting cage area (see photo 33 next page). **Estimated Cost: \$6,240.00**
- Refer to site plan included with this report: (33) Install wood handrails that meet ADAAG 4.8.5 on both sides of an existing ~46' long section of concrete leading to the playground area due to slopes between 5.6% - 9.5% at this section of walk (see photo 34 next page). **Estimated Cost: \$3,615.00**

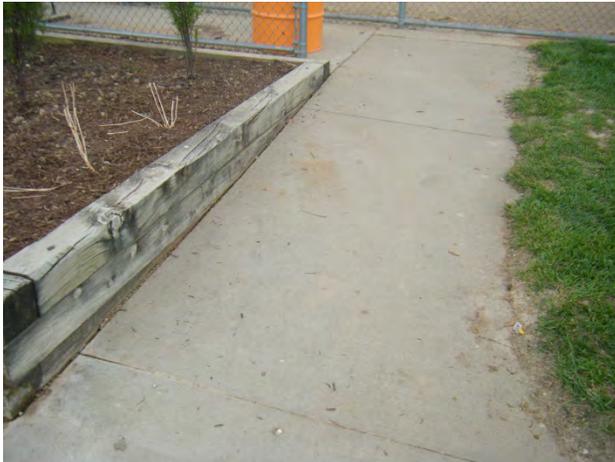
Photo 35

- Refer to site plan included with this report: (34) Install galvanized metal handrails that meet ADAAG 4.8.5 on both sides of an existing ~12' long section of concrete ramp leading up to the south T-ball dugout due to slopes up to 8.9% (see photo 35 below).  
**Estimated Cost: \$1,824.00**

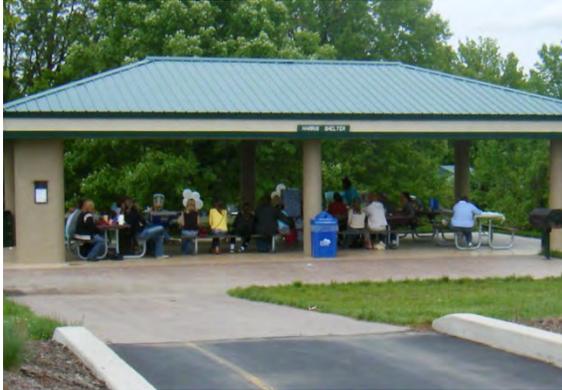
Photo 37

- Refer to site plan included with this report: (35) Install wood handrails that meet ADAAG 4.8.5 on both sides of an existing ~30' long section of concrete leading to the volleyball court due to slopes greater than 5% at this section of walk (see photo 36 above).  
**Estimated Cost: \$2,495.00**
- Refer to site plan included with this report: (36) Install galvanized metal handrails that meet ADAAG 4.8.5 on both sides of an existing ~15' long section of concrete ramp leading to the Harris Shelter due to slopes up to 7.5% (see photo 37 next page).  
**Estimated Cost: \$2,675.00**

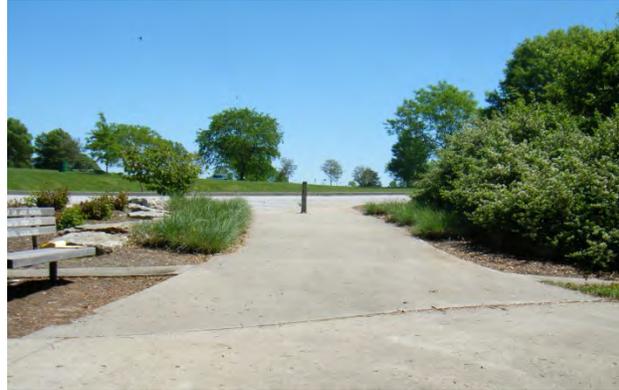
Photo 38

- Refer to site plan included with this report: (37) Install wood handrails that meet ADAAG 4.8.5 on both sides of ~50' long section of concrete ramp being replaced (see Section 1.1 above) leading to the Steinberg Playground due to slopes greater than 5% (see photo 38 above). **Estimated Cost: \$3,895.00**

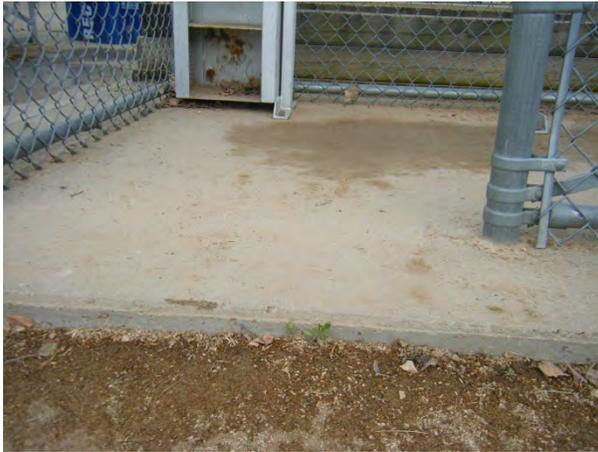
Photo 39

- Refer to site plan included with this report: (38) Install min. 36" wide gate (must provide min. 32" clear opening) @ the end of each dugout at the two T-ball fields (4 total gates) to allow wheelchair access to the field and dugouts. The field surface will need to be built up ~1.5" at each gate to eliminate the change in level (see photo 39 below). **Estimated Cost: \$2,200.00**

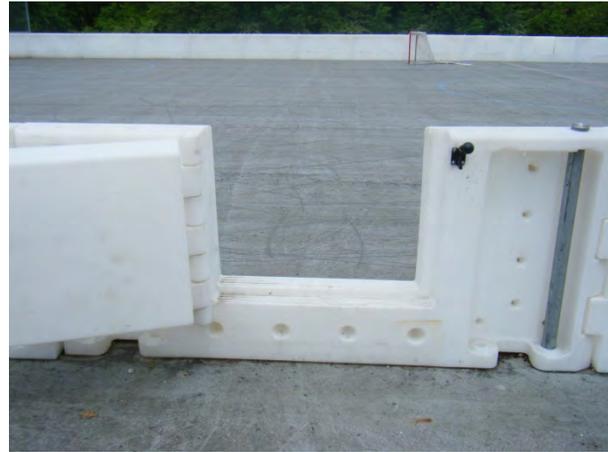
Photo 40

- Refer to site plan included with this report: (39) Modify or replace entry gate section at the Roller Rink (see photo 40 above) to eliminate the 12" high threshold section at entry (may need to make this a removable threshold section if it is necessary to have in place during play).

**Estimated Cost: \$500.00**

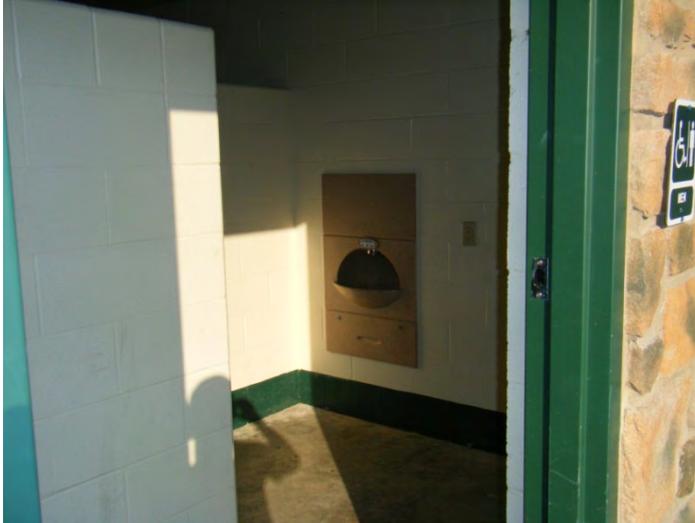
Photo 41

- Refer to site plan included with this report: (55) & (57) Existing lavatory in the Men's Restroom is recessed into wall (see photo 41 next page) and does not meet ADAAG 4.19 requirements for knee space below the lavatory. Options are to remove existing recessed lavatory unit and replace with a new wall-mounted lavatory that meets ADAAG 4.19 or modify the existing lavatory to obtain required knee space below the lavatory (see photo 42 next page for example) or leave existing recessed lavatory in place and install an additional wall-hung accessible lavatory next to the existing lavatory. If the additional lavatory is installed, a portion of the privacy wall at the entry will need to be removed to allow proper wheelchair maneuvering into the restroom. Also, the existing urinal is mounted 1" too high to meet ADAAG 4.18.2 – lower urinal to be max. 17" from floor to front rim. **Estimated Cost: \$2,075.00**

- Refer to site plan included with this report: (56) & (58) Existing lavatory in the Women's Restroom is recessed into wall (see photo 41 above) and does not meet ADAAG 4.19 requirements for knee space below the lavatory. Options are to remove existing recessed lavatory unit and replace with a new wall-mounted lavatory that meets ADAAG 4.19 or modify the existing lavatory to obtain required knee space below the lavatory (see photo 42 above for example) or leave existing recessed lavatory in place and install an additional wall-hung accessible lavatory next to the existing lavatory. If the additional lavatory is installed, a portion of the privacy wall at the entry will need to be removed to allow proper wheelchair maneuvering into the restroom.

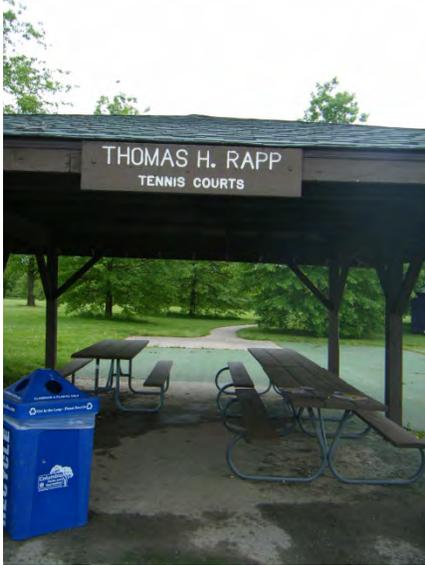
Photo 45

- Refer to site plan included with this report: (62) Raise Rapp Shelter sign so that it is min. 80" above grade (see photo 45 next page). **Estimated Cost: \$50.00**
