# Facility: Cosmo-Bethel Park

Address: 4500 Bethel Street

Date of Survey: 05/29/10

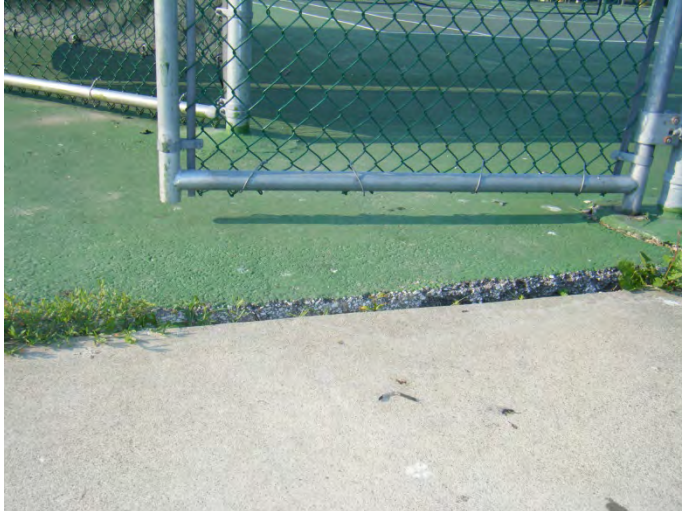
Photo 1

- Refer to site plan included with this report: (A) Remove ~ 20' long section of concrete walk at the shelter and replace with concrete walk at maximum slope of 5% (B) Patch gap (see photo 1 on next page) between sidewalk and tennis court surface at entry gates (C) Remove approximately 1,000 s.f. of existing sidewalk which includes sections with slopes up to 12.7% and replace with new sidewalk with maximum slopes of 5% and cross-slopes of 2% to the maximum extent feasible (D) Remove approximately 324 s.f. of existing sidewalk and ramp down into the east lower playground entry point and replace with new sidewalk with maximum slopes of 5% and cross-slopes of 2% to the maximum extent feasible (E) Installation of a new 4' wide concrete access path from the Leech Shelter down to the volleyball court and continuing down to the fishing lake shore. Maximum cross-slopes shall be 2%, but maximum slope of 5% will likely be infeasible due to existing grades but should be the goal for the new path as much as is feasible (F) Install a min. 4'x6' concrete pad at the shoreline for wheelchair seating area for fishing.

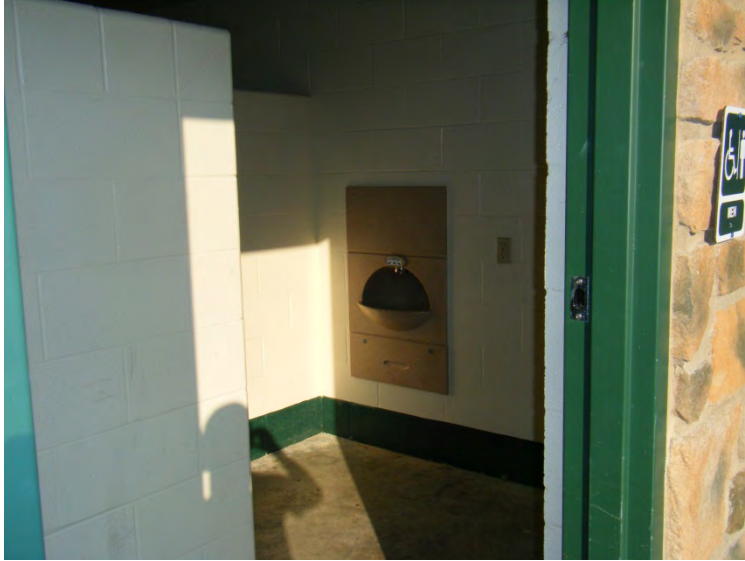
Photo 2

- Existing lavatory in the Men's and Women's Restroom is recessed into wall (see photo 2 on next page) and does not meet ADAAG requirements for knee space below the lavatory. Either remove and replace with a new wall-mounted lavatory that meets ADAAG 4.19 or modify the existing lavatories to obtain required knee space below the lavatories (see photo 3 on next page for example).  
**Estimated Cost: \$2,000.00**
- Existing urinal in Men's Restroom has rim mounted at 18.5" a.f.f. Lower urinal such that the front rim is no more than 17" a.f.f. **Estimated Cost: \$300.00**
