Facility: Douglass Park & Pool

Address: 416 N. Providence Road

Date of Survey: 06/01/10 & 06/02/10

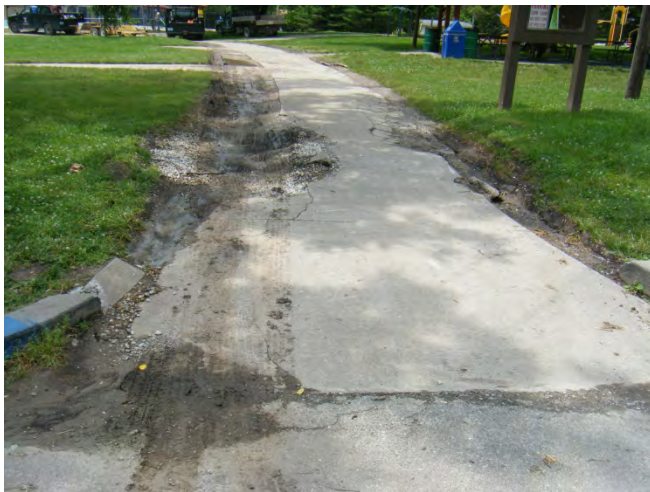
Photo 1

- Refer to site plan included with this report: (F) Repair several sections of damaged concrete walk just west of the accessible parking spaces and install contrasting truncated dome detectable warning surface where concrete walk intersects with parking lot (see photo 1 below). **Estimated Cost: \$2,061.00**

- Refer to site plan included with this report: (1) Parking lot has ~ 28 spaces, so two ADA parking spaces are required with one of the two being van-accessible. Only one ADA parking space currently exists, therefore one additional space needs to be added on the north side of the existing access aisle. Re-stripe (blue paint) for new ADA space (min. 8' wide), raise existing parking sign to 72" above grade, add a new ADA parking sign at new parking space and patch/smooth transition from asphalt to sidewalk (see photo 1 above). **Estimated Cost: \$254.00**

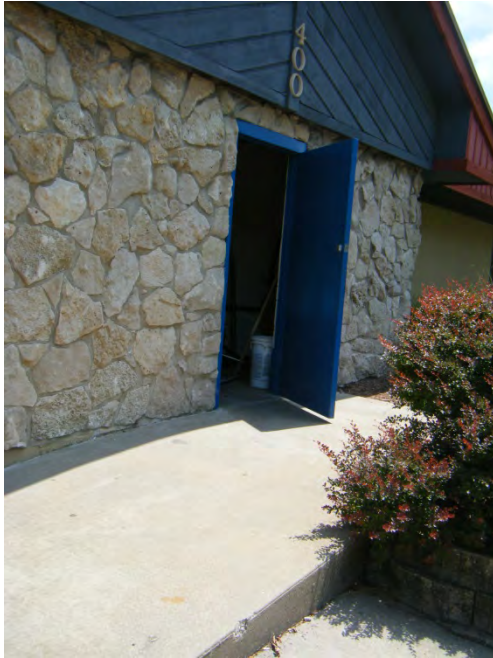
Photo 2

- Refer to site plan included with this report: (G) Existing ramp (see photo 2 below) up to the pool facility entrance door slopes up to 10.7% (ADAAG max. allowed is 8.33%), has no handrails and does not have proper sized landing at the door. Remove existing ramp and install new concrete ramp with galvanized handrail system that meets ADAAG 4.8 (~ 20' long x 6' wide ramp).

Estimated Cost: \$8,720.00

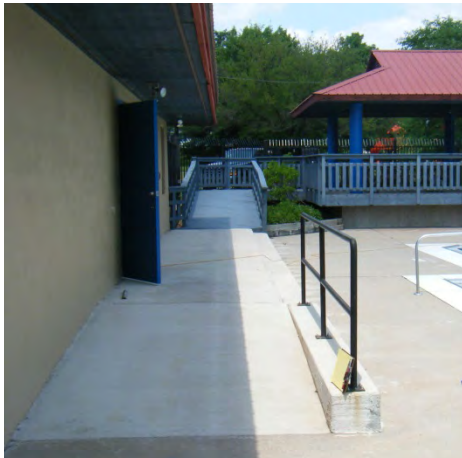
Photo 3

- Refer to site plan included with this report: (H) Existing concrete ramp (see photo 3 below) at pool deck does not have handrails mounted between 34" – 38" above grade on both sides of the ramp as required by ADAAG 4.8.5. Install 1.5" diameter galvanized metal handrails on both sides of ramp (~ 28 linear feet of new handrail).

Estimated Cost: \$938.00

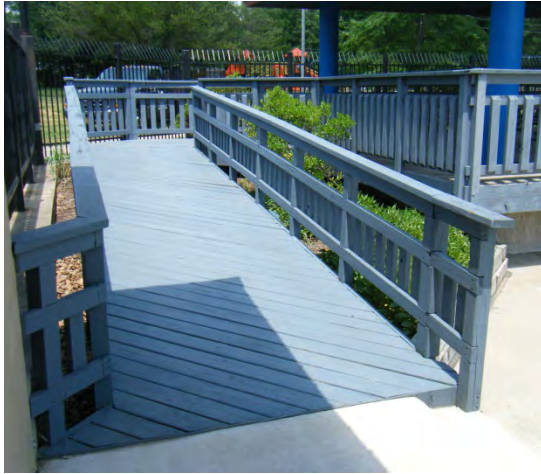
Photo 4

- Refer to site plan included with this report: (I) At existing wood ramp (see photo 4 below) up to pool shelter, replace ~ 5% - 10% of the wood ramp decking due to cupping and deterioration, add a min. 2" high wood curb at each side of the ramp surface (~ 56 linear feet of curbing), install 1.5" dia. wood handrails at 34" – 38" above grade on both sides of the ramp (~ 56 linear feet of railing) and modify the ramp landing to provide ADAAG required 5' square level landing.

Estimated Cost: \$1,345.00

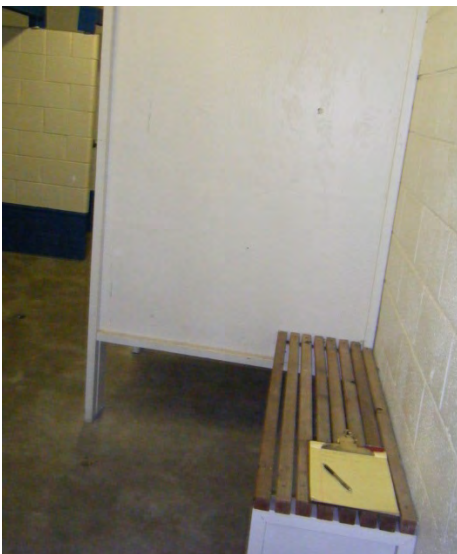
Photo 5

- Refer to site plan included with this report: (N) Women's Pool Restroom/Shower Room: Remove the fixed bench (see photo 5 below) to allow proper wheelchair maneuvering/access. Existing lavatory does not meet ADAAG 4.19 requirements for knee clearance below the lavatory – raise lavatory so that the top surface is 34" a.f.f. and replace non-accessible faucet control with an accessible control (single-lever or wrist blades). Install a 24" long 1.5" dia. grab bar at 34" – 38" a.f.f. on the rear wall of the shower to fill gap where grab bar is missing (see photo 6 below).

Estimated Cost: \$592.00

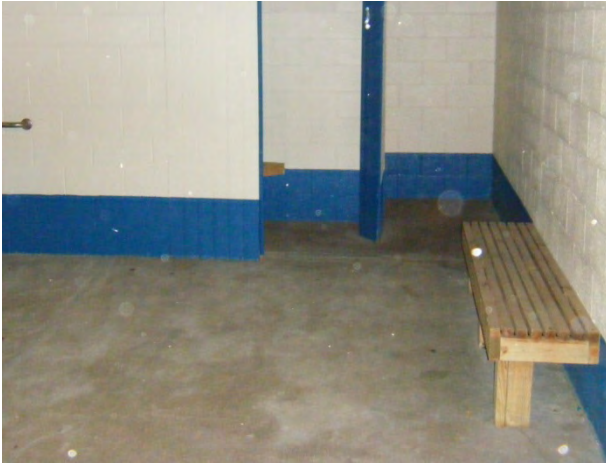
Photo 7

- Refer to site plan included with this report: (O) Men's Pool Restroom/Shower Room: Shift/relocate the fixed bench (see photo 7 below) ~ 3' further from the entry area to allow proper wheelchair maneuvering/access. Existing lavatory does not meet ADAAG 4.19 requirements for knee clearance below the lavatory – raise lavatory so that the top surface is 34" a.f.f. and replace non-accessible faucet control with an accessible control (single-lever or wrist blades).

Estimated Cost: \$546.00
