Facility: Valleyview Park

Address: 2210 Garden Drive Date of Survey: 05/04/10

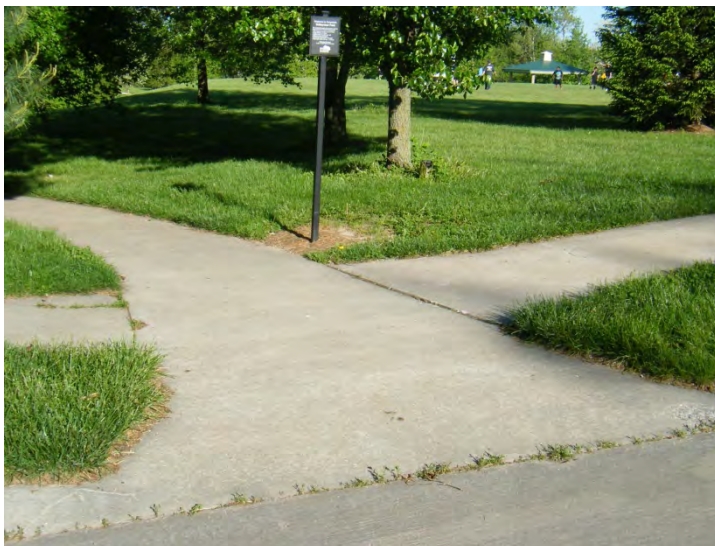
Photo 1

- Refer to site plan included with this report: (F) Install a contrasting truncated dome detectable warning surface at the existing Garden Street curb-cut (see photo 1 below). **Estimated Cost: \$1,272.00.00**

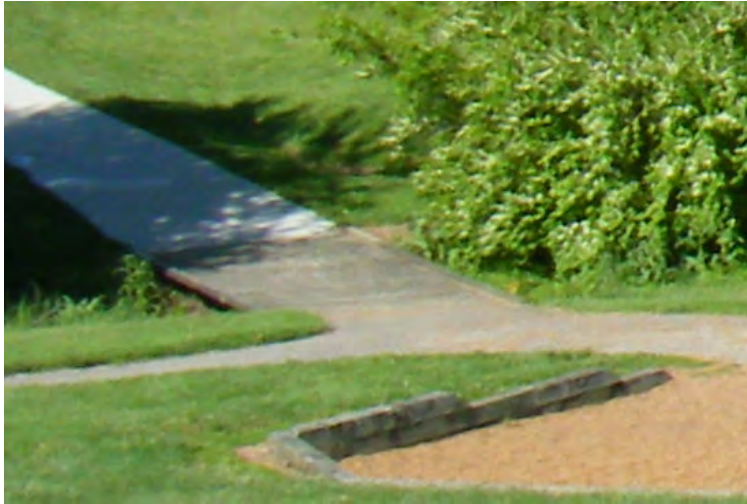
Photo 2

- Refer to site plan included with this report: (G) Install wood handrails on both sides of the ~18' long section of steep concrete walk attached to and west of the site wood bridge and on both sides of the ~36' long section of steep concrete walk attached to and east of the site wood bridge. Handrail system shall meet requirements of ADAAG 4.8.5 (see photo 2 below).

Estimated Cost: \$2,808.00.00

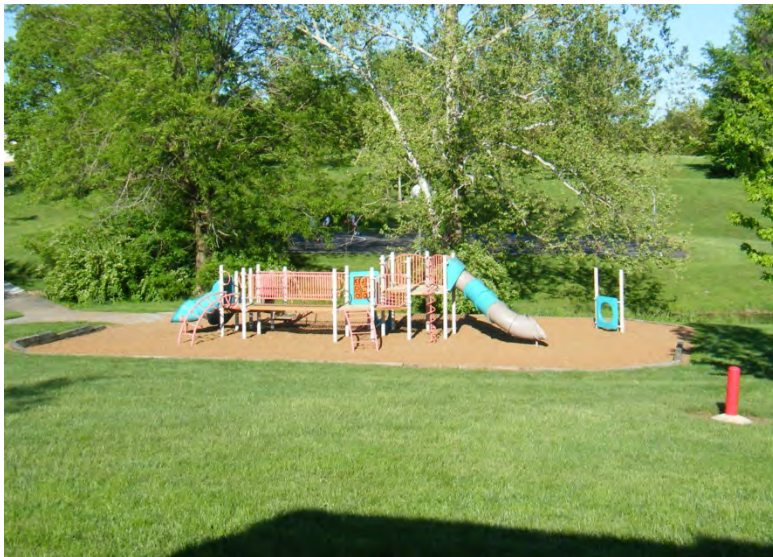
Photo 3

- Refer to site plan included with this report: (I) Due to remote location of swing-set play area and grade/slope/swale issues to make access difficult and costly, recommend that a new swing-set with at least one child/infant swing and one adult swing be installed adjacent to the existing playground just east of the shelter (see photo 3 below for suggested location). Installation includes ~768 s.f. of new well-compacted wood fiber surface for the swing-set and surrounding “use zone”.
Estimated Cost: \$4,235.00.00

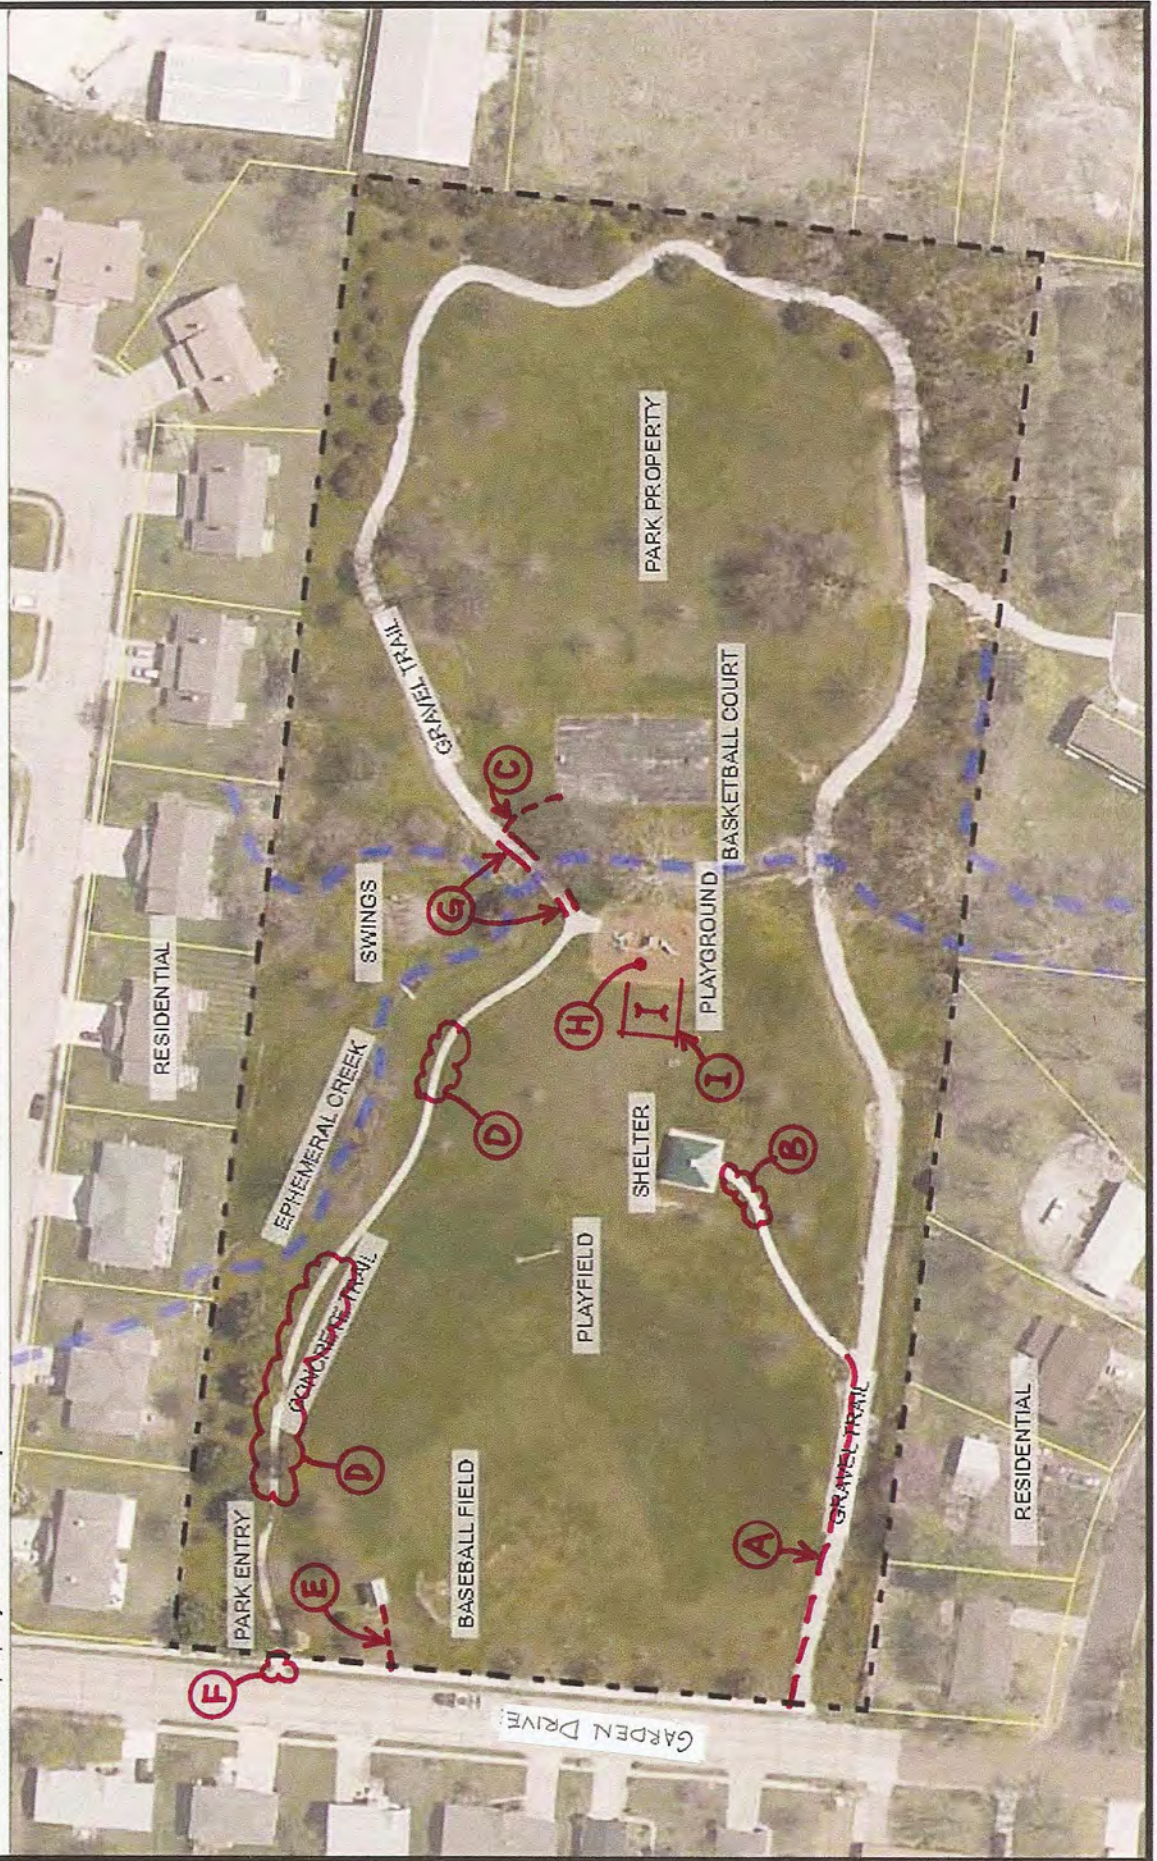
VALLEYVIEW PARK FACILITIES

- Refer to site plan included with this report: (A) Install a new concrete or asphalt access path from the Garden Street sidewalk east to the existing concrete walk that leads up to the shelter (~ 212 linear feet of 4' wide sidewalk total). Max. slope of access path should be 5% with a max. cross-slope of 2% as much as is feasible. **Estimated Cost: \$5,398.00**
- Refer to site plan included with this report: (B) The top 17' of sidewalk at the shelter has slopes from 5.1% - 7%. Remove approximately 40 linear feet of walk so that new sidewalk can be installed with overall slopes not exceeding 5% and cross-slopes no greater than 2%. **Estimated Cost: \$3,005.00**

- Refer to site plan included with this report: (C) Install a new concrete or asphalt access path from the existing sidewalk north of the basketball court over to the edge of the basketball court playing surface (~ 60 linear feet of 4' wide sidewalk total). Due to existing grades and swales, a small wood bridge may also be required for access. Max. slope of access path should be 5% with a max. cross-slope of 2% as much as is feasible. **Estimated Cost: \$2,872.00**

- Refer to site plan included with this report: (D) Remove and replace sections of concrete walk due to cross-slopes exceeding 3% in various areas. Replacement concrete sidewalk (~ 160 linear feet of 5' wide sidewalk total) should have max. slope of 5% and a max. cross-slope of 2% as much as is feasible. **Estimated Cost: \$6,804.00**

- Refer to site plan included with this report: (E) Install a new concrete or asphalt access path from the Garden Street sidewalk over to the small shelter at the NW corner of the park site (~ 35 linear feet of 4' wide sidewalk total). Max. slope of access path should be 5% with a max. cross-slope of 2% as much as is feasible. **Estimated Cost: \$1,292.00**

- Refer to site plan included with this report: (H) Replace the existing pea gravel play surfacing with well-compacted wood fiber material in the playground area (~2,016 s.f. area). **Estimated Cost: \$7,056.00**
