TO: City Council
FROM: City Manager and Staff *[Signature]*
DATE: December 31, 2007
RE: Field Park/Heibel Building Drainage Issue

Heibel Building Photos
(Photos #2-8 Taken 12/28/07)

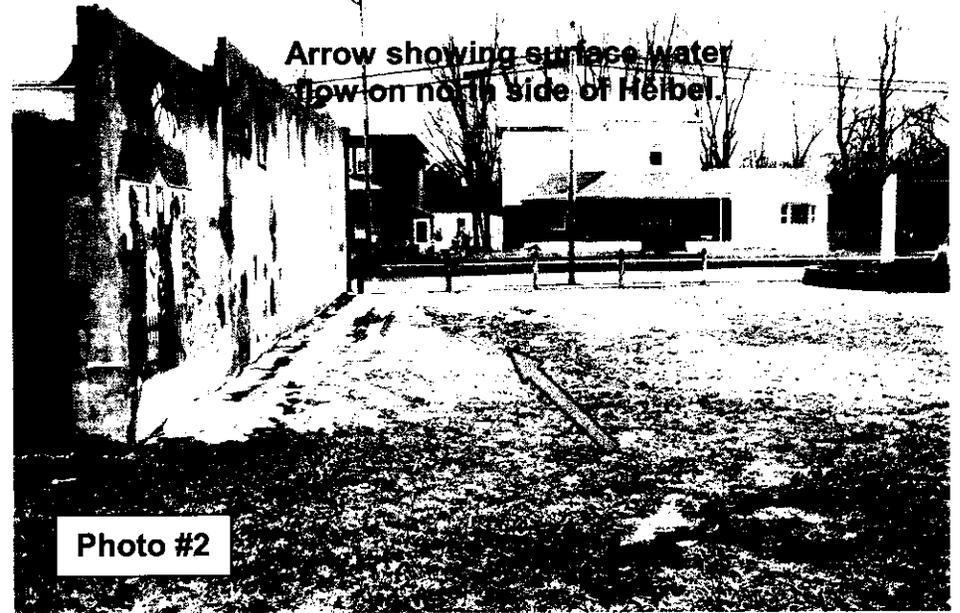
Photo #2

The original sidewalks are located on Range Line and Wilkes Blvd. These sidewalks were not altered as part of the park construction project. There is a gentle swale on the north side of the building that appears to handle most rains (Photo 2). Park staff have been onsite on two occasions during and after rains and found that the water was draining via this swale. Increasing the depth of this swale would be difficult due to the existing grade of the sidewalks that surround the building. Mike Snyder, the Sr. Parks Planner that designed the park and supervised it's construction, met with CMCA's representative to review the terrain and confirmed that the construction of the park was not held in or around a 15-20 ft buffer around the building. The grade around the building allows for water to run away from and around the building (Photos 3 & 4). The grade was certainly not raised higher than the floor as indicated. Preliminary discussions were held regarding building issues and future grading and landscaping possibilities, but responsibility for these issues were not confirmed.

**Arrow showing surface water
flow on north side of Heibel.**

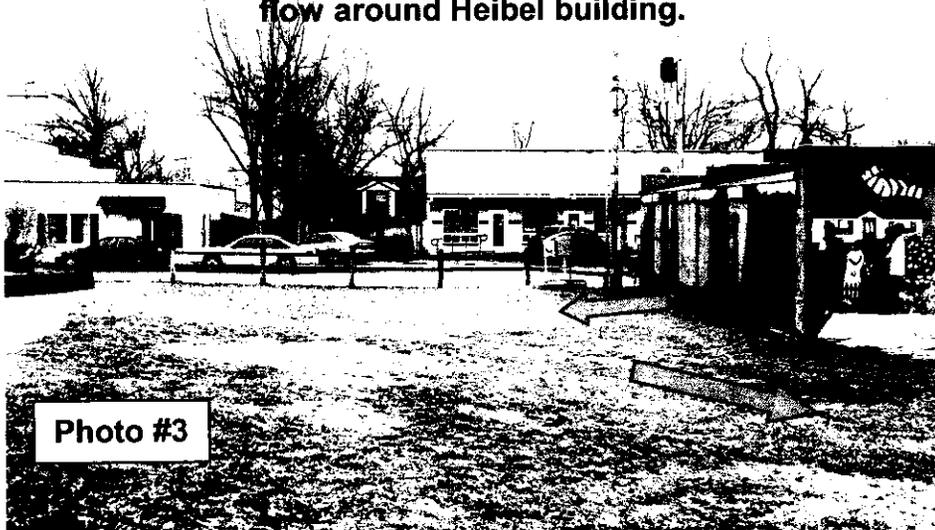
Photo #3

**Arrows showing surface water
flow around Heibel building.**

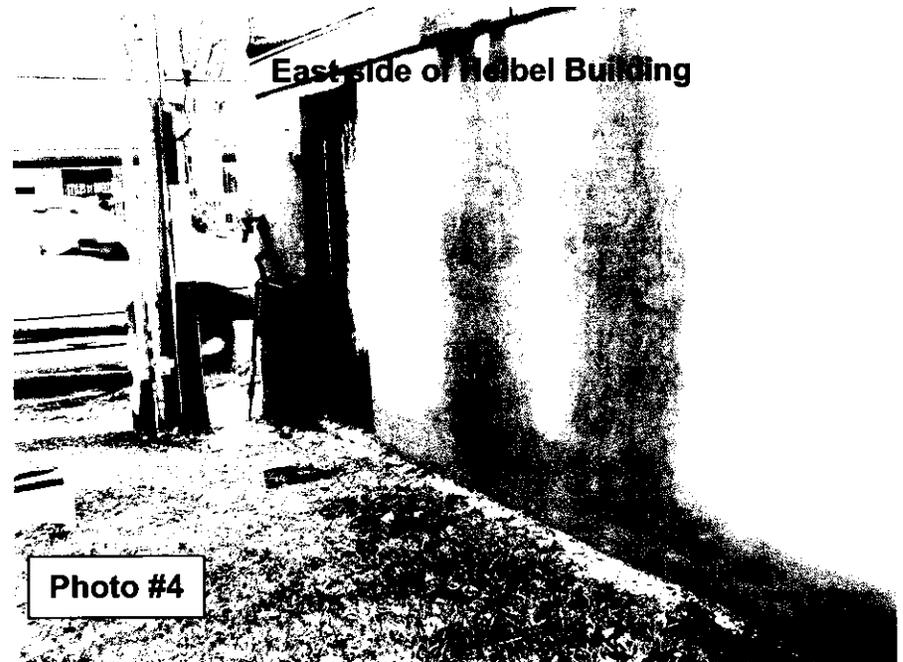
Photo #4

2. The roof slopes from the front of the building to the back (west to east) and does not have any gutters. Therefore, all rain water runs off of the roof, down the exterior of the east wall and pools against the building. The east side of the building is also an area where the grade was not disturbed or altered by the construction of the park. The Heibel roof is still under renovation and is currently covered with felt paper that is curling up and coming off in some sections. While grading and altering the terrain of this area will help, unless the roof is completed and gutters are installed, it will not stop the water from entering into the building.

East side of Heibel Building

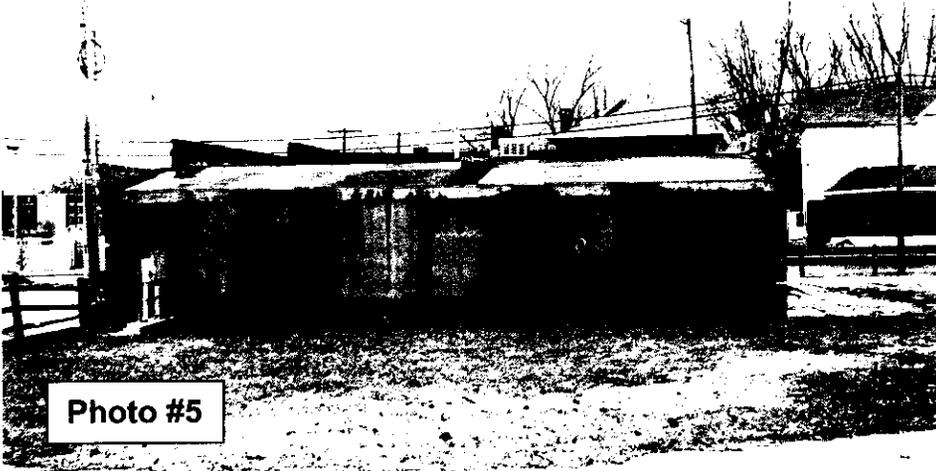
**East side of building showing
sloped roof and water running down walls.**

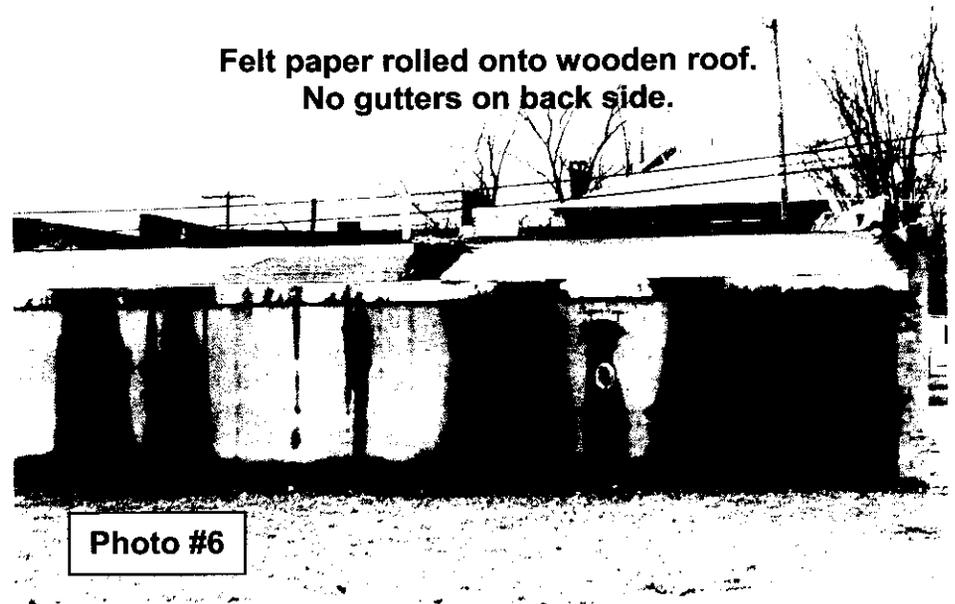
**Felt paper rolled onto wooden roof.
No gutters on back side.**
