Re: Public Hearing for Maplewood Home Improvements

MAPLEWOOD HOUSE

3701 Ponderosa St.

BUILDING SURVEY, July 2015

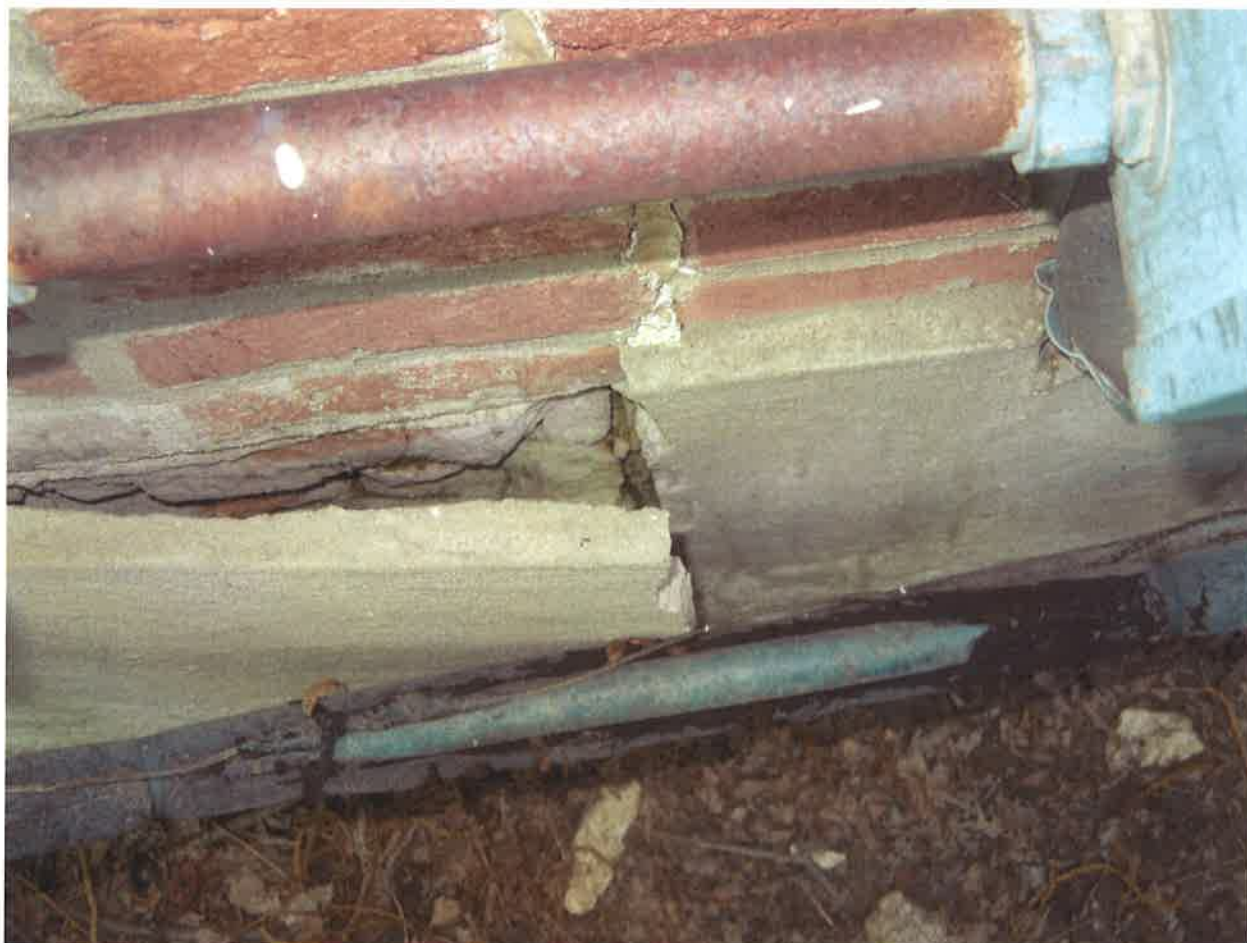
Foundation Parging

The building sits on a brick foundation which appears to be the same brick the above grade exterior walls are constructed. A parge coat of mortar covers the foundation brick. The parging extends below grade and I assume terminates at the foundation footing. The above grade foundation parging is damaged / deteriorated in several locations. Due to the weathering effect of the soil and moisture, and the likely movement of the foundation it is credible the below grade parging is in poorer condition explaining basement ground water infiltration and excessive crawl space moisture.

It is my experience the most effective method for waterproofing / damp-proofing a foundation is done on the exterior. The process begins by excavating along the wall, all the way down to the footings. Dirt, loose mortar, brick dust and parging are removed from the foundation wall and a "parge" coat of mortar is applied over the entire wall that provides a more uniform and above grade decorative surface.

Once the parge coat has cured, an exterior waterproofing membrane consisting of asphalt-modified polyurethane is applied to the below grade wall. Next install a foundation drain tile system with a sump pump. The excavated trench is filled to within two feet of the final grade with a granular backfill such as 1" clean rock. The remaining portion of the ditch is backfilled with clean soil and graded causing positive surface water drainage away from the foundation.

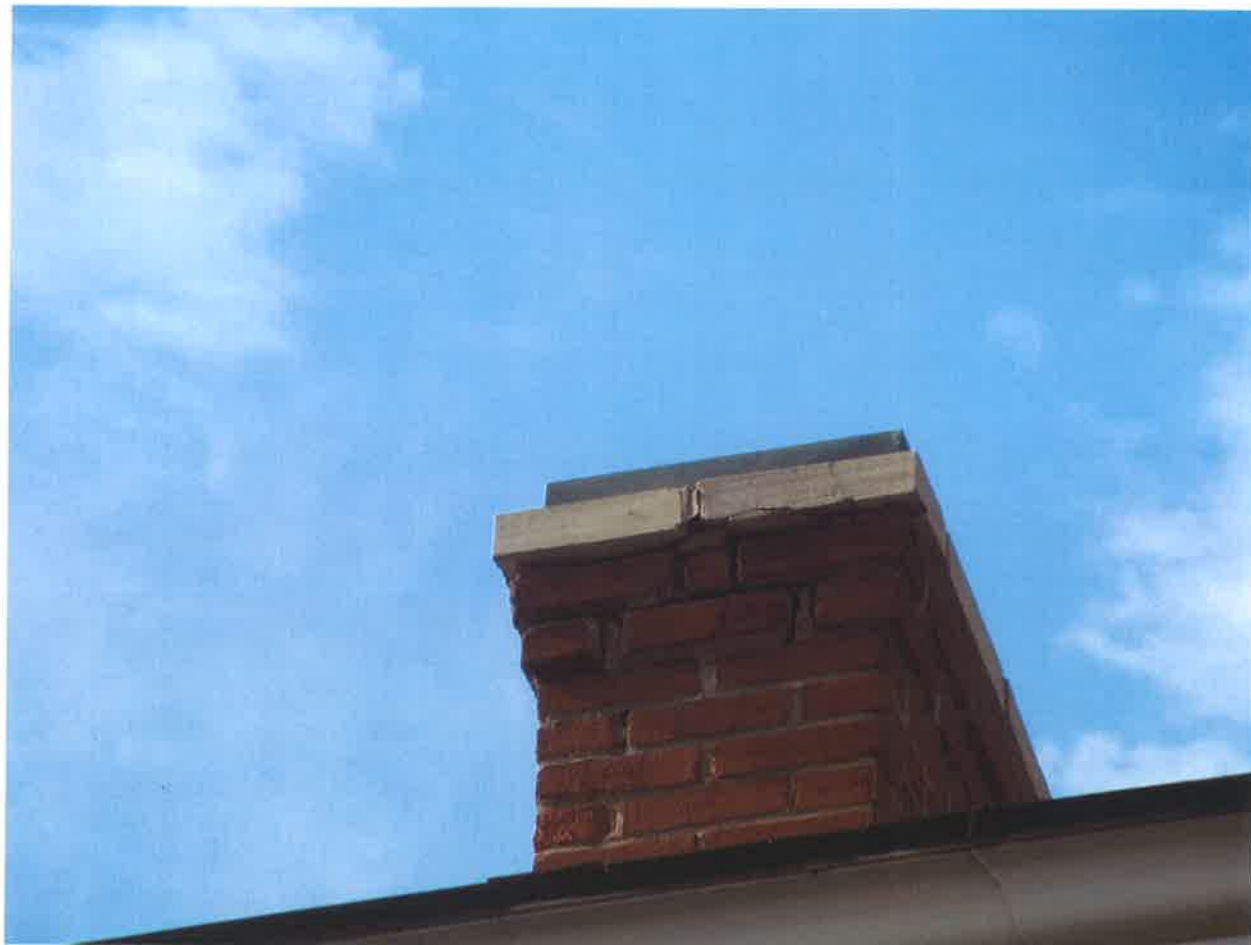
Brick Chimney

There are four brick chimneys, three are nonfunctional, one is used as a metalbestos furnace flu chase. All four brick chimneys need repointing, and portions of three chimneys needed to be rebuilt above the roof line. All sheet metal chimney caps are not properly secured and sealed.

As a general rule conditions which require repointing include: (1) mortar erosion equal to or greater than one quarter (1/4) inch (2) crumbling mortar, (3) hairline cracks in the mortar, and (4) cracks between the brick and mortar. As shown in the attached photos (BrickChimney1-7) portions of the Maplewood House chimneys' mortar deterioration exceeds the above guidelines warranting a partial rebuild.

The occasional repair of the mortar joints is expected over the life of the brick masonry. Unfortunately the occasional repair of the brick chimneys' mortar joints has not occurred. That is why portions of the chimneys are deteriorated to the point warranting a partial rebuild.

An imperative reason for repointing brick masonry is to improve water penetration resistance and maintain structural integrity. Repointing mortar joints is one of the most effective and permanent ways of decreasing water entry into brickwork. This is because the most common means of water entry into brick masonry is through deboned, cracked or deteriorated mortar joints.

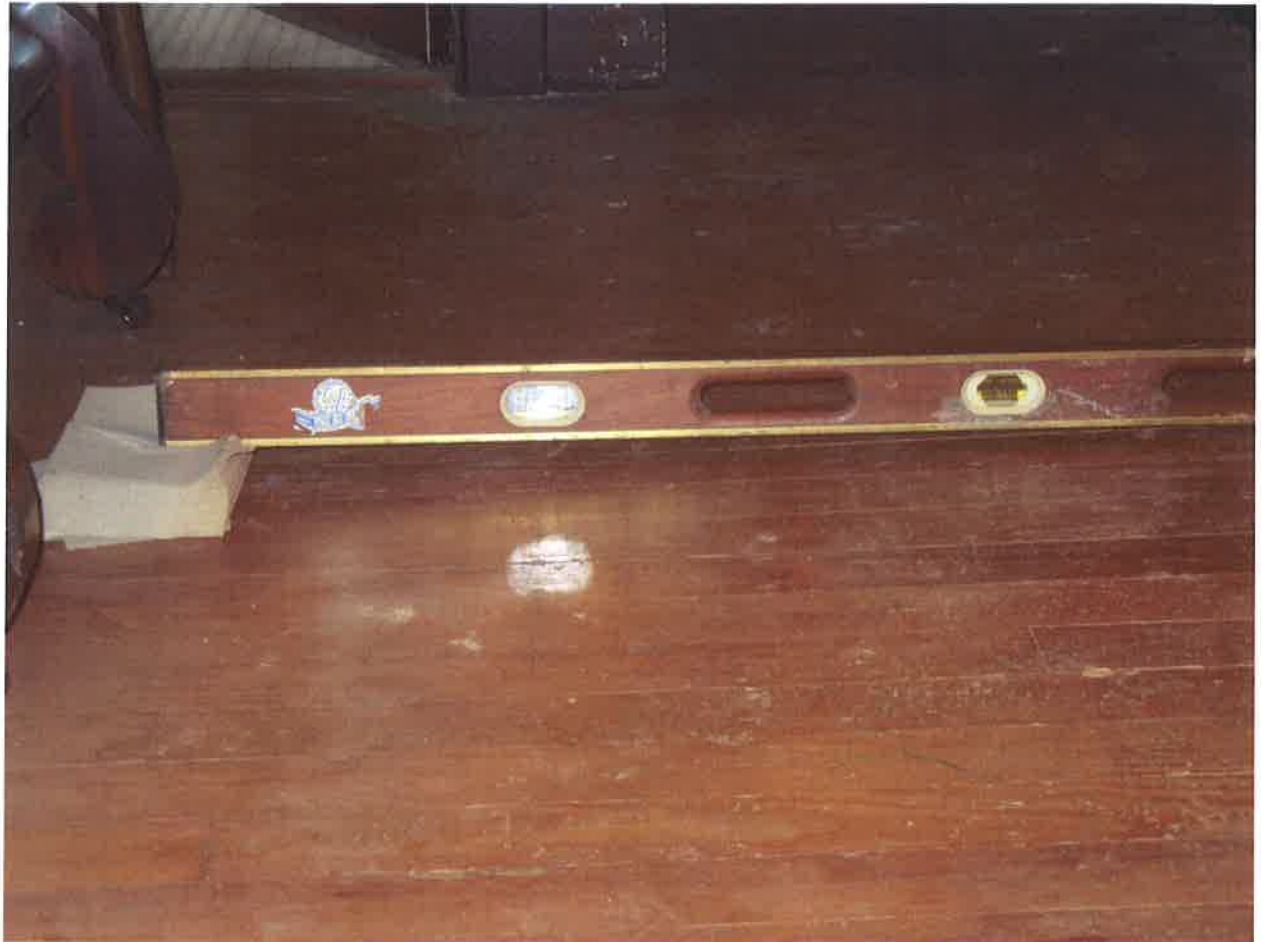
Unlevel Floor

The down stair bathroom, the adjoining utility room and the adjoining hall way floor assemblies have failed. These floors are out of level three quarters of an inch (3/4") in three (3) feet meaning a 2% slope. The down stair bathtub is falling through the subflooring. These conditions are due to improperly support floor joists and beams, rotting/damaged floor joists and rotting subflooring. Defective conditions include improper bearing and support, termite damage and dry/wood rot due to excessive moisture.

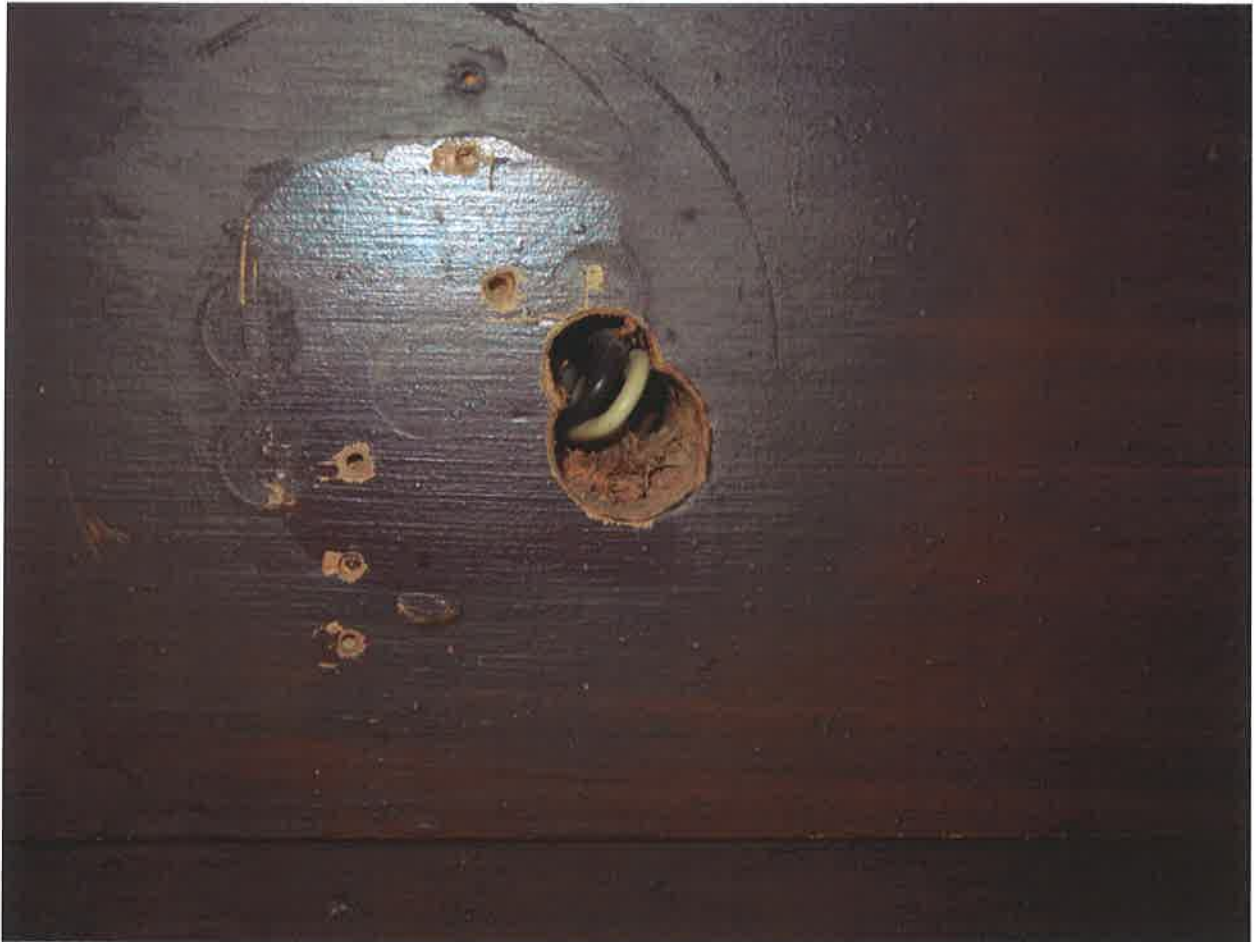
1. Pinched wire in basement light.
2. Improperly supported / secured non-metallic cable in basement and crawl space.
3. Coils of non-metallic cable in basement improperly terminated.
4. Eliminate use of extension cord in basement.
5. Exposed electrical wires and open j-boxes.
6. Electrical surface raceways improperly strapped / secured.

7. Exterior AC disconnect box not secured to the structure.

The electrical system is a potential fire hazard in any structure if the integrity of the system's electrical service, distributions panels, controls, wiring, fixtures, equipment, devices and appurtenances are not properly maintained. There are a number of conditions, which I have previously listed, which qualify for classification as unsafe or hazardous. A thorough inspection and testing by a licensed electrician of the structures electrical system is needed. The inspection and testing should include:

1. Continuity
2. Bonding Conductors Continuity
3. Polarity
4. Earth Electrode Resistance
5. Wiring Methods
6. Boxes and Conduit Bodies
7. Cabinets and Cutout Boxes
8. Switches, Receptacles and Fixtures
9. Replace circuit breakers AFCI breakers

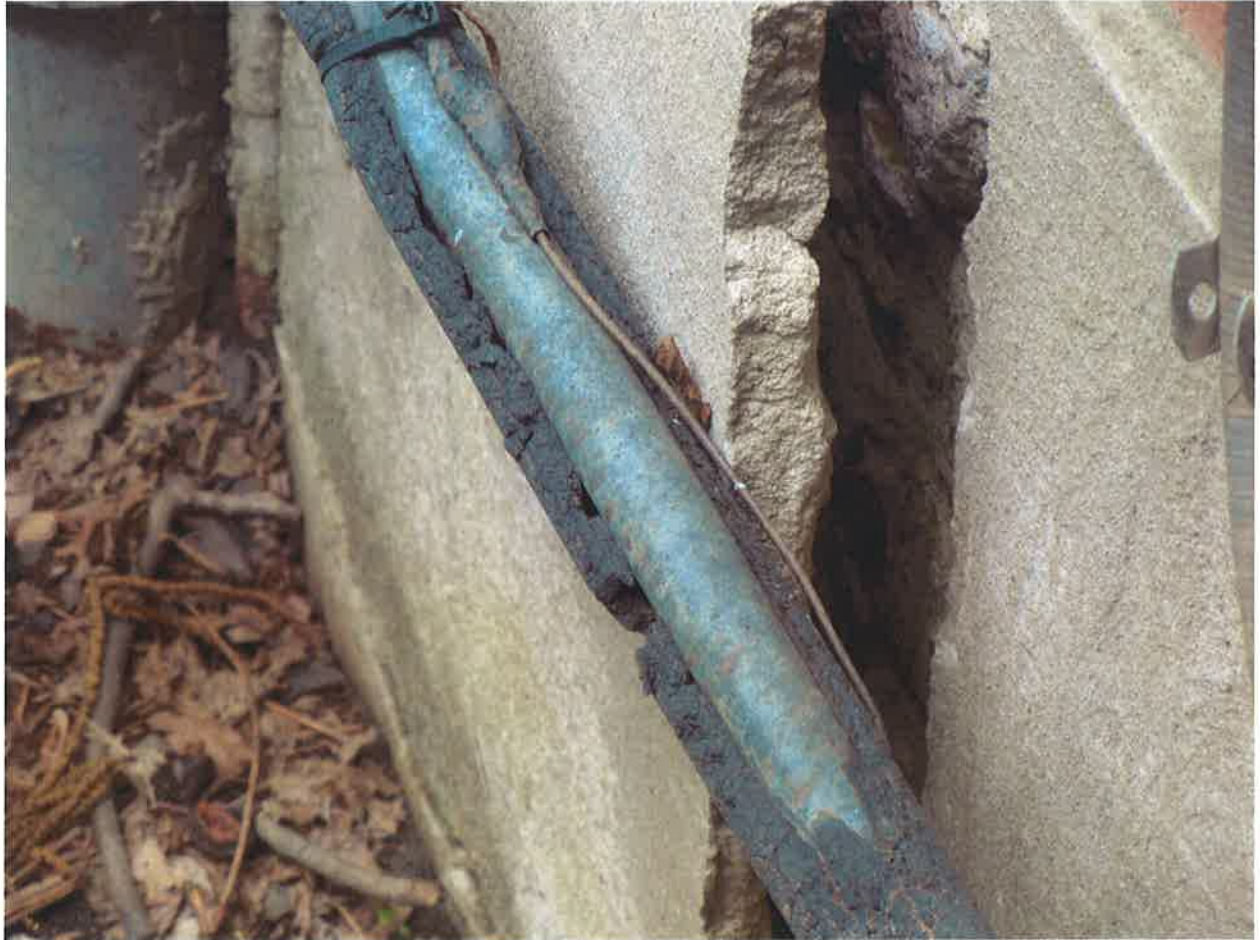
1. The first floor air handling unit (furnace) located in the basement is dated, inefficient and possibly unsafe. Due to basement ground water infiltration the furnace is rust damaged. Of greatest concern is the integrity of the heat exchanger, and the real possibility the heat exchanger rust has caused pitting and the potential release of carbon monoxide. The manufacturer's equipment plate is illegible so I am unable to determine the manufacturing date and the unit's designed efficiency based upon BTU input and output. In looking at the furnace cabinet, the gas valve, limit switch etc.; I estimate this unit was manufactured in the late seventies or early eighties at best. For equipment of this age the designed thermo-efficiency is typically around 76% under optimum conditions.

2. The two air conditioning units are at least 20 years old. Equipment of this age typically has a SEER Rating (BTUs of Cooling per watt) of 10. All equipment becomes less efficient with time, and Water & Light Energy Services staff estimates the unit's efficiency to be 7-8 SEER. The current model energy code specifies a minimum SEER rating of 13.

I am recommending the replacement of the first floor air handling unit and the two air conditioning condensing units with high efficiency equipment with humidifying capabilities and smart Wi-Fi thermostats. The existing HVAC equipment and controls are inefficient and lack the capability of creating and regulating the needed interior climate.

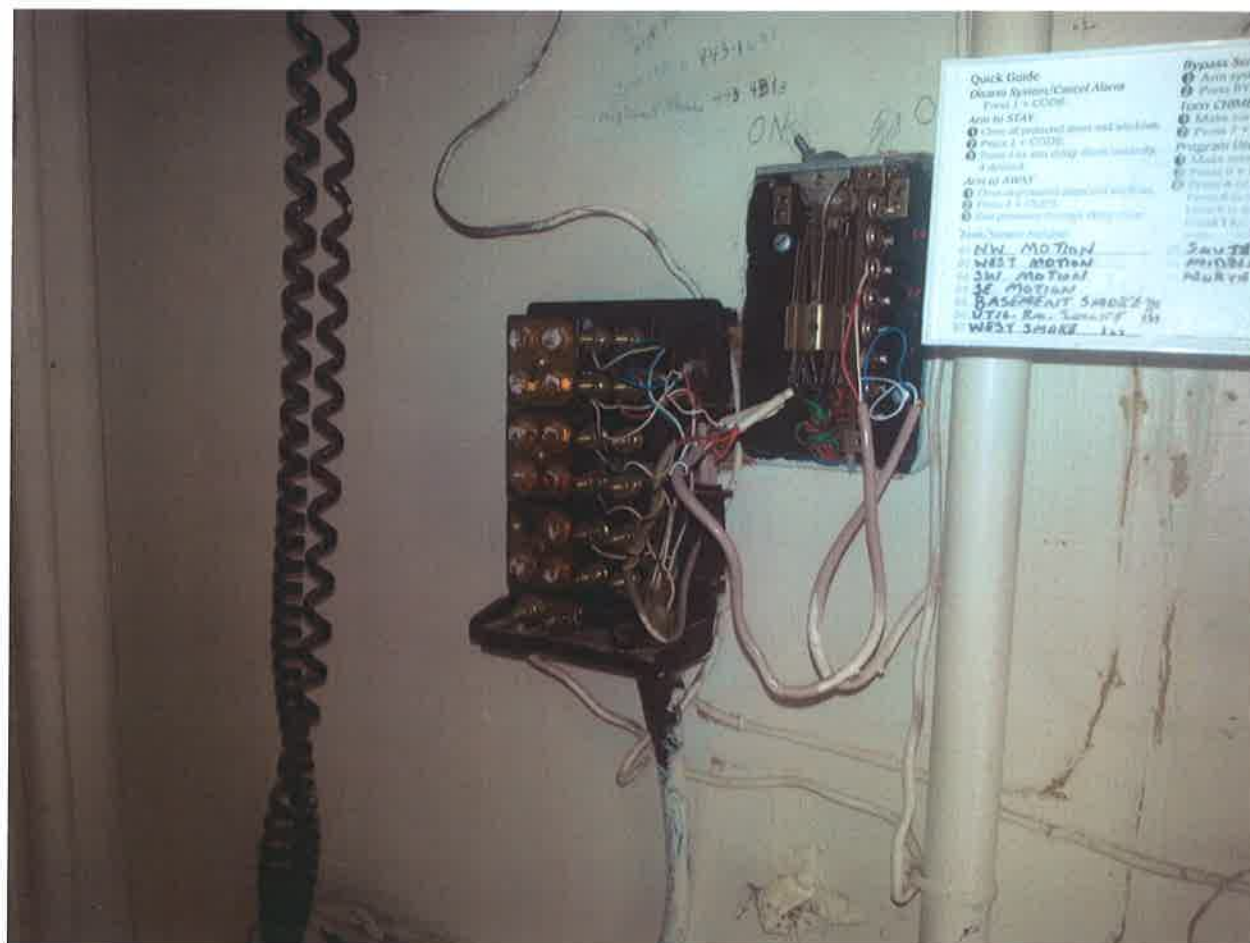
Alarm Wiring Phone Dmarc

1. The control panel has a single network line for communication and monitoring.
2. The audible alarms are built into the smoke detectors which is indicative of a residential fire detection system. Fire notification should include an indoor siren and visual strobe notification.
3. There are no manual fire alarm pull stations.
4. There is no detector in the attic monitoring the attic HVAC system.
5. The detectors in furnace locations should be both heat and smoke devices.
5. The telephone demarcation point equipment is old, I am guessing circa 1950s. For an unknown reason some of the on premise fire detector wiring is switched meaning a portion of the fire protection system can be manually switched off. See Photo "Alarm Wiring"

I lack the expertise, testing equipment, comprehensive knowledge of industry standards and equipment compatibility for me to categorically state the system can be upgraded or should be replaced. To drive a budget number I have assumed a total replacement of the existing system with the following features.

1. Contemporary control panel
2. Wireless receiver
3. Landline and cellular communicator
4. Wireless synchronized smoke detectors
5. Wireless motion sensors
6. Wireless door sensor
7. Indoor siren
8. Visual (strobe) alarm
9. Smoke and heat detectors in furnace locations
10. Manual alarm pull station
