# Facility: MLK Jr. Memorial at Battle Garden

Address: 800 W. Stadium Blvd.

Date of Survey: 04/18/10

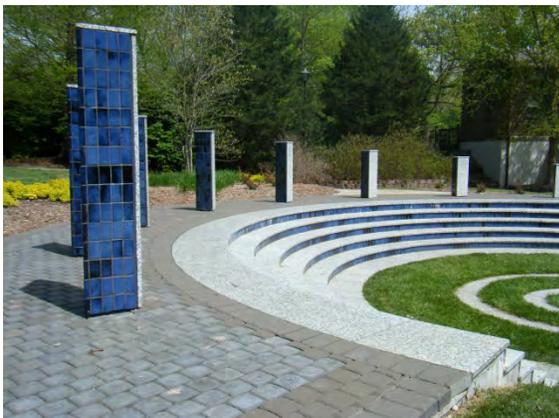
Photo 1

- Note: Slopes of walks up to the MLK memorial pillars are mostly 5% or less. The masonry pavers around the pillars are only minimally wheelchair accessible, but no changes have been identified in this report. Recommend looking at the installation of a more accessible paving stone or other surface in the future when maintenance is necessary in this area (see photo 1 below).

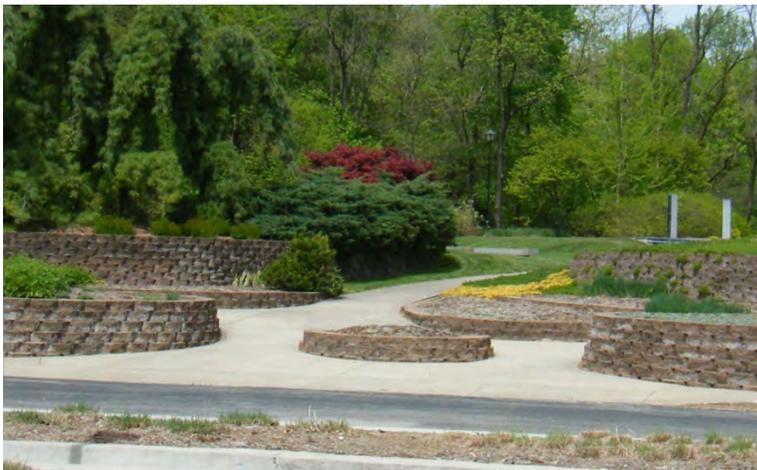
Photo 2

- Refer to site plan included with this report: (A) Install a minimum 3' deep strip of contrasting truncated dome detectable warning surface across the entire width of the sidewalk intersection with the parking lot (see photo 2 below).

**Estimated Cost: \$2,460.00**

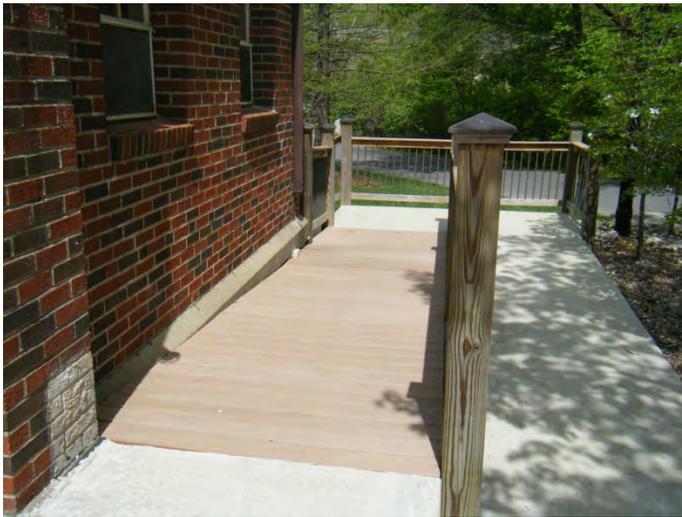
Photo 3

- Refer to site plan included with this report: (B) Install wall-mounted handrail on both sides of ramp (existing guardrail does not meet ADAAG 4.8.5 requirements for handrails – see photo 3 below). Handrails shall be 1.5” diameter, be continuous along the gripping surface and mounted between 34” & 38” above the ramp surface. **Estimated Cost: \$1,340.00**

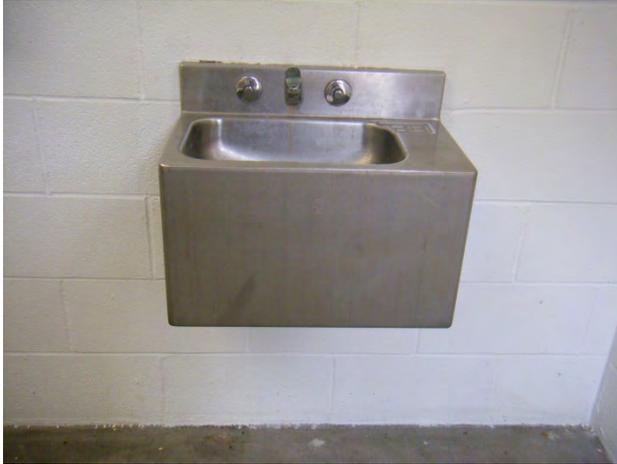
Photo 4

- Refer to site plan included with this report: (D) Men's Restroom in lower level of the Audubon Society Museum Building – Install a braille/tactile ADA restroom sign at 60" a.f.f.at the latch side of the entry door, replace the non-accessible lavatory (see photo 4 next page) with an ADA compliant lavatory mounted no higher than 34" a.f.f. with minimum knee clearances meeting ADAAG 4.19, lower mirror to be no higher than 40" a.f.f. to bottom reflective edge, lower one urinal so that the front lip is no higher than 17" a.f.f., reconfigure the toilet stall to meet ADAAG Fig. 30 (b) 36" wide alternate stall (includes moving and/or lowering the toilet fixture as necessary) and modify shower to meet ADAAG 4.21 and Fig. 35 (b) (lower controls, install an additional fixed shower head at 48" a.f.f. and install proper grab bars). **Estimated Cost: \$4,459.00**

- Refer to site plan included with this report: (D) Women's Restroom in lower level of the Audubon Society Museum Building – Install a braille/tactile ADA restroom sign at 60" a.f.f.at the latch side of the entry door, replace the non-accessible lavatory (see photo 4 next page) with an ADA compliant lavatory mounted no higher than 34" a.f.f. with minimum knee clearances meeting ADAAG 4.19, lower mirror to be no higher than 40" a.f.f. to bottom reflective edge, reconfigure the toilet stall to meet ADAAG Fig. 30 (b) 36" wide alternate stall (includes moving and/or lowering the toilet fixture as necessary and removing a minimum of 2" of the concrete masonry unit stall divider wall to allow for minimum of 42" access path to the toilet stall) and modify shower to meet ADAAG 4.21 and Fig. 35 (b) (lower controls, install an additional fixed shower head at 48" a.f.f. and install proper grab bars). **Estimated Cost: \$4,059.00**
