Re: Hazardous Tree Removal Report

**Parks Services Natural Resources  
Tree Hazard Evaluation Form**

Site/Address: Stephens Lake Park

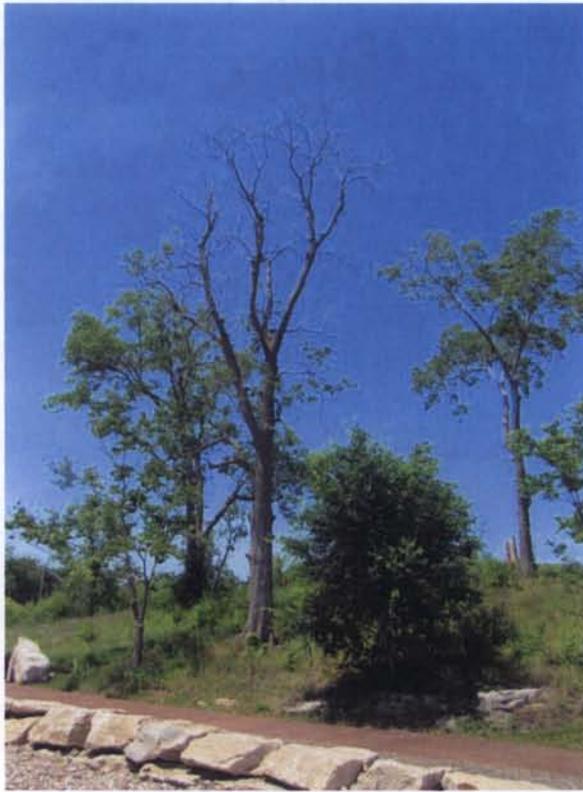
Hackberry Tree

Part most likely to fail: Large scaffolding limbs and limbs of the canopy and crown

This tree is located in a high traffic area of a high use park. As the dead limbs of the canopy decay further, there is a high potential for it to drop these limbs on both park users and structures/facilities. Approximately 80 % of the canopy of this tree is dead. The tree has gone through this decline fairly rapidly, and I foresee the remaining live portion of the tree continuing this decline. It is my opinion that this tree should be removed as soon as possible.

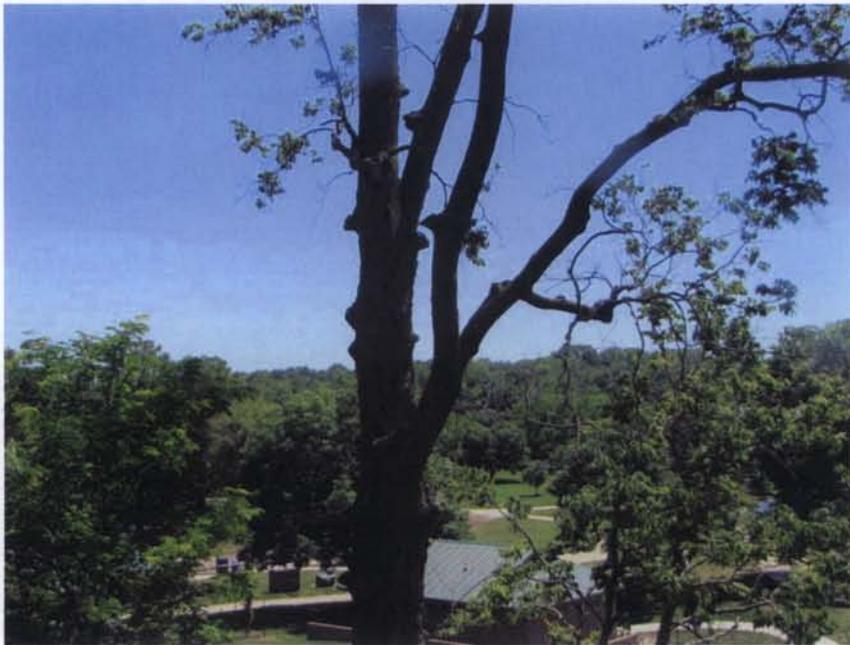
Hackberry Trunk Damage

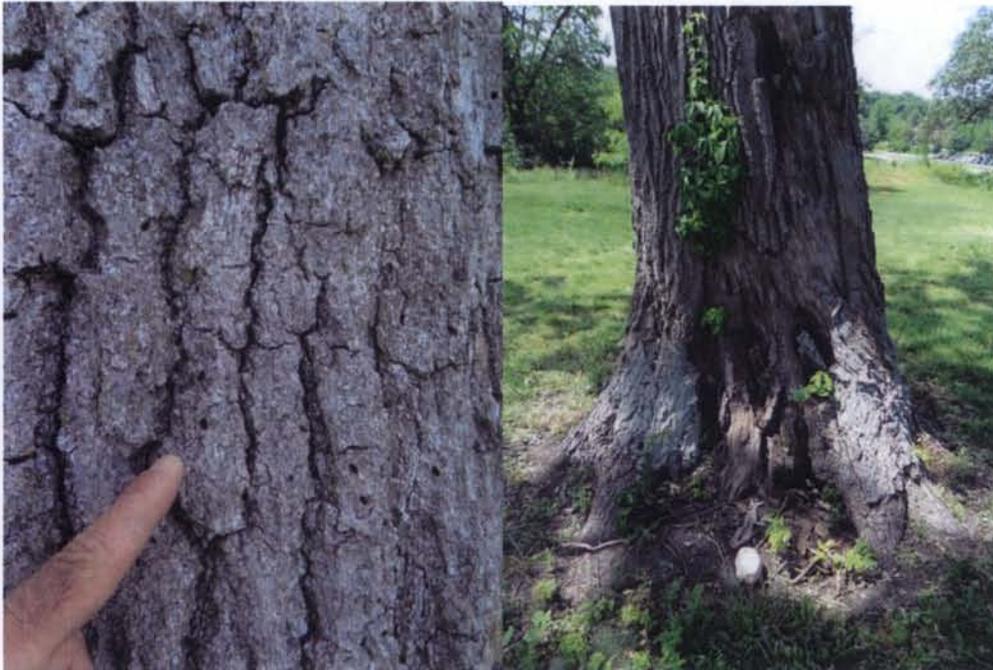
Northern Red Oak

This tree has been slowly declining for several years. There is a large amount of rot in the root flare (base) of the tree, coupled with an unnatural lean. The presence of borers in the main stem is also a concern. The tree is in a high use area of the park, above the seating for the park amphitheater. Because of the rot in the base of the tree, the most likely scenario for failure would be the entire tree failing at the base. This tree is located on top of an open hill and is exposed to winds from all directions.

Insect Borers

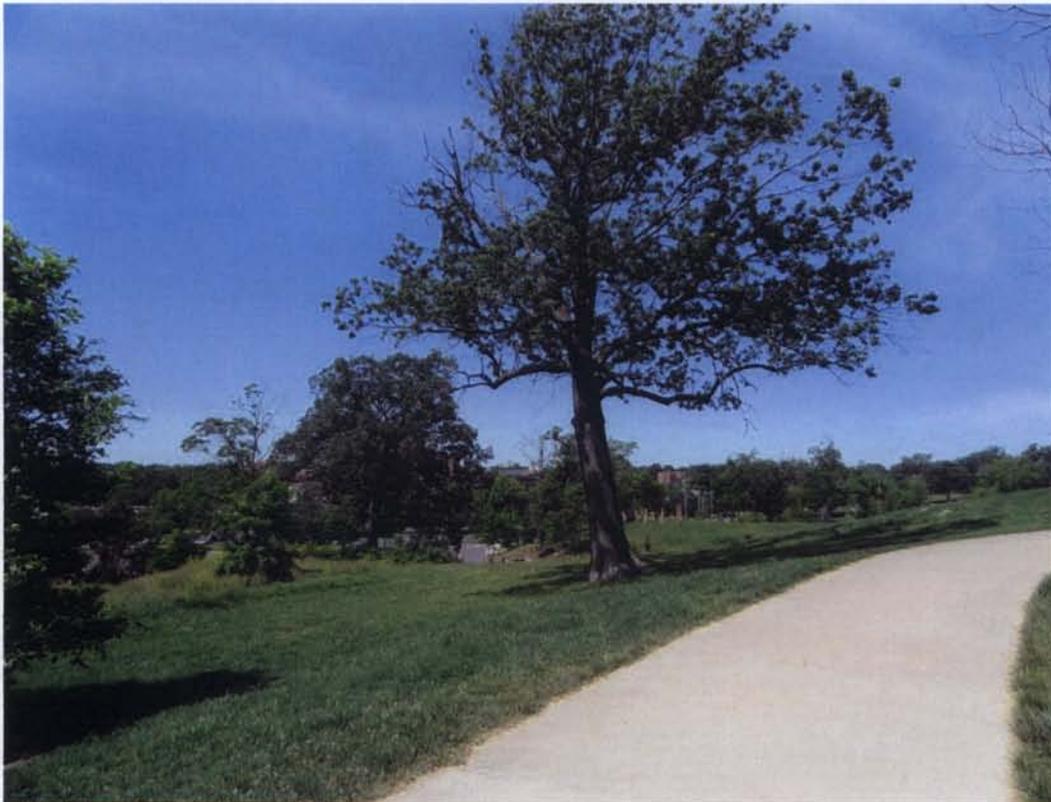
Root Decay

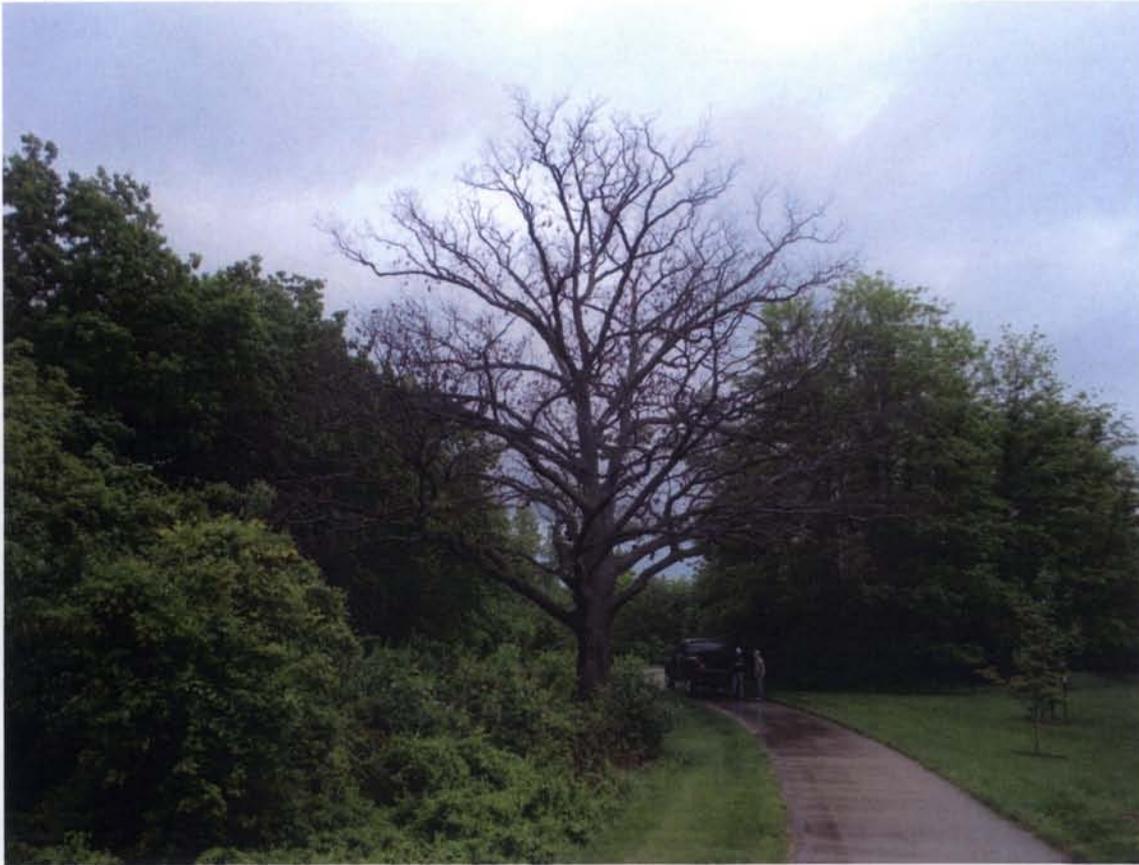
## Chinkapin Oak

Major pests/diseases: Extensive dieback, hypoxylon canker, borer damage

This tree is next to a high use paved fitness trail, with a high target potential beneath it. It began to go into a rapid decline following the extended drought/heat wave in the summer/fall of 2011. In the spring of 2012, 99% of the tree failed to leaf out, and signs of hypoxylon canker were evident throughout the tree. Borer damage was also present on the majority of the trunk and main scaffolding branches. By April of 2012 the remaining live branches had died, and the wood in the canopy of the tree had become quite brittle. The likelihood of branch failure is very high.

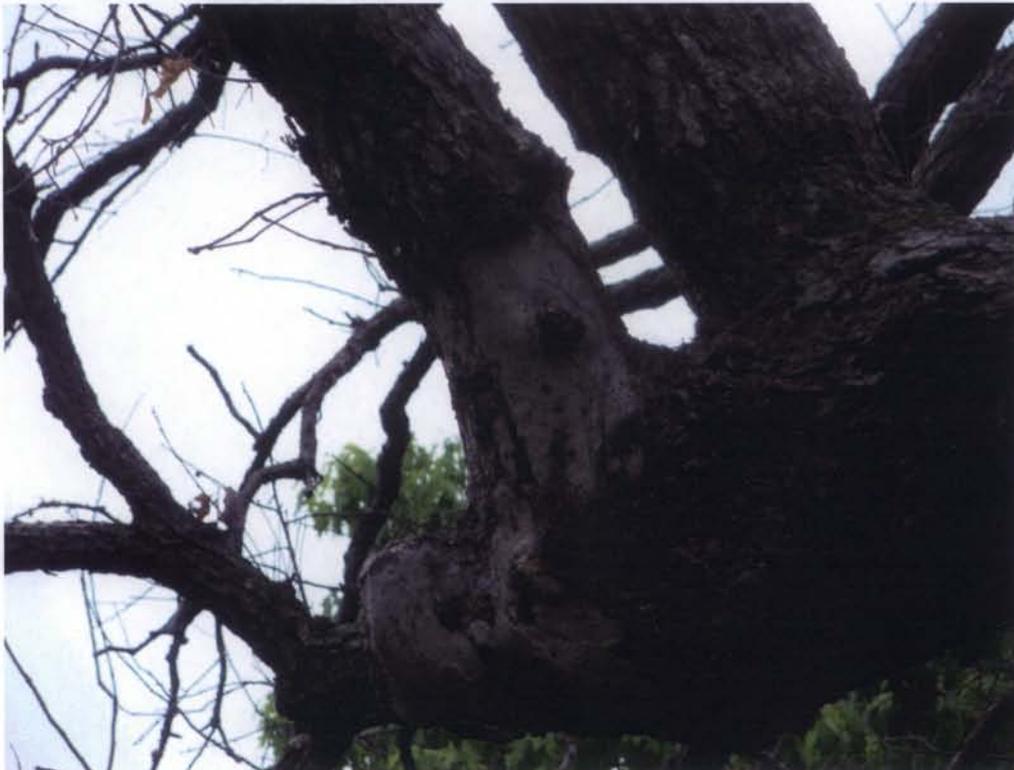
Chinkapin Scaffolding Branch Damage
