Agenda Item No: REP 164-12

Council Meeting Date: November 5th, 2012

Re: Hazardous Tree Removal Report: Nifong, Westwinds & Stephens Lake Parks

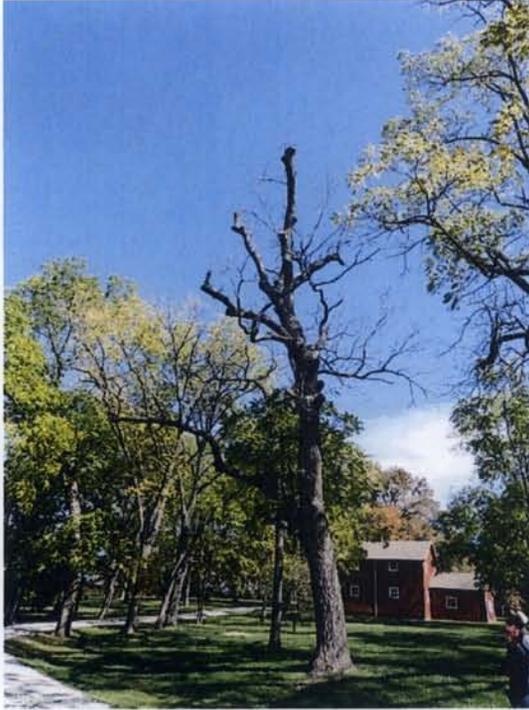
Nifong Park Black Walnut

The Black Walnut tree that the Parks and Recreation Forestry staff is proposing to remove is located in Nifong Park along the curve of the service road west of the Maplewood Home. The 34-inch DBH tree has wounds throughout the trunk, and has a live crown of less than 20% possessing a high potential for falling scaffolding branches and dead limbs from the crown and canopy. Forestry Staff has tracked the decline of the tree for 5 years and removed a large amount of deadwood from the tree two years ago. Staff has observed the continual decline of the tree and the potential for failure is the key factor for the determination of removal due to the high traffic use of the park area during festivals and events.

This mature black walnut has been in decline for the past 5 years. Two years ago a large amount of deadwood was removed from this tree. Since this pruning was done more of the branches have died creating more of a hazard. On a day to day basis this park sees little use, however, it hosts several festivals and events when there are hundreds of people in the park and under this tree. I recommend that this tree be removed in the near future because of its past history of limb failure and because there are events that bring hundreds of people to this park.

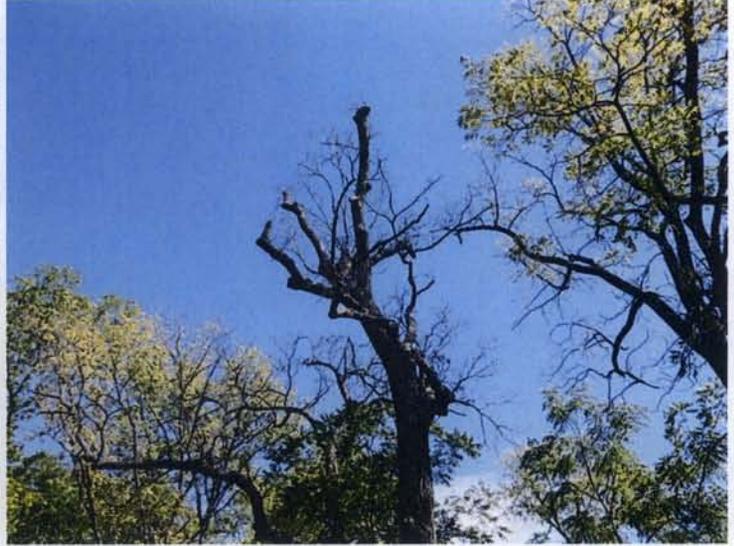
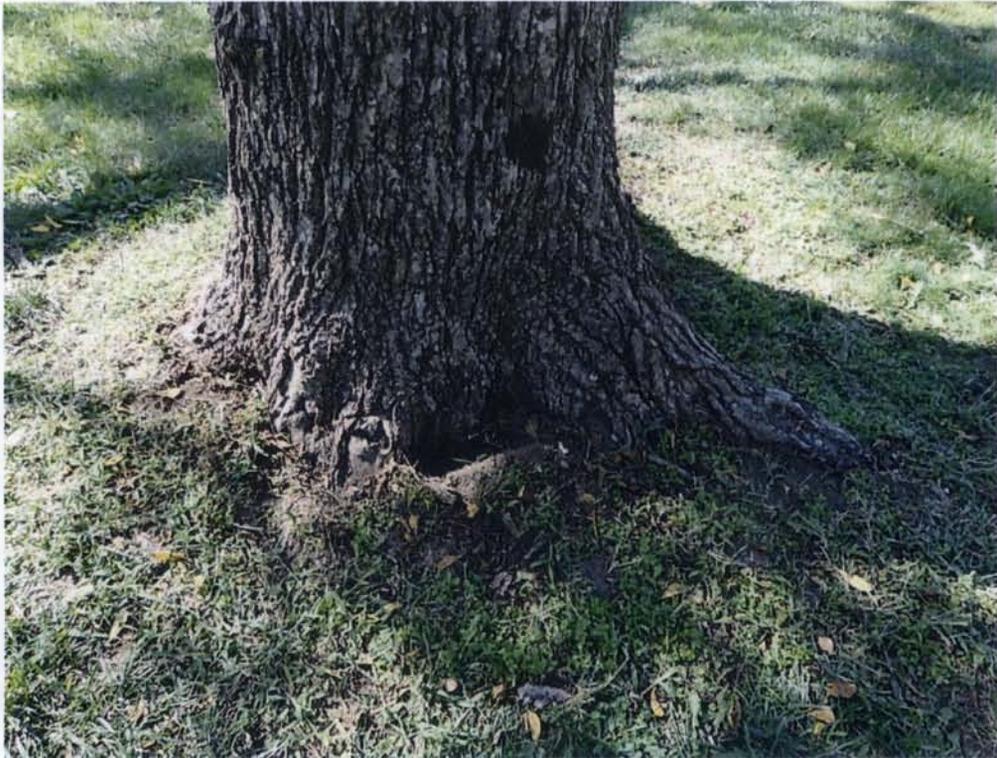
Black Walnut—Trunk Collar Wounds

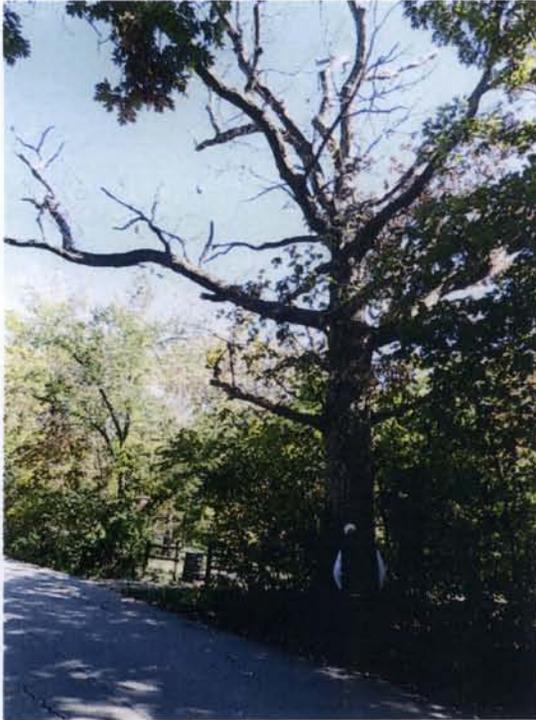
Westwinds Park White Oak

The second tree recommended for removal is a White Oak tree located along Westwinds road west of the main park entrance. The Oak tree has grown to a mature height of 45 feet with a 35" diameter at breast height. The tree has no living crown and is classified as over-mature within park guidelines. Staff has observed a large amount of Hypoxylon Canker and Armillaria which is a known cause of root failure. The tree is located near city streets and power lines on the north side and a sidewalk and basketball court within the park on the north side of the tree. Staff is requesting permission to remove the dead tree due to the risk of failure and public safety due to the recorded loss of root stability and live crown.

This tree is mostly dead and has several types of fungus growing on it. The first fungus is hypoxylon canker which has infected the entire tree making the majority of the dead wood very brittle and prone to failure. The second fungus observed is Armillaria which feeds off of the rotting roots of the tree leading to a high potential for root failure. This tree is located near a city street and power lines on the north side and a sidewalk and basketball court on the south side. I recommend that this dead tree be removed to prevent damage to any of these surrounding targets.

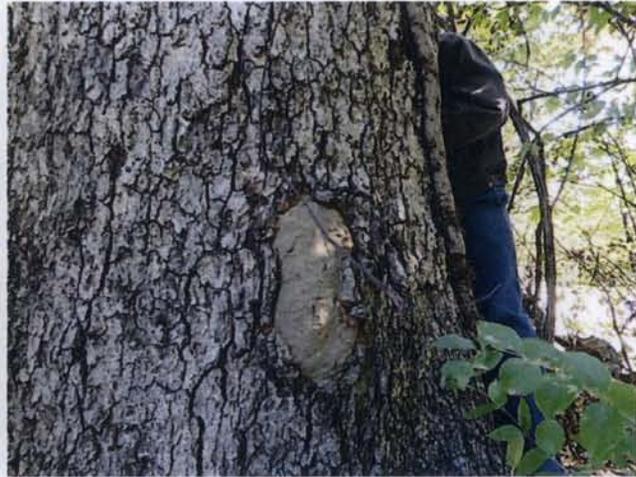
Major pests/diseases: Hyponxylon canker and armillaria were both present.

Westwinds Park—White Oak Hypoxylon Canker

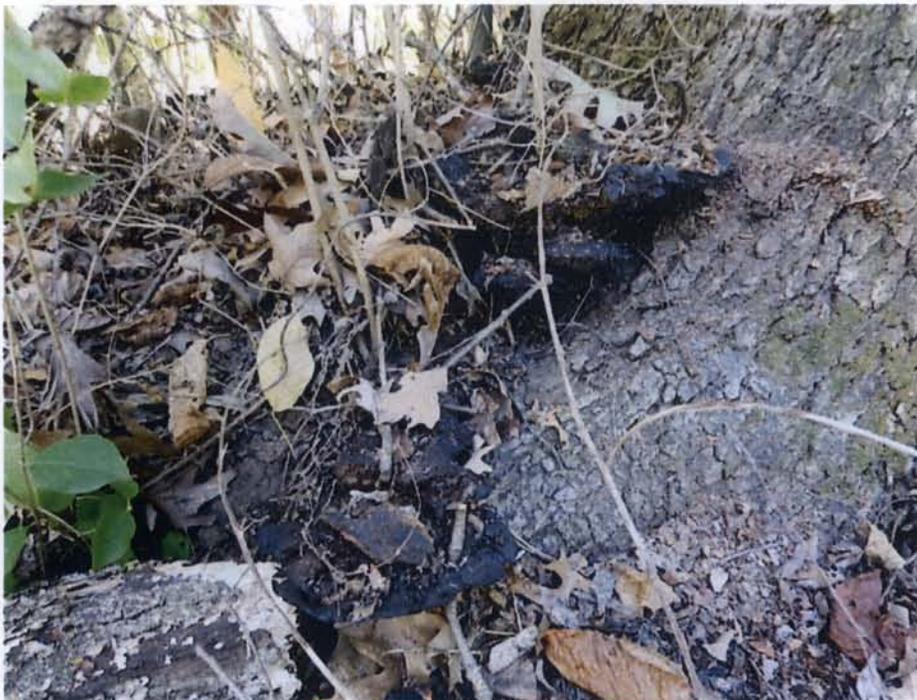
Suspect root rot:  Y  N Mushroom/conk present:  Y  N ID: Armillaria and hypoxylon  
 Exposed roots:  S  M  L Undetermined:  S  M  L  
 Root pruned: 1 ft from trunk Root area affected: 50 % Buttress wounded:  Y  N When: \_\_\_\_\_  
 Restricted root area:  S  M  L Potential for root failure:  S  M  L

Westwinds Park—White Oak Armillaria Root Rot

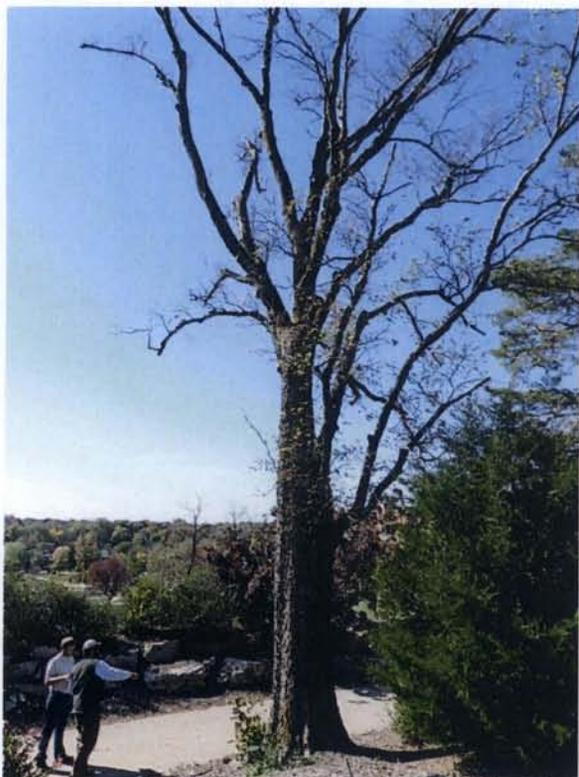
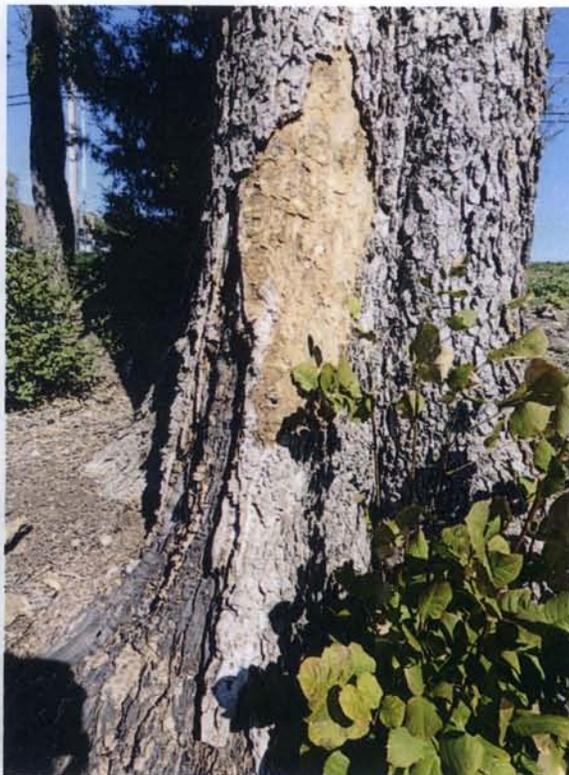
Stephens Lake Park Hackberry

The final tree recommended for removal by Forestry staff is a mature Hackberry tree located between Walnut St. and the hard surface trail at Stephens Lake Park. The tree has a 32" diameter at breast height and a height of 50 feet. The Hackberry currently has a live crown of approximately 10% and exhibit signs of decay, rot and borers throughout the trunk and main scaffolding branches. The tree sits approximately two feet from the hard surface trail. Staff has monitored the tree for 5 years and has witnessed a steady failure of the tree canopy and have started to see a number of branches falling from the tree. The removal of the tree is necessary due to the weakened state of the tree and the potential for falling directly on the hard surface trail or Walnut Street.

During construction of Stephens Lake Park a concrete trail was build two feet from the base of this tree. This construction could have destroyed roughly half of the trees root system. Over the past 5 years this tree has been in a steady decline and now more than half of the canopy is dead. The dead branches of this tree have a high potential of falling on either the heavily used recreation trail, or on Walnut street. Due to the high likelihood of failure and the targets mentioned earlier I recommend that this tree be removed.

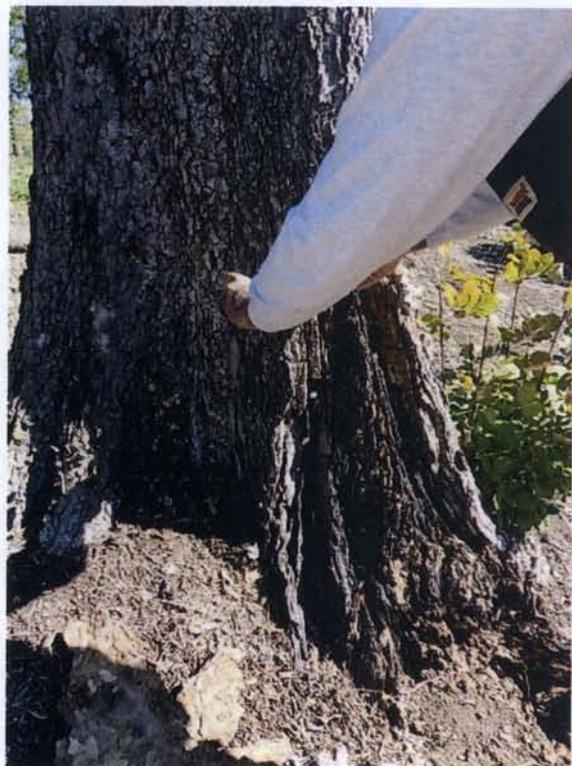
Root Rot
