Facility: Armory Sports Center

Address: 701 E. Ash Street Date of Survey: 01/08/10 & 05/25/10

The Armory Sports Center is a downtown recreation facility located within an old three-story renovated Armory building. All floors are accessible via an elevator. The lower level Exercise/Program Room also supports daycare and after-school activities for children.

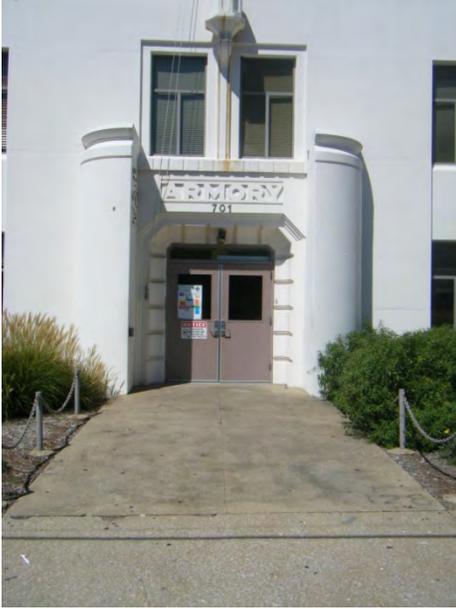
Photo 1

- South (main) Building Entrance sidewalk from entry doors to main sidewalk along Ash Street is in good condition but has a 4.6% slope at the doors therefore not providing required level landing (no more than 2% slope in any direction) at the doors. Removal of existing section of walk and replacement would be required to obtain level landing. Level landing should be 5'-0" in depth and remaining walk back to the main sidewalk should be no greater than 5% slope or no greater than 8.33% slope if handrails are added on each side (see photo 1).

Estimated Cost: \$2,197.00

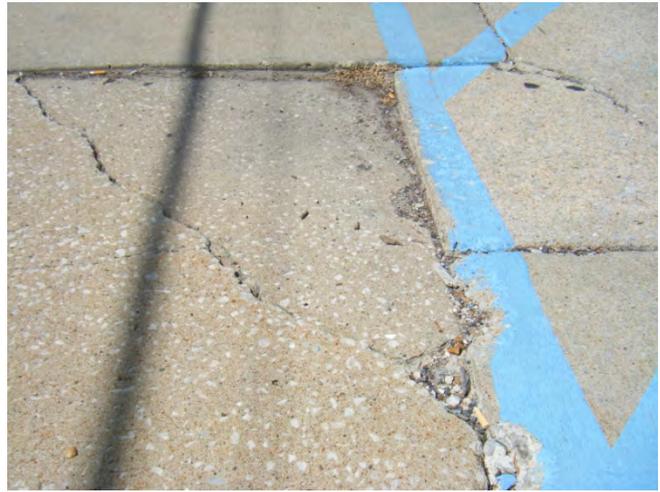
Photo 2

- Replace approximate 4' x 3' section of sidewalk that has settled just south of the accessible parking access aisle (see photo 2). **Estimated Cost: \$107.00**

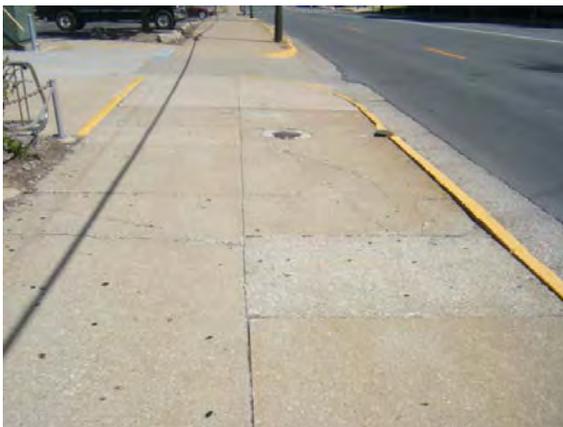
Photo 3

- Sidewalk leading from existing accessible parking space to the main entry sidewalk is generally in fair condition with some cracking and some patching and/or repair of the walk is advisable (see photo 3).

Estimated Cost: \$266.00

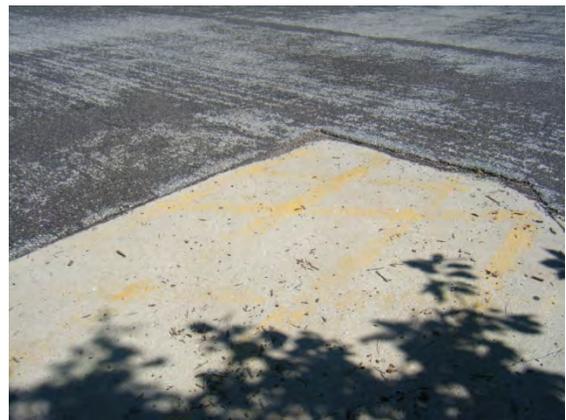
Photo 4

- Sidewalk leading to asphalt permit parking lot to the east is in good condition, but the connection between the concrete walk and asphalt parking lot should be leveled (grind level or feather cold patch asphalt) for a smooth transition as it is recommended that additional accessible parking spaces be added in this lot (see photo 4).

Estimated Cost: \$54.00

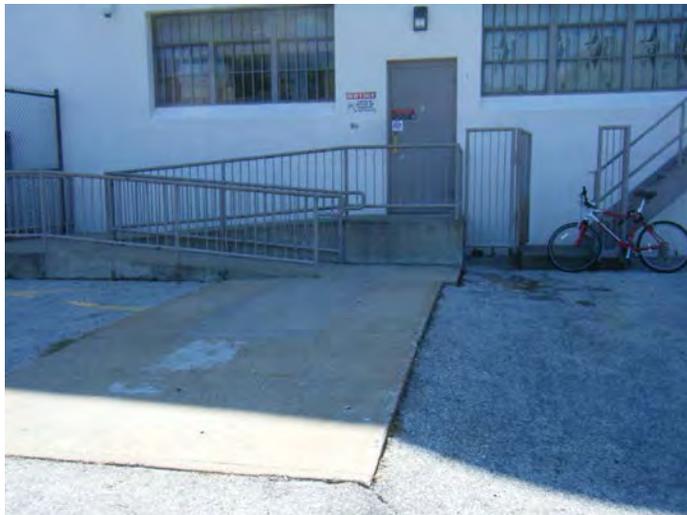
Photo 5

- Ramp located at the north exit door is concrete with metal handrails (see photo 5) – replacement option #1:
 - Top landing and mid-landings are 4” shy of the required 60” clear depth and width per ADAAG 4.8.4 and the landing at the door does not meet ADAAG 4.13.6 for clearances at the latch side of the door. If the ramp were installed prior to 1990, modifications to make it completely ADA compliant would be considered to be optional. If the ramp was installed after 1990, then modifications should be made to bring it into compliance with the ADA Accessibility Guidelines. Major modifications to the existing ramp and rails or complete replacement of the ramp and rails would be required to strictly meet those guidelines.
Option #1 Estimated Cost: \$18,685.00

- Ramp located at the north exit door is concrete with metal handrails (see photo 5) – modifications/improvements to existing ramp and rails option #2:

- Missing required handrail on south side of upper ramp section per ADAAG 4.8.5 (1).
Option #2a Estimated Cost: \$423.00
 - Handrails are 2” dia. gripping surface which exceeds ADAAG 4.26.2 by ½”. Because the 2010 Standards for Accessible Design (New ADAAG) 505.7.1 allows handrail gripping surface to be up to 2” diameter, it is my opinion that there is no need to replace the existing handrails.

- Ramp edge protection does not meet ADAAG 4.8.7 as ramp does not have curbs and the bottom horizontal rail is 6.5" above the ramp surface. Install a 2" diameter bottom rail midway between the current bottom rail and the concrete surface. **Option #2b Estimated Cost: \$1,141.00**

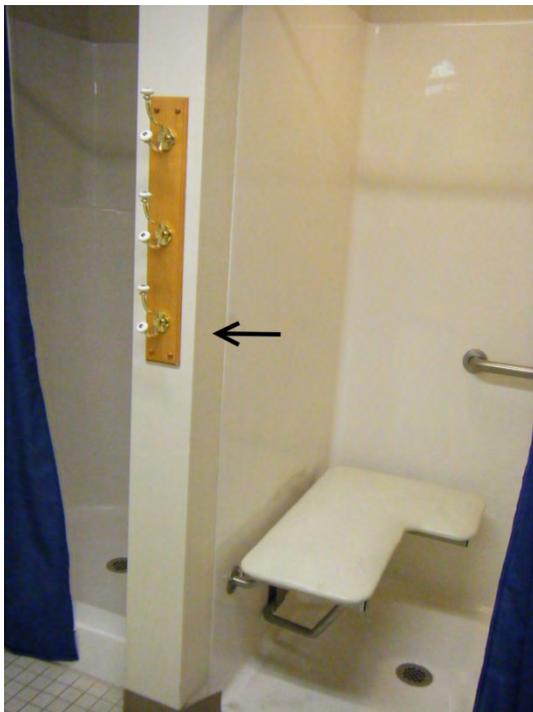
Photo 6

- Accessible shower stall: Wall on seat side of shower stall extends beyond the 36" deep stall by 5.5" and into the required clear space adjacent to the shower stall (see photo 6) which could restrict wheelchair transfer access. If this wall extension is not structural, remove the wall extension to be flush with the shower stall insert. Relocate shower head to be 18" from side wall to meet ADAAG 4.21.5 and Fig. 37 (a).
Estimated Cost: \$323.00

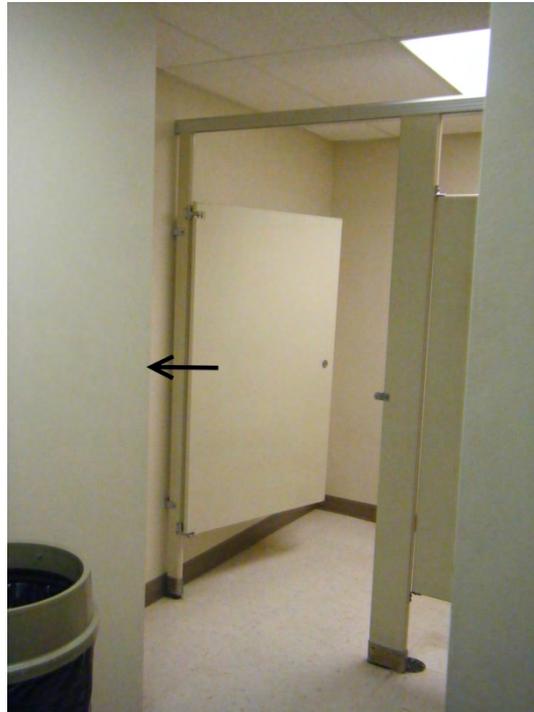
Photo 7

- Accessible toilet stall door approach required maneuvering space depth is only 36" due to location of wall (see photo 7). In order to obtain minimum required 48" depth at door to meet ADAAG Fig. 25 (a), the wall that separates the Restroom from Office 108 would have to be modified which would also require the door into Office 108 and likely the door into Janitor Closet 111 to also be relocated.
Estimated Cost: \$936.00

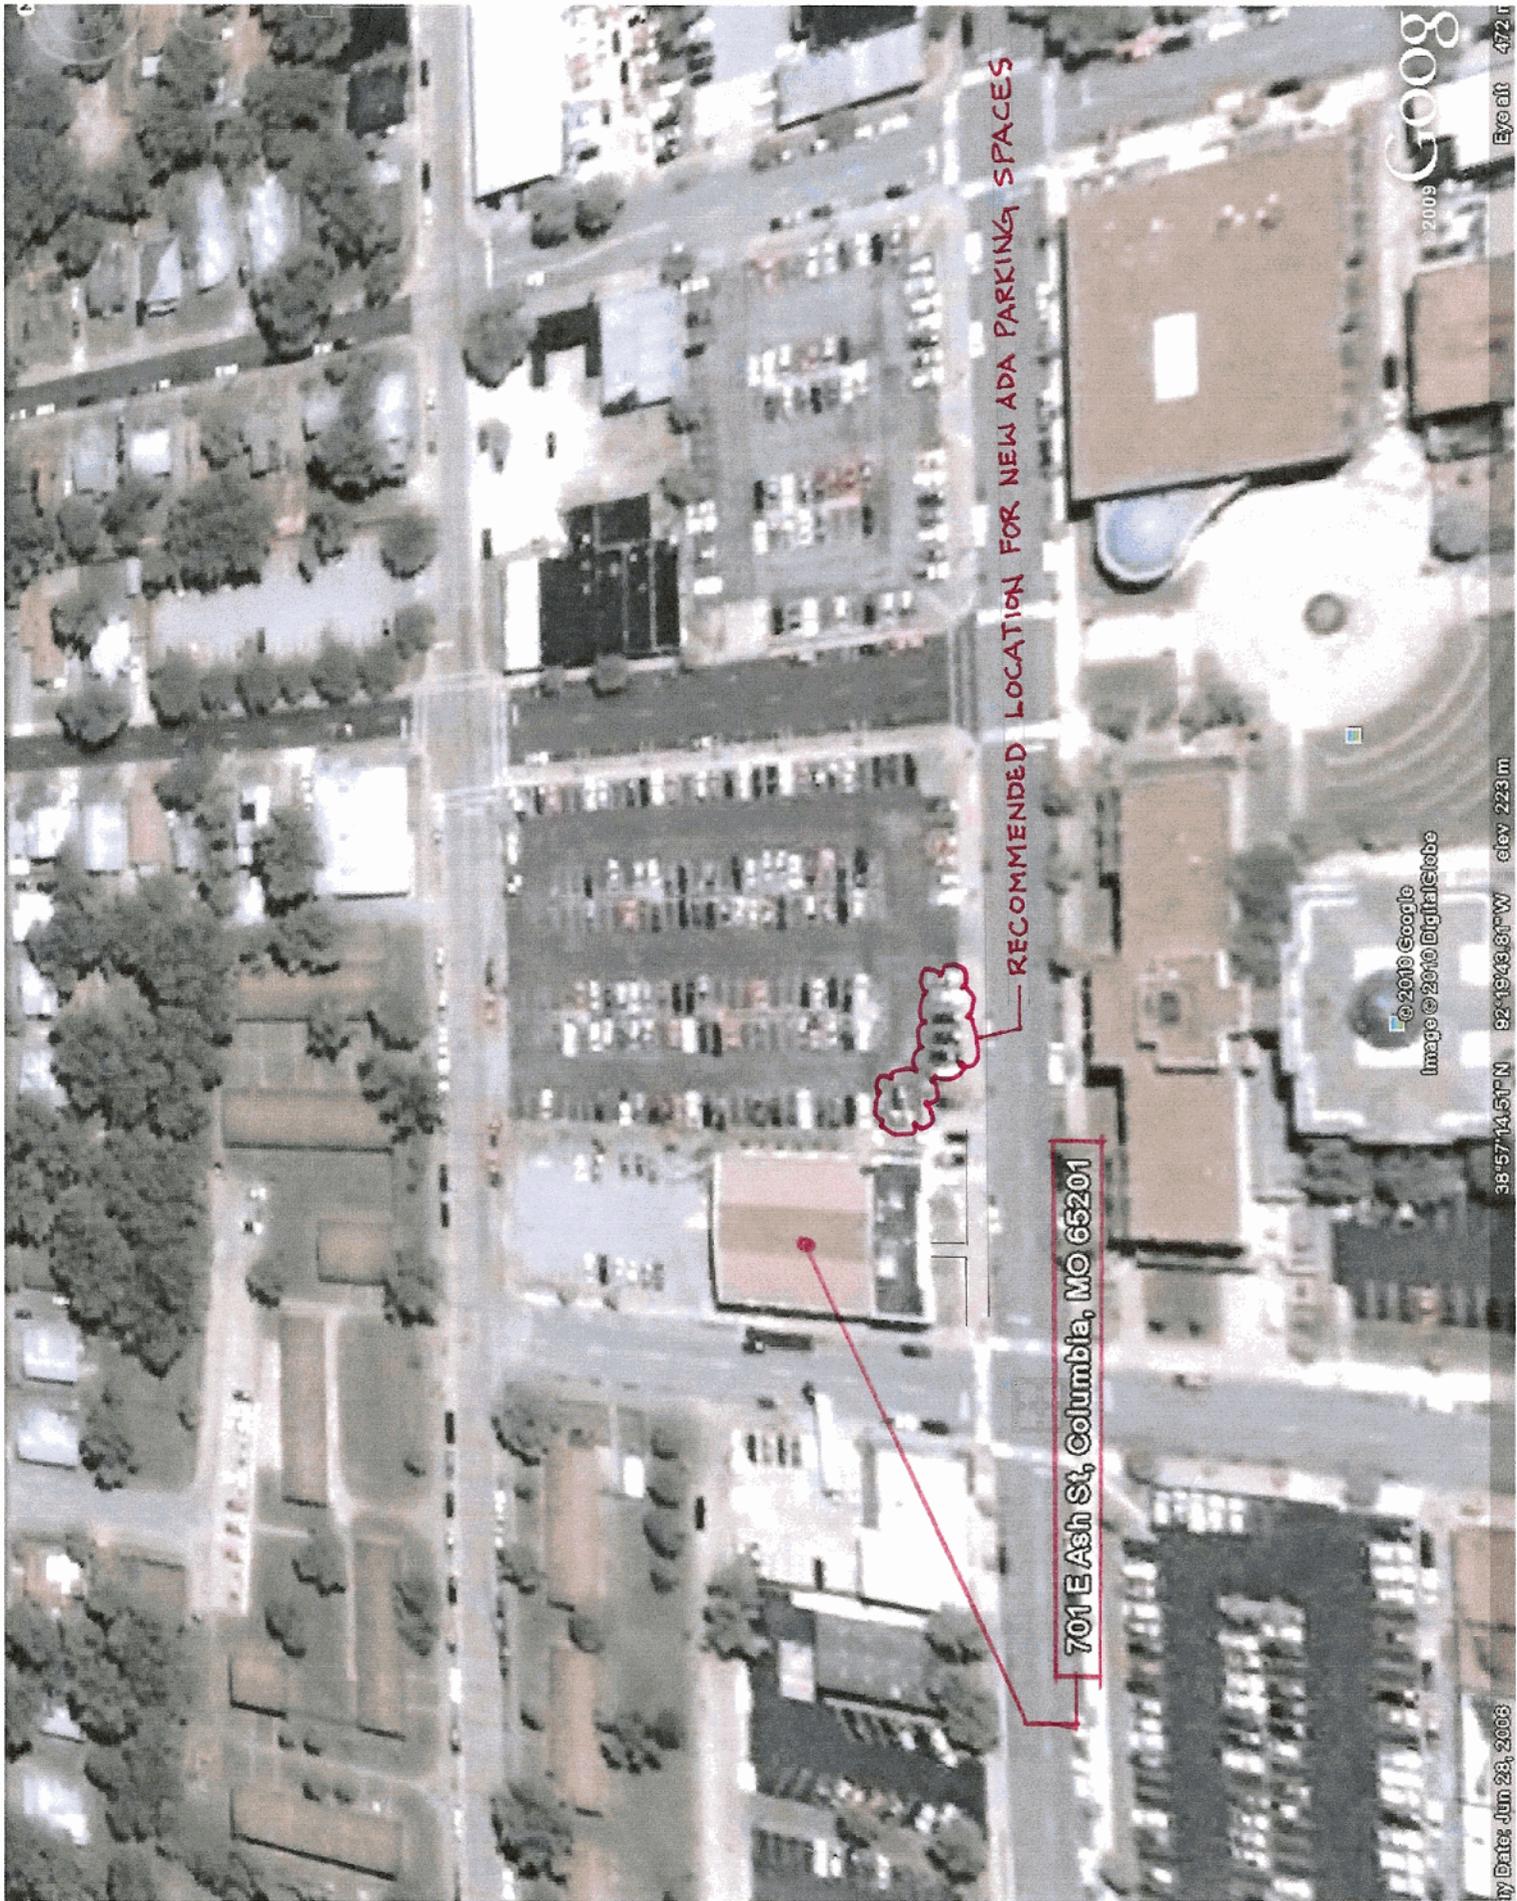
RECOMMENDED LOCATION FOR NEW ADA PARKING SPACES

- Parking lots located to the east and north of the building are both “permit parking only” lots, but Saturday parking is free. There is one non-permit van accessible parking space at the SE corner of the building that meets ADAAG. With a total of 187 permit spaces (per the City of Columbia Parking Inventory List dated 10/21/09), ADAAG 4.1.2 requires 6 accessible parking spaces with a minimum of one of those required spaces being van accessible. Therefore, 5 additional accessible parking spaces should be added to the permit parking lots adjacent to the building. There are existing spaces located in the SW corner of the east lot that could easily be converted to accessible spaces as the slopes of those existing spaces are close to required maximum slope of 2% and should require only minimal asphalt modification/repairs and the addition of parking signs and re-striping. (Note: Most spaces in the east lot exceed the 2 % slope requirement; additionally, several spaces could be developed in the north parking lot, but the door on that side of the building appears to be mainly for employee access and emergency egress as the door is locked from the outside during regular hours of operation.)

Estimated Cost: \$1,797.00

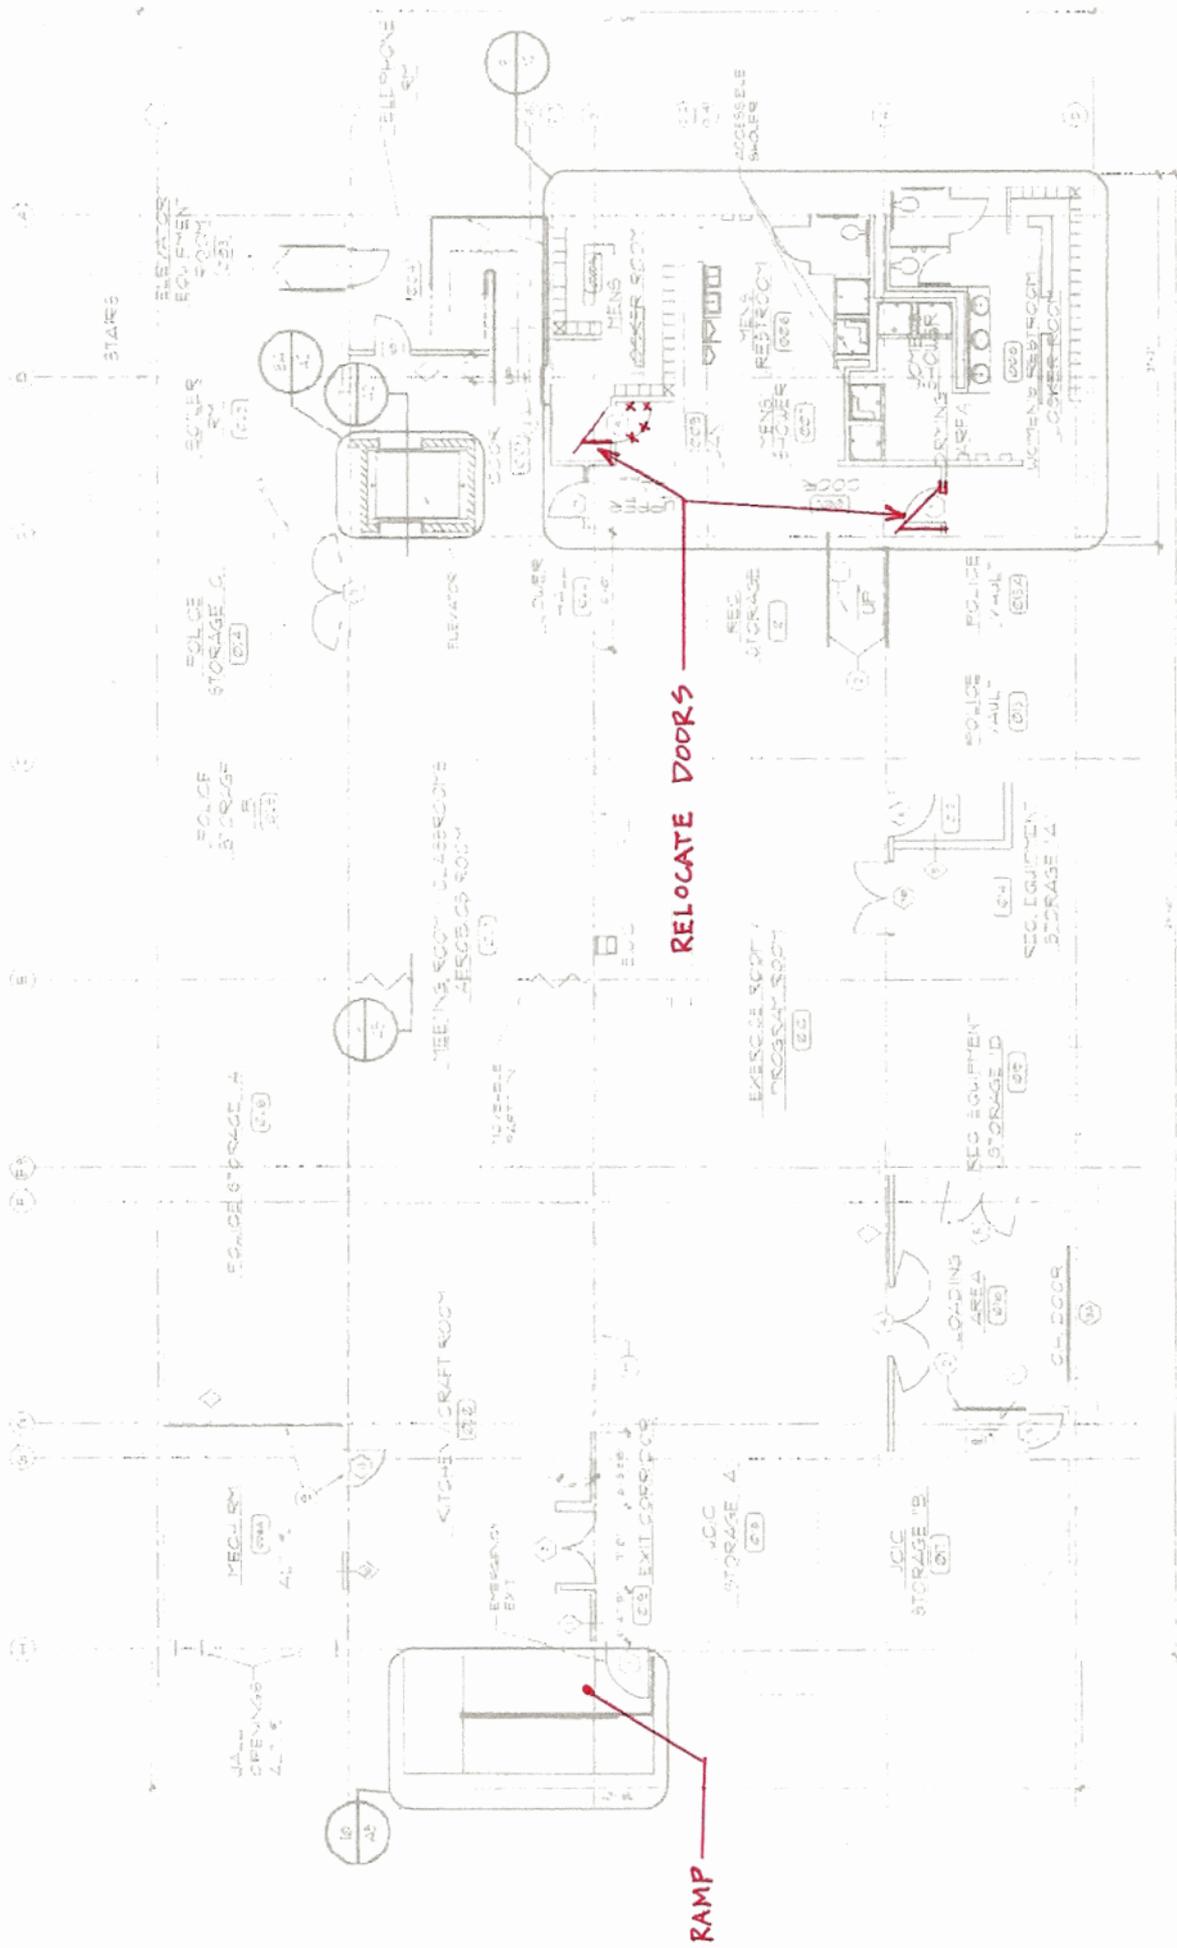
GROUND FLOOR - NEW WORK
SCALE 1/8" = 1'-0"

MOVE WALL FOR CLEARANCE
