Facility: Rock Quarry Park

Address: 2002 Grindstone Parkway Date of Survey: 05/31/10

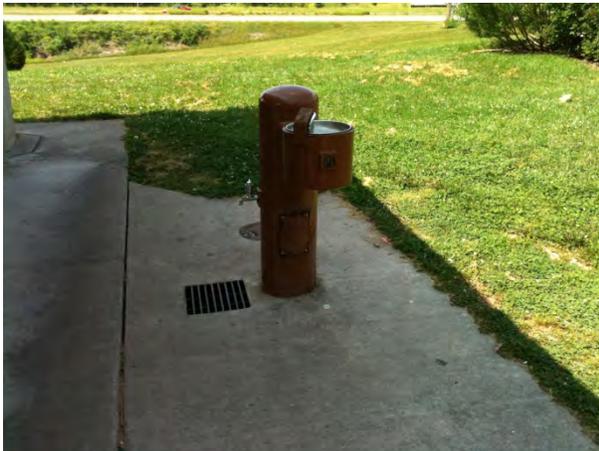
Photo 1

- Refer to site plan included with this report: (D) Patch/repair concrete slab that has settled to create a smooth beveled transition for wheelchair uses to access the drinking fountain near the shelter (see photos 1 & 2 below).

Estimated Cost: \$300.00
