CONDITION ASSESSMENT REPORT

Well Field, McBaine Water Treatment
Plant, and West Ash Booster Pump
Station

B&V PROJECT NO. 188264

Columbia Missouri Water and Light

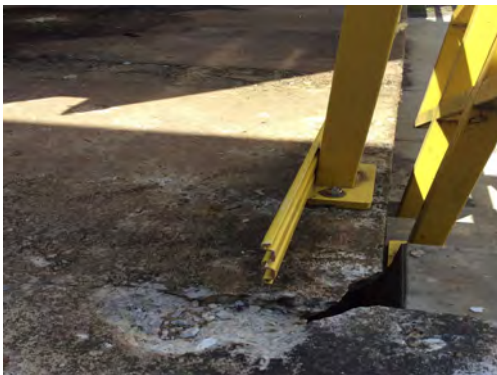
A visual inspection of the structural conditions at the aerators revealed concrete platform cracking and two locations of concrete spalling. The cracking observed was all narrow hairline width cracks with exception of cracking originating at the spall at the north reentrant corner. Photos of this crack and spalling are shown below. The other location of spalling occurs at the underside of the expansion joint on the north side walkway. These items are not a threat to the integrity of the structure at this time.

Re-entrant corner with spall and crack.

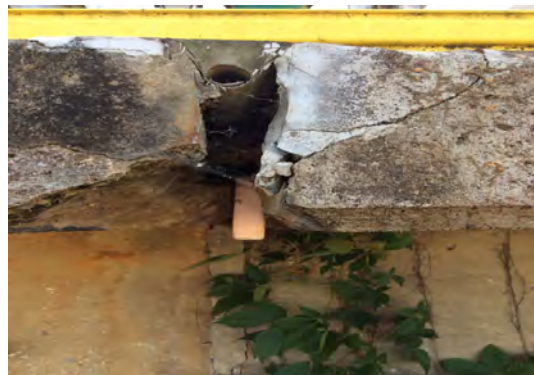
Spalling at construction joint.

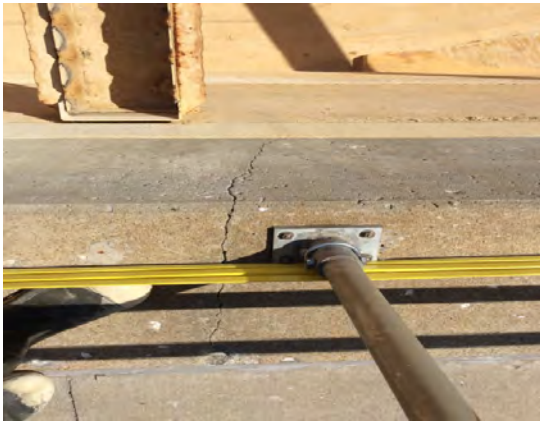
Crack in Top of North Wall in Primary Basin No. 1.

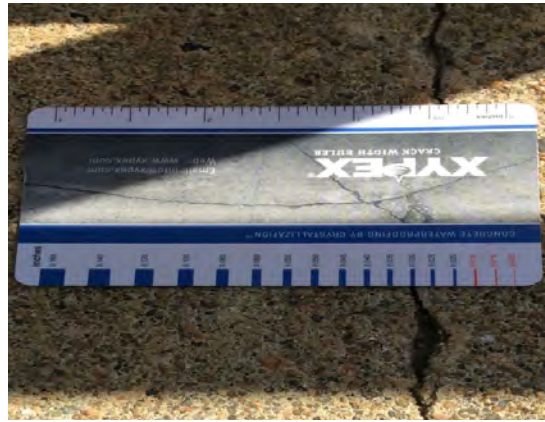
Crack Comparator Measurement at Top of Wall.

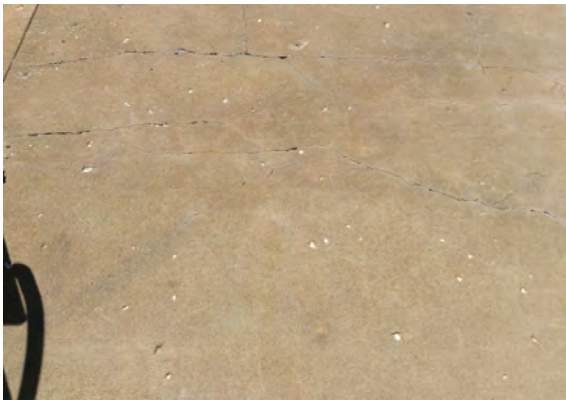
Cracking and Popouts in Top Slab of Tunnel near Primary Basin No. 1.

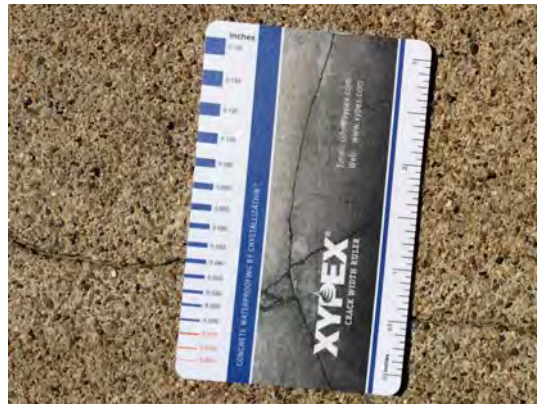
Crack Comparator Measurement at Top Slab of Tunnel near Primary Settling Basin No. 1.

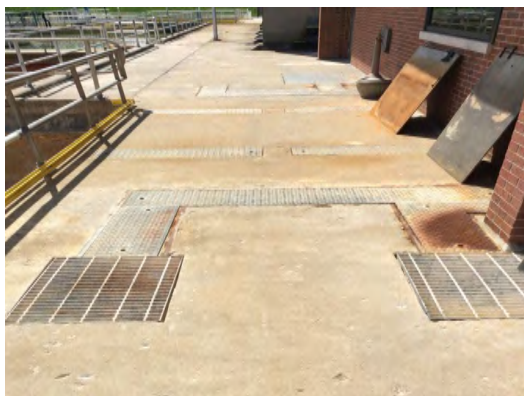
Surface Corrosion of Cover Plate and Support Embedments.

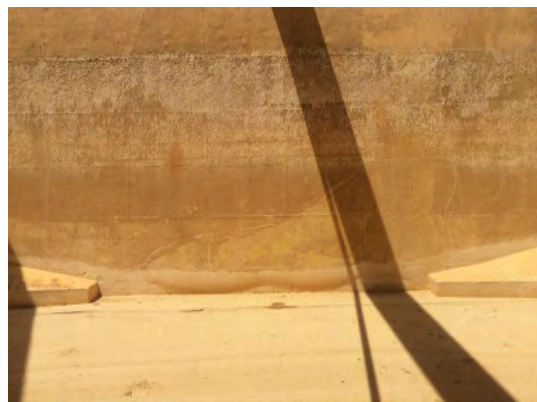
Coating failure on North Wall of Primary Settling Basin No. 1.

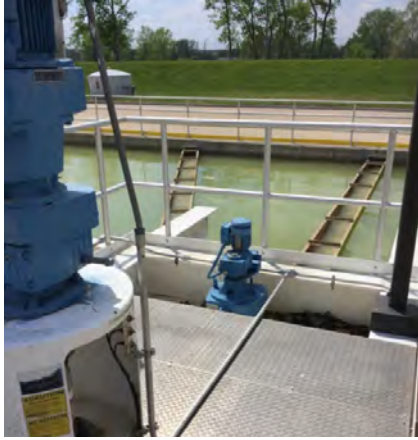
Primary Basin No. 4 - Conduit posing a tripping hazard and subject to damage.

Primary Basin No. 4 equipment appeared to be in good condition with the exception of some deterioration in the paint on the collector and mixer motors. The basin equipment is stainless steel. Motors for the basin equipment appeared to be serviceable. Two electrical installation items were observed regarding electrical conduits which are recommended for correction. Electric conduits routed to the collector motor are routed along the floor of the surrounding platform. This presents a tripping hazard to personnel and is subject to physical damage. It is recommended this conduit be revised to be routed underneath the platform to eliminate these hazards. Additionally, it was observed that there are electrical conduits which route under the waterline within Primary Basin No. 4. Corrosion was observed at the water line interface of this conduit. The loss of structural integrity of this conduit will act as a drain with water being funneled to the electrical equipment at the terminus of these conduits. It is recommended an alternative route be determined and implemented for these circuits and the existing conduits be removed.

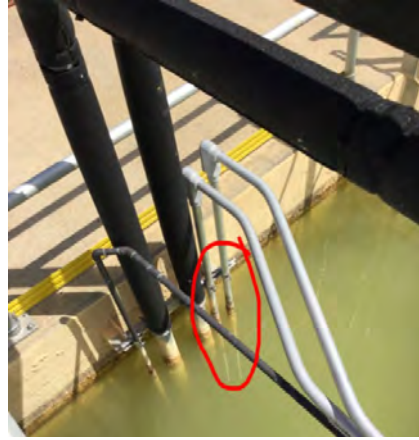
Primary Basin No. 4 - Conduit routed below the water line.

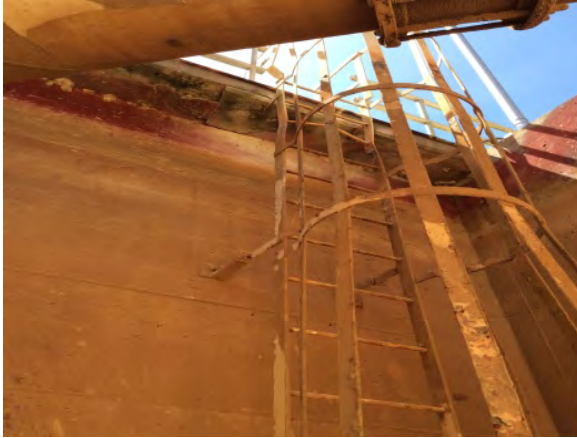
Bent and Damaged Ladder at Secondary Settling Basin No. 2.

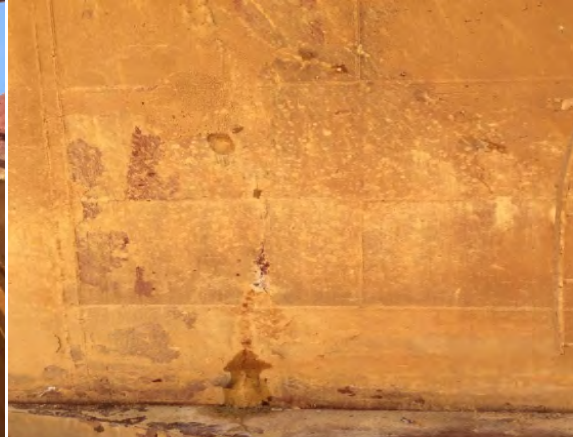
Crack in West Wall of Secondary Settling Basin No. 2.

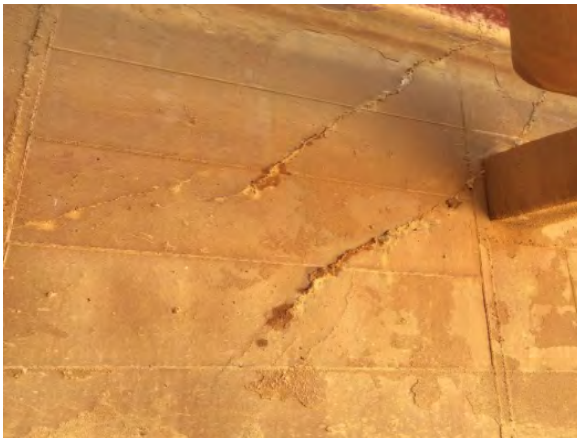
Crack in Southwest corner of West Wall in Secondary Settling Basin No. 2.

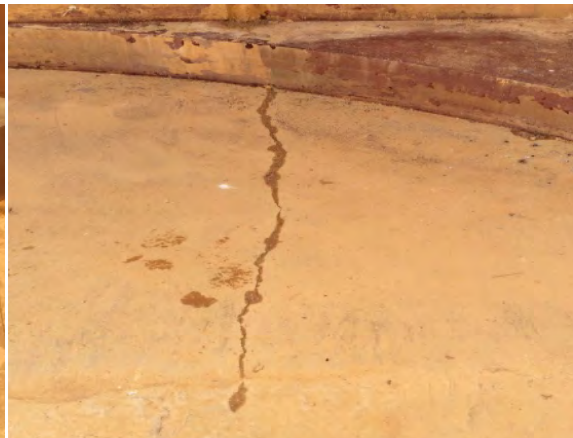
Crack in Base Slab of Secondary Settling Basin No. 2.

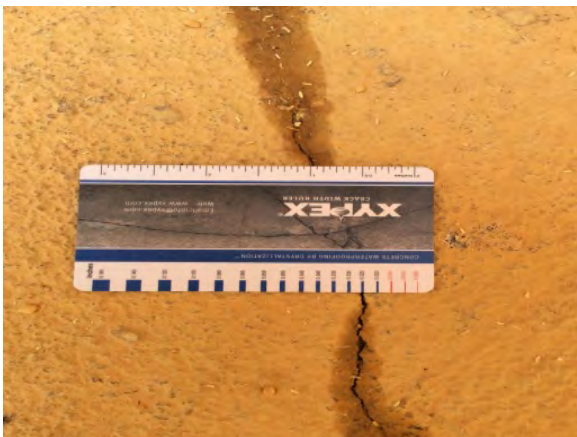
Crack Comparator Measurement of Base slab Crack.

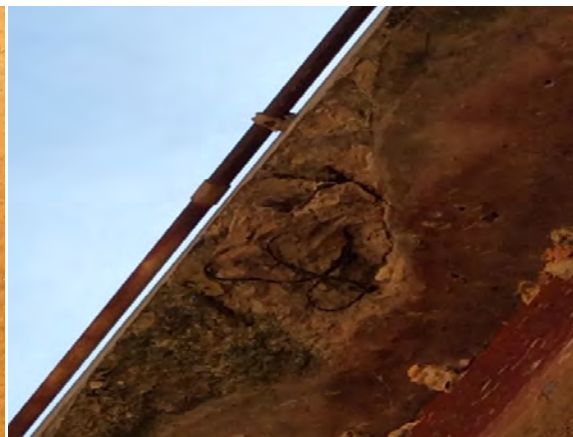
Concrete Spalling at Underside of Walkway on West Side of Secondary Settling Basin No. 2.

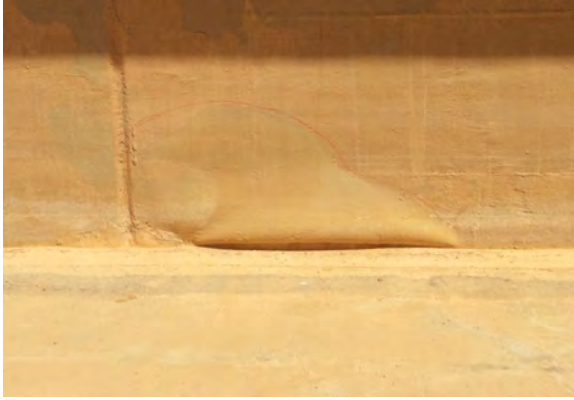
The coating failures are likely due to moisture migration during the life of the coating or local defects in the surface preparation during the coating installation. These areas will eventually rupture the coating and increase potential of the tank to leak more than current leakage rates. As a preventative measure we recommend these local failures be repaired. Repair would include local removal of the coating and reinstallation of a new coating with proper surface detailing and transition with the existing coating.

Coating Delamination with Fluid Build Up in Secondary Settling Basin No. 2.

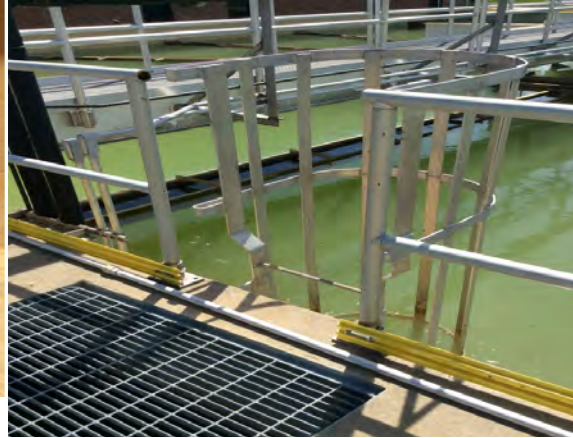
Missing Fall Protection Gate at Ladder (Typical 4 locations) and Conduit Tripping Hazard at Ladder Entry.

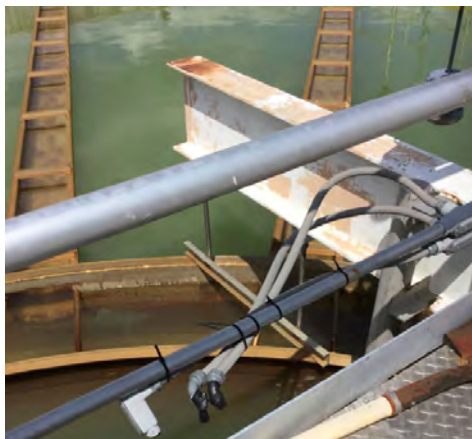
Secondary Basin No. 4 – Abandoned Conduits

Basin No. 4 equipment and overall installation appeared to be in good condition. Motors for the basin equipment appeared to be serviceable. Electric conduits routed to the collector motor are routed along the floor of the surrounding platform, similar to Primary Basin No. 4. This presents a tripping hazard to personnel and is subject to physical damage. It is recommended this conduit be revised to be routed underneath the platform to eliminate these hazards. Additionally, it was observed that there are electrical conduits which route under the waterline within Secondary Basin No. 4, similar to Primary Basin No. 4. Corrosion was observed at the water line interface of this conduit. The loss of structural integrity of this conduit will act as a drain with water being funneled to the electrical equipment at the terminus of these conduits. It is recommended an alternative route be determined and implemented for these circuits. Also, a number of circuits appear to have been disconnected and abandoned to equipment no longer present. It is recommended these circuits and raceways be completely removed.

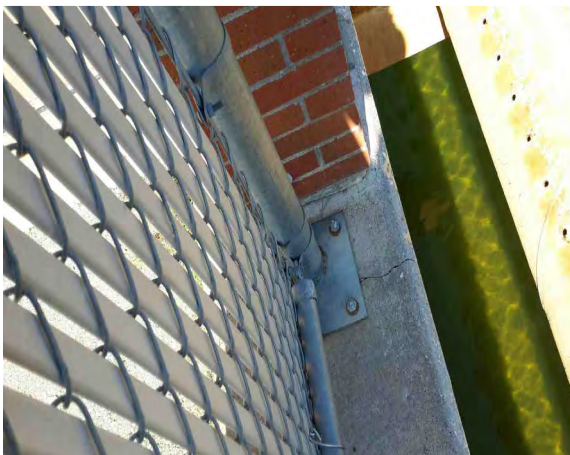
Crack at Base of Guardrail Post.

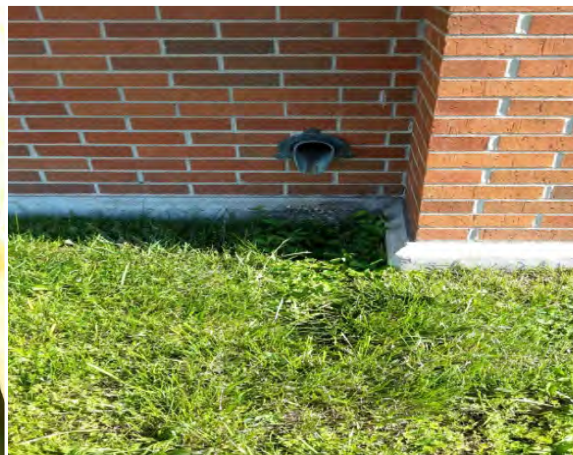
Roof drainage from down spouts drains towards foundation walls.

Exterior notable items are one location of cracking near a guardrail post at the northeast corner of the building, missing splash blocks, poor site drainage at the down spouts, and one location of concrete spalling at the southwest corner of building at the top of the concrete footing supporting the face brick. All of these items are minor in nature at this time. As a preventative repair step, it is recommended to repair the concrete surface and inject the exposed crack. The missing splash blocks and drainage issues can be resolved by adding fill to drain runoff away from the building and placing splash blocks under all down spouts.

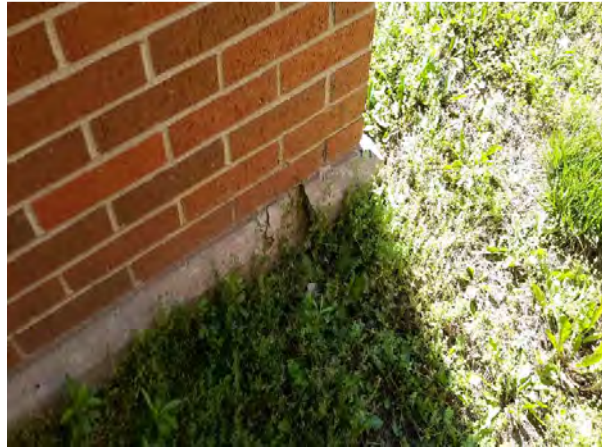
Spall at base of face brick.

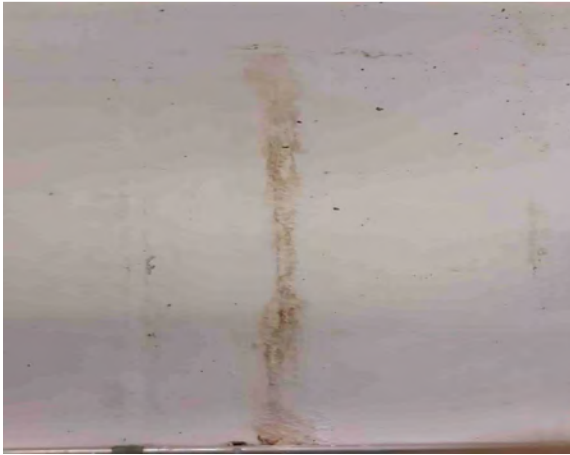
Crack with efflorescence on filter wall. Surface damp to the touch. Typical two locations.

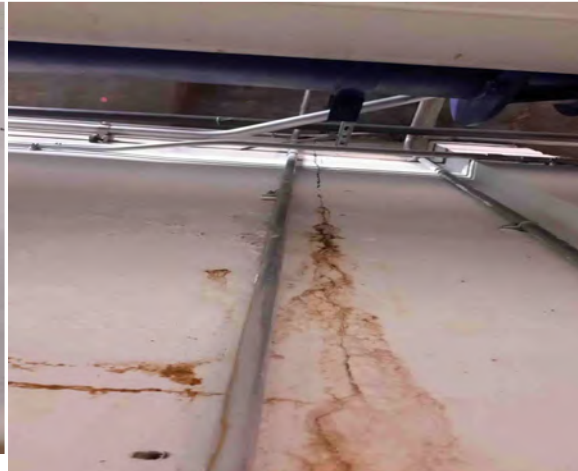
Leaking expansion joint in Filter building Basement.

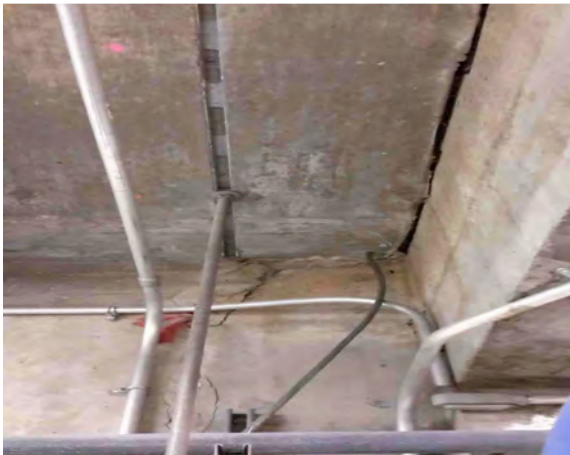
Top of leaking expansion joint. With spalling and cracks.

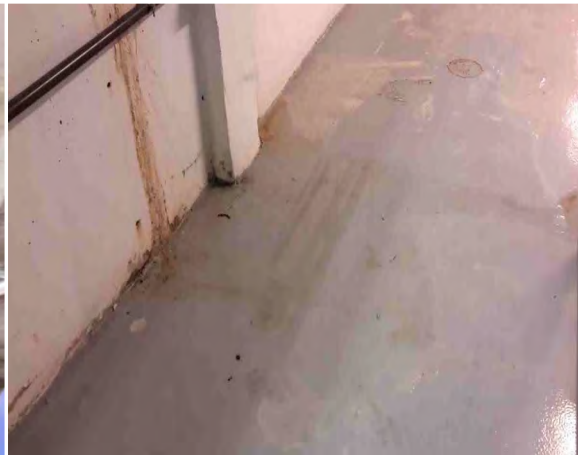
Base of north side expansion joint with water pooling and flowing to floor drain.

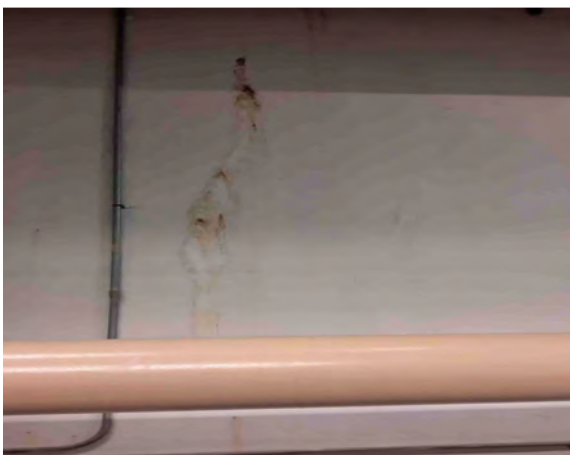
Crack with efflorescence on filter wall. No moisture on surface.

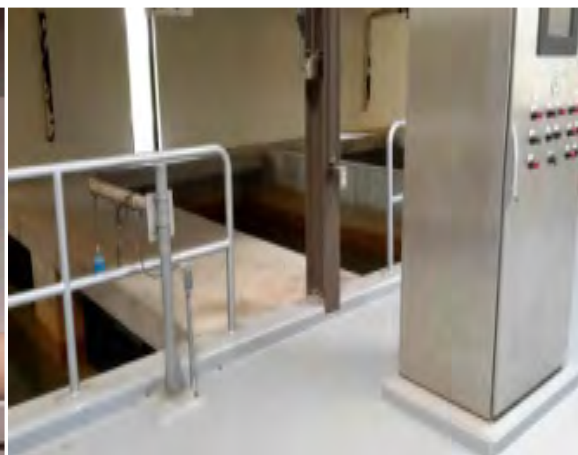
Opening in Guardrail. Recommend this be closed with new safety gate.

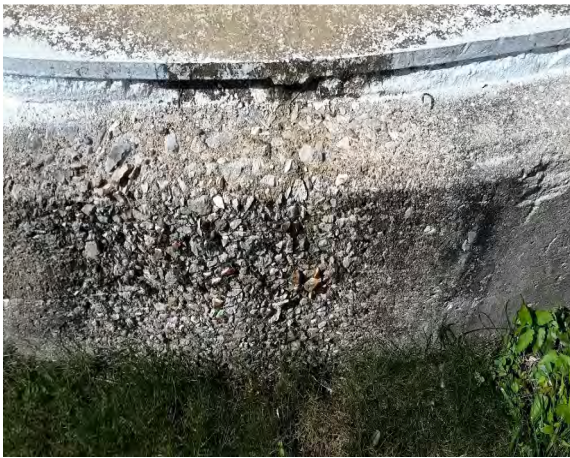
Scaling Due to Erosion of Cement Paste at Base of Wash Water Tower.

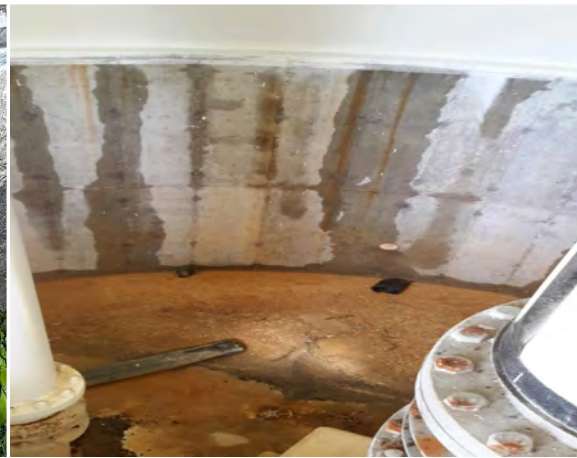
from the tower surfaces accumulating on the base slab. The condensation water is likely depositing surface corrosion product from the piping, valves, and tower. The surface corrosion in the interior is very minor and considered superficial at this time.

Staining on Interior Surfaces of Tower Foundation Concrete Walls and Base Slab.

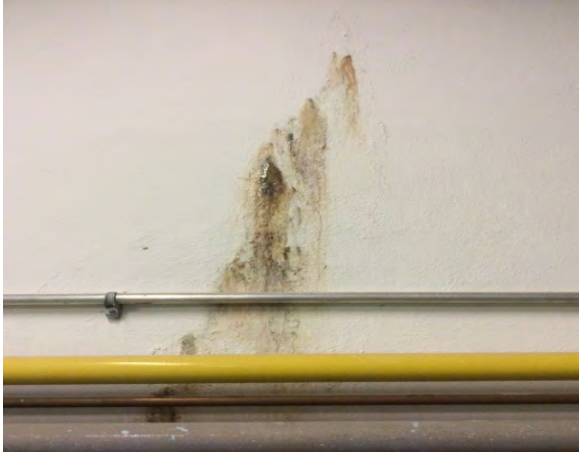
Notable structural items for the tunnels include various cracks in the tunnel walls. Example cracks are shown in the following photos. These cracks are due to temperature and shrinkage effects. We recommend injecting the leaking cracks in the walls with hydrophilic polyurethane foam. Ideally these should be repaired during winter or early spring months during the period where the cracks are widest.

Crack in Tunnel wall.

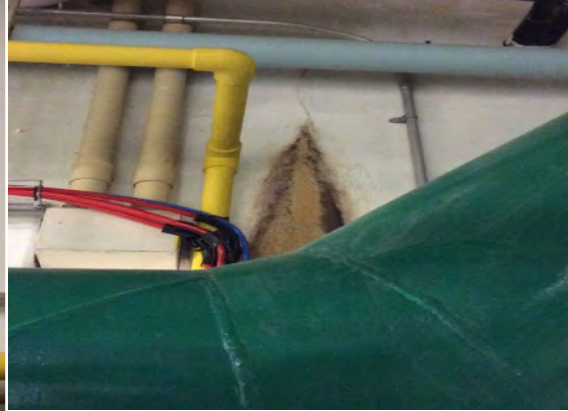
Crack with Active Leak at Basin Corner in Chemical Building Basement.

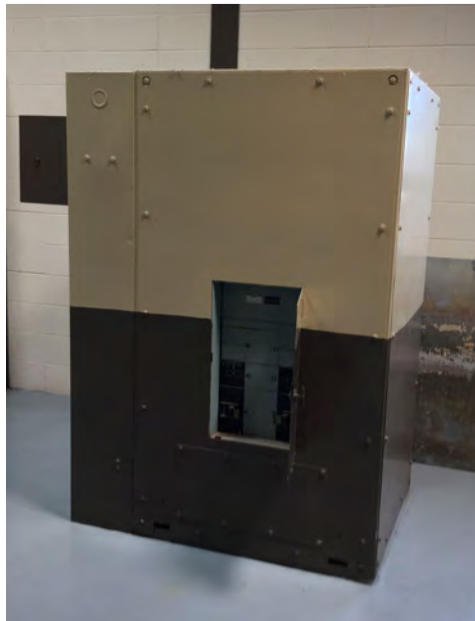
Power Center 1 is located on the operating floor of the original Filter Building and supplies power to Filters 1 through 4 as well as the original Filter Building mechanical loads. Power Center 1 is over 40 years old and is a custom fabricated substation consisting of a 2.4 kV air terminal connection (disconnect switch located at adjacent 2.4 kV motor control line-up), a 300 kVA 480 V step-down transformer, a 37.5 kVA 120/240 V dry-type transformer, a 5 kVA 120/240 V dry-type transformer and an integral 480 V distribution panelboard. Refer to the following photo. The load center consists of mainly Westinghouse components. Westinghouse is no longer in business. CW&L staff reported this unit started smoking in the recent past; however, the unit did not fail and has continued in operation. The CW&L staff is sufficiently concerned that replacement equipment has been procured and was observed sitting nearby. Replacement is not planned until a catastrophic failure is realized due to the fact that the unit cannot be replaced without shutting down the majority of the plant. Power Center 1 is at the end of its useful life and is not considered reliable.

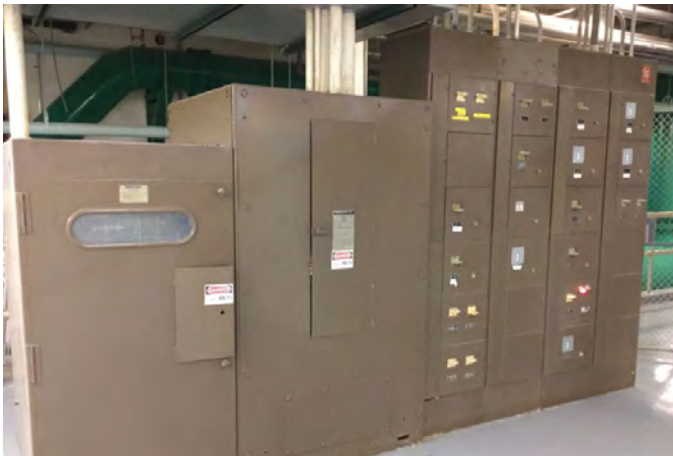
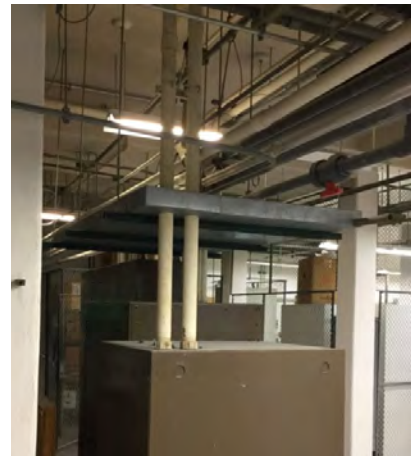
Power Center 2 is located in the basement of the Operations Building and supplies power to the original Chemical Feed and Lime Handling loads as well as Settling Basins 1 and 2 and the Aerators. Power Center 2 is over 40 years old and is a custom fabricated substation consisting of a 2.4 kV disconnect switch, a 500 kVA 480V step-down transformer, 50 kVA, 37.5 kVA and 7.5 kVA 120/240V dry-type transformers, an integral 480 V distribution panelboard and a close coupled motor control center (MCC-2). Refer to the following photo. The load center consists of mainly Westinghouse components. Westinghouse is no longer in business. When the unit was observed, excessive vibration and noise caused by ferroresonance in one of the transformer units was noted. Additionally, the unit has a number of water or chemical pipes running directly over the electrical equipment. This does not meet the requirements of the NEC which require the area 6-feet above all electrical distribution equipment to be free of any non-electrical installations. Furthermore, there is evidence that leaking pipes may have caused issues previously as a large drip tray has been fabricated and installed. Refer to the following photo. Power Center 2 installation is not well suited for critical electrical equipment. Since it is the same age as Power Center 1, it is at the end of its useful life and is not considered reliable.
