Facility: Columbia Regional Airport

Address: 11300 S. Airport Drive Date of Survey: 01/05/10

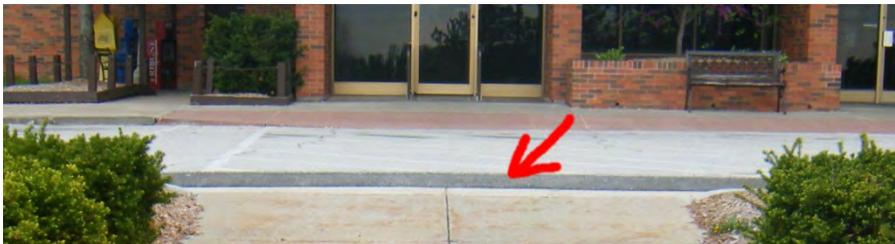
Photo 1

- Refer to site plan included with this report: (A) Remove and redo existing 2' wide asphalt patch in drive due to excessive slope (up to 9%). Extend patch area as necessary to obtain a slope as close to 5% as is feasible (see photo 1 below).

Estimated Cost: 1,500.00

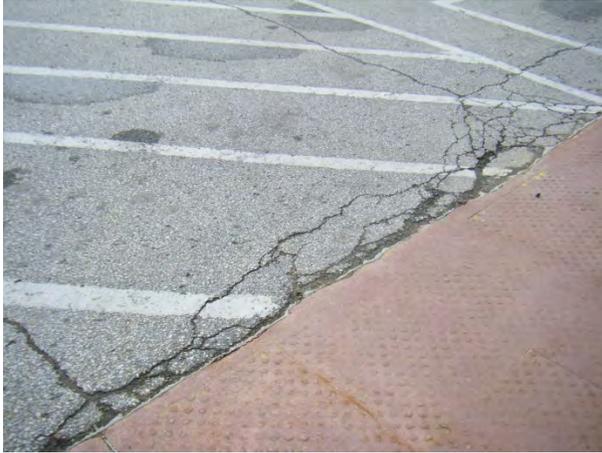
Photo 2

- Refer to site plan included with this report: (B) Smooth/patch asphalt along the edge of the main sidewalk truncated dome surfaces (see photo 2 next page).

Estimated Cost: 400.00

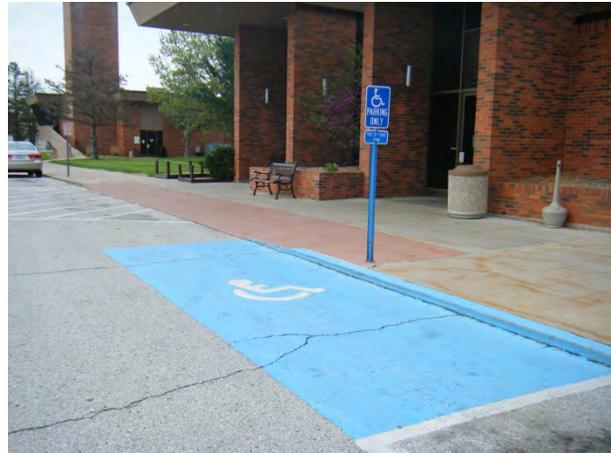
Photo 3

Note: With a total of 275 parking spaces at the Main Terminal, ADAAG 4.1.2 requires 7 accessible parking spaces with a minimum of one of those required spaces being van accessible. Only 5 total spaces have been provided (two of those are van accessible spaces). One of the existing spaces (see photo 3 above) is located in the drive directly adjacent to the main terminal entrance, but that space has a raised curb and therefore does not meet ADAAG for a proper access aisle. It is recommended that this existing space be maintained as an accessible drop-off space, but this space will not be counted in the overall requirement of 7 spaces. Therefore, we recommend adding three additional ADA parking spaces (see information below).

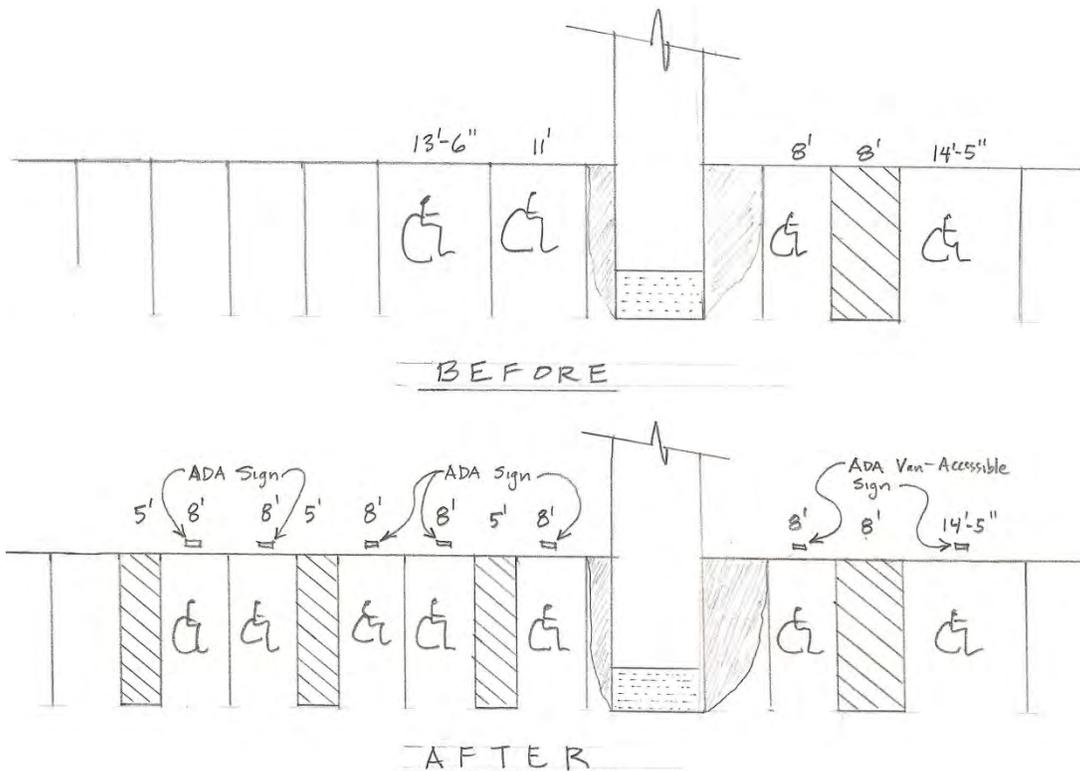
- Refer to site plan included with this report: (1) There are two ADA parking spaces located just north of the access walk in the parking lot. These spaces do not have the required access aisle, but the slopes are acceptable. Also recommend adding the three additional ADA parking spaces in this area (see sketch on next page for proposed layout). Restripe (with blue paint) the existing and new parking spaces and related access aisles as shown in the sketch, raise the existing ADA parking signs and install new ADA parking signs in locations shown in sketch (signs to be 72" above grade).

Estimated Cost: \$804.00

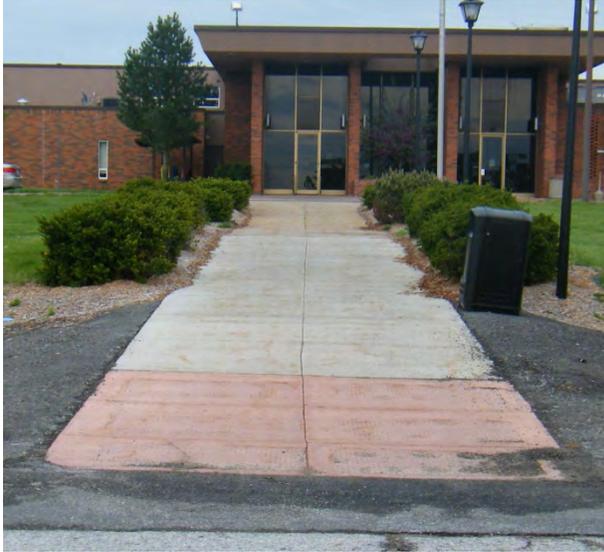
Photo 4

- Refer to site plan included with this report: (C) The existing 10' wide concrete access path (see photo 4 next page) from the accessible parking area leading to the main terminal entrance area has a 50' lower section with running slope of 5.2% - 7.7% and a 27' upper section with a running slope of 6.4% - 9.3%. At these two sections of walk (ramp), install handrails meeting ADAAG 4.8.5 on both sides of the existing access path. **Estimated Cost: \$9,515.00**

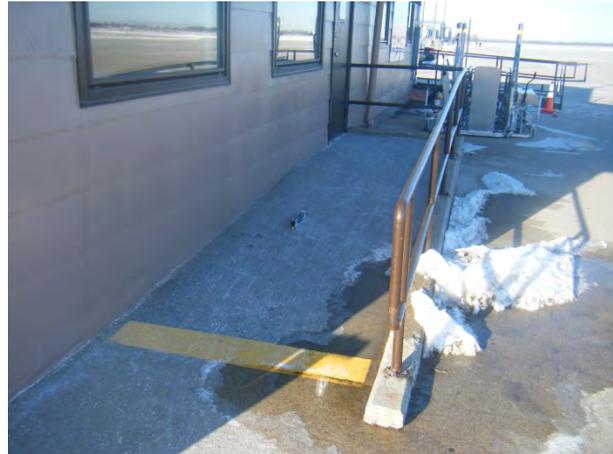
Photo 5

- Refer to site plan included with this report: (D) East exterior ramp from tarmac to baggage room entry door (see photo 5 above) is missing a handrail on one side of the ramp. Install a wall-mounted galvanized steel handrail meeting ADAAG 4.8.5. **Estimated Cost: \$903.00**

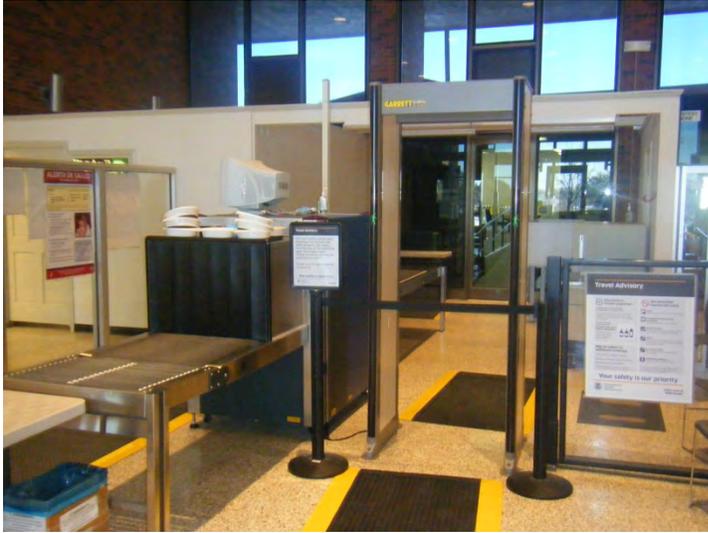
Photo 6

- The existing walk-through metal detection unit (see photo 6 next page) provides only 30" clear pass-through space which is 2" shy of minimum ADAAG required wheelchair clearance of 32" at doors or openings. There is a pass gate directly adjacent to the detection opening that provides 34" wide clearance. As long as wheelchair users are allowed to pass through this gate if their wheelchairs are too wide for the standard detection opening, no further changes are required.

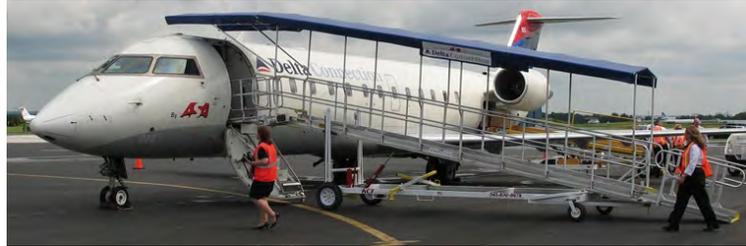
Photo 8

- A means of wheelchair access is required for planes with a seating capacity of 31 or more per Federal Regulations by the DOT (49 CFR Part 27 – Nondiscrimination on the Basis of Disability in Air Travel effective June 04, 2001). Per conversation with Airport management staff, they do provide a mechanical means of access to their aircraft for persons with disabilities. I did not see firsthand the method or equipment used at this airport and the federal regulations are not specific on what would be considered an acceptable means of providing such access, but it is likely that the use of a mechanical lift, portable ramp or accessible jetway structure or boarding bridge would be required and considered to be acceptable. It is recommended that the management staff along with a group of individuals with disabilities review the current means of access to these aircraft to determine if it is acceptable. Should it be determined that the current means of wheelchair access is not ADA compliant, safe and/or user friendly, they may want to consider several other options that would be available. A manually powered wheelchair lift (see photo 7 next page) designed specifically for use on a tarmac and with the type of aircraft that flies in and out of Columbia will cost around \$30,000. A better solution might be a mobile accessible passenger

boarding ramp (see photo 8 below) which costs around \$19,000 - \$24,000 depending on the options required or desired. For the purposes of this survey, I have not figured any costs at this time.

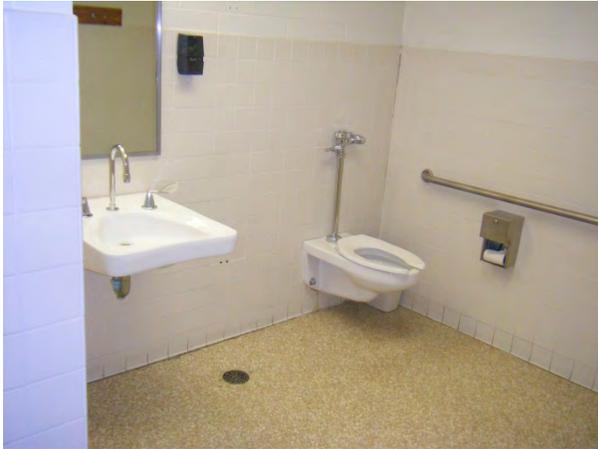
Photo 9

- Refer to building plan included with this report: (H) South Women's Restroom: Relocate the existing braille/tactile ADA restroom sign on the door (or provide a new sign) and mount at the latch side of the door and mounted to be 60" from floor to centerline of the sign, remove the door closer due to the lack of required 12" latch side clearance at corridor side door entry area, build/fur out the side wall 1.5" with a half wall so that the toilet fixture will be 18" from that wall to the centerline of the toilet fixture (requires removal and reinstallation of the side grab bar and tpd also), replace the toilet fixture or adjust existing fixture down at least 1" to get a seat height of 17" – 19", install a min. 36" long rear grab bar (will have to be a split bar due to

height of flush valve) to meet ADAAG Fig. 29 (a) or lower flush valve so that a single 36" long grab bar can be installed (see photo 9 below), relocate the paper towel dispenser and hand dryer to the wall adjacent to the lavatory as they are protruding more than 4" into the access pathway (see ADAAG 4.4.1) in their current location (other option would be to keep them in current location and install a detectable warning below them at a max. height of 27" and extending out from wall same depth as the dispenser and dryer), relocate the shelf with coat hooks to the west wall as it is also protruding into the access path and insulate the pipes below the lavatory

Estimated Cost: \$2,151.00

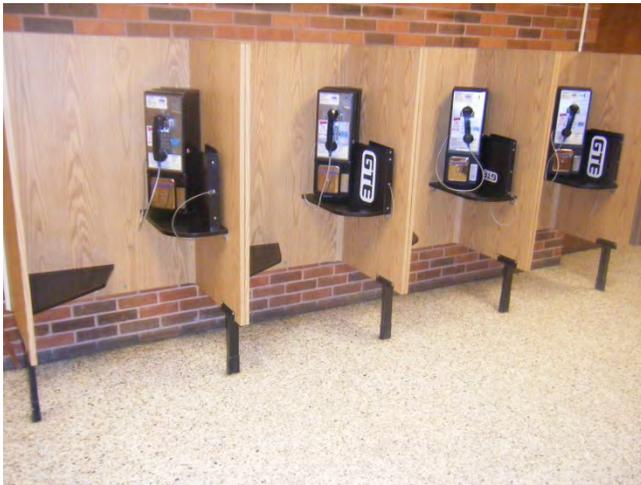
Photo 11

- Refer to the building plan included with this report: (J) Remove the fixed seat in one of the phone booths and install a flip-up seat or a non-fixed chair that can be easily moved to allow for wheelchair access to the phone (see photo 11 below).

Estimated Cost: \$150.00
