Facility: Albert Oakland Park & Pool

Address: 1900 Blue Ridge Blvd. Date of Survey: 06/06/10

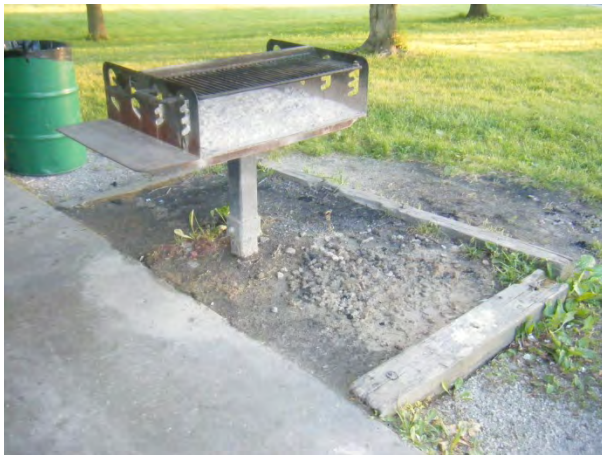
Photo 1

- Refer to site plan included with this report: (C) Install a 4' wide concrete access path from the new walk to tennis court over to the existing sidewalk that leads to the volleyball access path. Path shall have slope not exceeding 5% as much as is feasible and cross-slope not exceeding 2%. **Estimated Cost: \$1,130.00**
- Refer to site plan included with this report: (D) Install a min. 4'x6' concrete pad at the Shelter No. 1 BBQ grill for wheelchair access (see photos 1 below). **Estimated Cost: \$620.00**

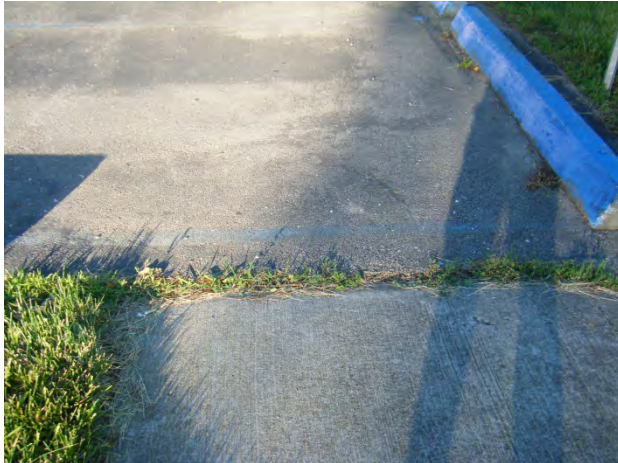
Photo 2

- Refer to site plan included with this report: (1) Two ADA parking spaces with no access aisle existing in this location. These spaces have slopes up to 4.8%.

Repave the spaces for proper slopes, take the east parking space and turn it into an access aisle (reducing this parking area to 1 ADA space), patch/smooth transition from asphalt to sidewalk (see photo 2 below), restripe spaces and remove parking sign at new access aisle. **Estimated Cost: \$678.00**

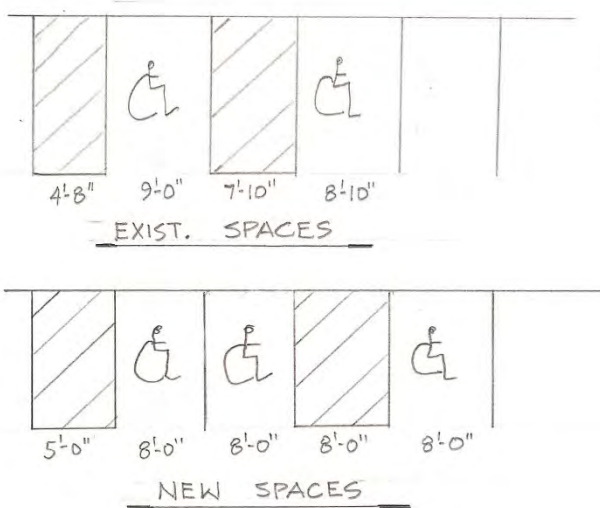
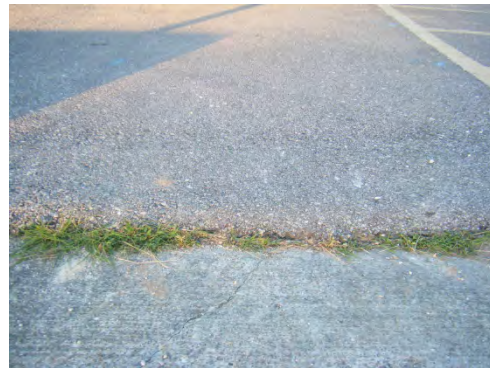
Photo 3

- Refer to site plan included with this report: (7) There are two existing ADA spaces in this parking area, but three are required due to total lot count of 56. Slopes of spaces are up to 3% and cross-slopes are up to 4.3%. Modify the layout of the existing spaces by adding one new parking space and properly sizing the access aisles as shown in the sketch below. Repave for proper slopes, restripe, relocate the existing van-access parking sign, add one additional ADA parking sign mounted at 72" above grade and patch/smooth the gap between the asphalt parking and the concrete walk (see photo 3 below).

Estimated Cost: \$1,571.00

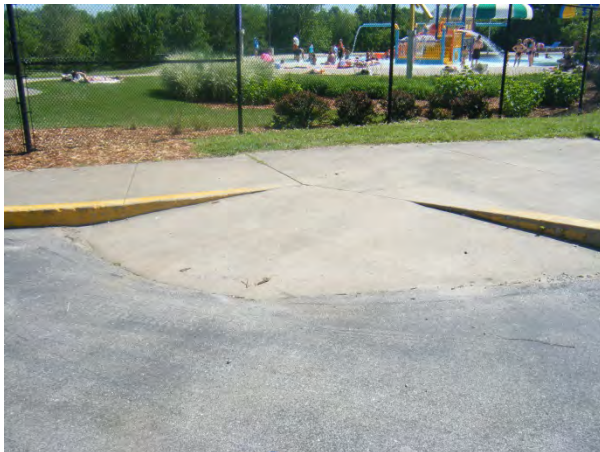
Photo 4

- Refer to site plan included with this report: (L) Replace two non-compliant curb ramps at the drive near the pool facility (see photos 4 & 5 below) with new contrasting truncated dome curb ramps.

Estimated Cost: \$5,000.00

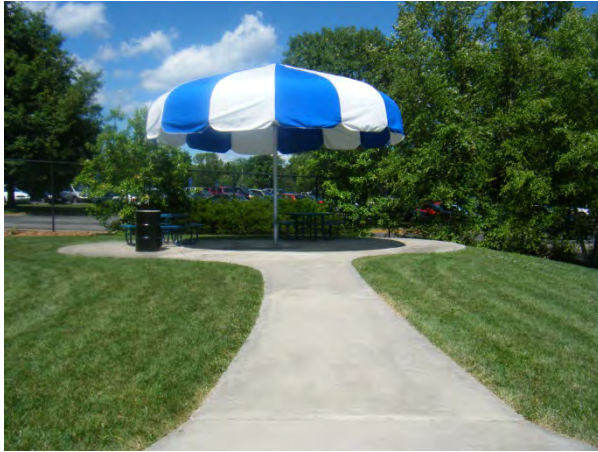
Photo 6

- Refer to site plan included with this report: (M) Add one wheelchair accessible picnic table at the pool concessions area. **Estimated Cost: \$795.00**
- Refer to site plan included with this report: (N) Add one wheelchair accessible picnic table at the kids spray area seating at the pool (see photo 6 below for location). **Estimated Cost: \$795.00**

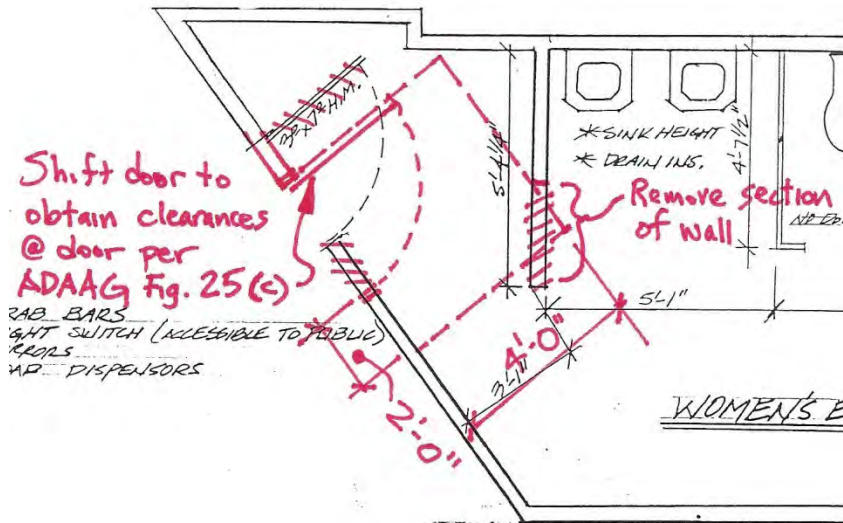
- Refer to site plan included with this report: (T) Public Women's Restroom @ Pool Facility: Existing entry door does not meet clearance requirements of ADAAG 4.13.6 and Fig. 25 (c) – modify entry area as shown in restroom sketch on next page. Existing toilet is 17" from side wall to center of fixture which is now acceptable per the new 2010 ADA Standards for Accessible Design, but the seat height is low (14.5" high) - install a toilet seat extender to raise seat to be 17" – 19" a.f.f. Existing lavatory does not meet ADAAG 4.19 requirements for knee clearance below the lavatory – raise lavatory so that the top surface is 34" a.f.f. Install braille/tactile ADA restroom sign on latch side of entrance door at 60" above floor to centerline of sign. **Estimated Cost: \$1,336.00**

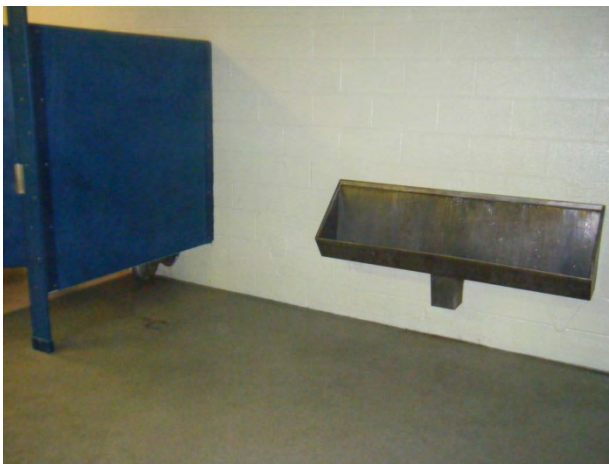
Photo 7

- Refer to site plan included with this report: (U) Men's Pool Restroom/Shower Room: Existing toilet is 17.5" from side wall to center of fixture which is now acceptable per the new 2010 ADA Standards for Accessible Design, but the seat height is low (15" high) - install a toilet seat extender to raise seat to be 17" – 19" a.f.f. The side grab bar needs to be moved so that it is 12" off of the rear wall. Existing lavatory does not meet ADAAG 4.19 requirements for knee clearance below the lavatory – raise one lavatory so that the top surface is 34" a.f.f. and insulate the pipes beneath. Install an ADA accessible urinal with elongated front rim no higher than 17" a.f.f. next to the existing trough-type urinal (see photo 7 below). Width of the ADA transfer shower is 37.5" which is 1.5" wider than transfer shower required by ADAAG Fig. 35 (a) – fur out seat wall 1.5" to obtain required width of 36". Lower existing mirror such that the max. height from floor to the lowest reflective surface of the mirror is 40". Add an accessible locker key handle to at least one locker and install braille/tactile ADA restroom sign on latch side of entrance door at 60" above floor to centerline of sign.

Estimated Cost: \$2,319.00

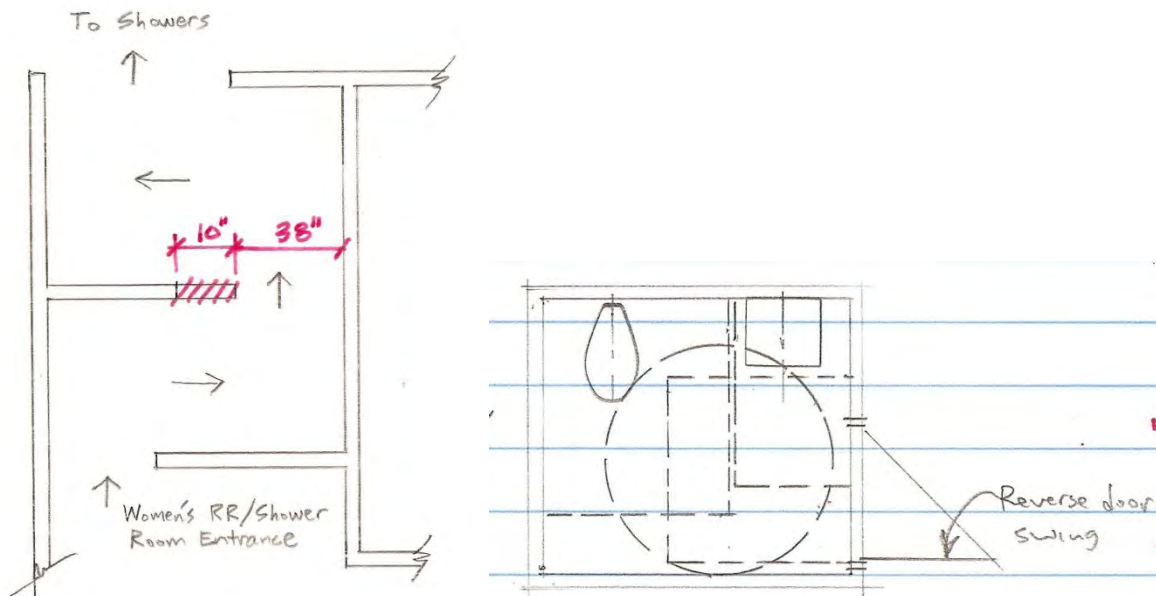
- Refer to site plan included with this report: (V) Women's Pool Restroom/Shower Room: Remove a min. 10" section of c.m.u. privacy wall to allow for proper wheelchair maneuvering space at entry area (see sketch below). Existing toilet is 19" from side wall to center of fixture which is non-compliant (ADAAG requires 18") – shift side stall divider panel 1" into the ADA stall to get to 18". The side grab bar needs to be moved so that it is 12" off of the rear wall and a rear grab bar needs to be installed (36" long min. at 6" off of side wall and at 33" – 36" a.f.f.). Additionally, because this restroom has a total of six toilet stalls, one of the existing toilet stalls needs to be reconfigured to be a 36" wide accessible stall meeting ADAAG 4.22.4. Existing lavatory does not meet ADAAG 4.19 requirements for knee clearance below the lavatory – raise one lavatory so that the top surface is 34" a.f.f. and insulate the pipes beneath. Width of the ADA transfer shower is 37.5" which is 1.5" wider than transfer shower required by ADAAG Fig. 35 (a) – fur out seat wall 1.5" to obtain required width of 36". Lower existing mirror such that the max. height from floor to the lowest reflective surface of the mirror is 40". Add an accessible locker key handle to at least one locker and install braille/tactile ADA restroom sign on latch side of entrance door at 60" above floor to centerline of sign.

- Refer to site plan included with this report: (W) Family Pool Restroom/Shower Room: In order to obtain proper wheelchair maneuvering clearances at the toilet room door, replace frame and use same door so that the door swings out (hinged on same jamb side as previous – see sketch above). Move side grab bar so that it is 12" from the rear wall and replace the rear 24" long grab bar with a min. 36" long grab bar mounted at 33" – 36" a.f.f. Existing lavatory does not meet ADAAG 4.19 requirements for knee clearance below the lavatory – raise one lavatory so that the top surface is 34" a.f.f. and insulate the pipes beneath. Add an
