# Facility: Grissum Building

Address: 1313 Lakeview Street

Date of Survey: 07/01/11

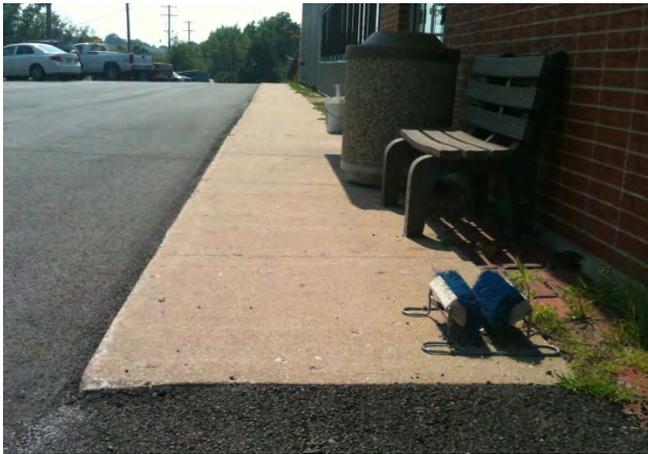
Photo 1

- Refer to site plan included with this report: (A) Relocate the boot brush attached to the sidewalk to allow for min. required 36" wide access path to entry door (see photo 1 below). **Estimated Cost: 40.00**

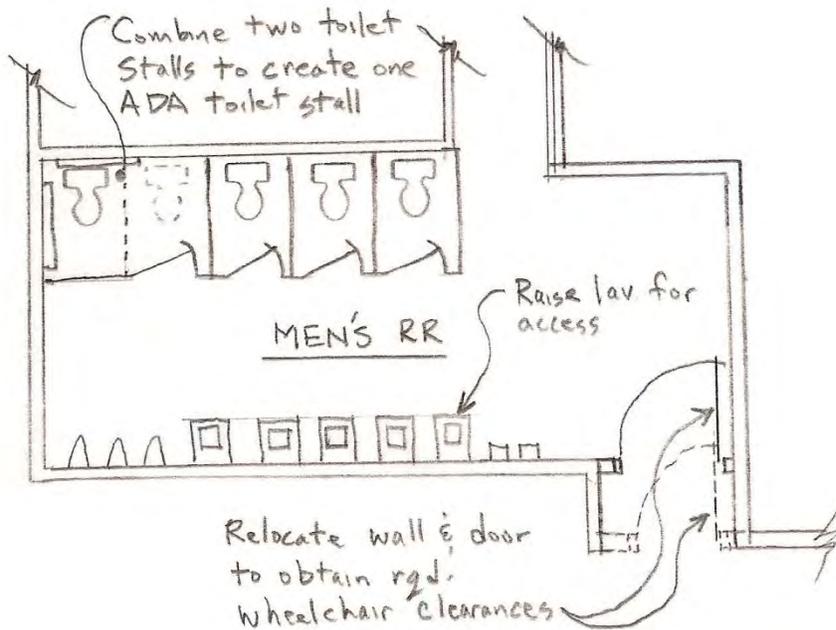
- Men's Restroom: Relocate entry door and wall so that it is flush with the wall that the lavatories are on to create wheelchair clearances at the door required by ADAAG 4.13.6, install a braille/tactile ADA restroom sign at the latch side of the door and mounted to be 60" from floor to centerline of the sign, adjust the door closer to open with 5 lbs. force or less, raise one lavatory to provide proper knee clearances per ADAAG 4.19, insulate the pipes below the ADA lavatory, lower the mirror at the ADA lavatory so that the lowest reflective surface is no higher than 40" a.f.f., and combine two end of the row toilet stalls and reconfigure to create one ADA toilet stall that meets ADAAG Fig. 30 (a), including the installation of grab bars (see sketch below).

**Estimated Cost: \$3,720.00**
