Facility: Parking Plaza

Address: 17 N. 8th Street

Date of Survey: 02/02/10 & 02/08/10

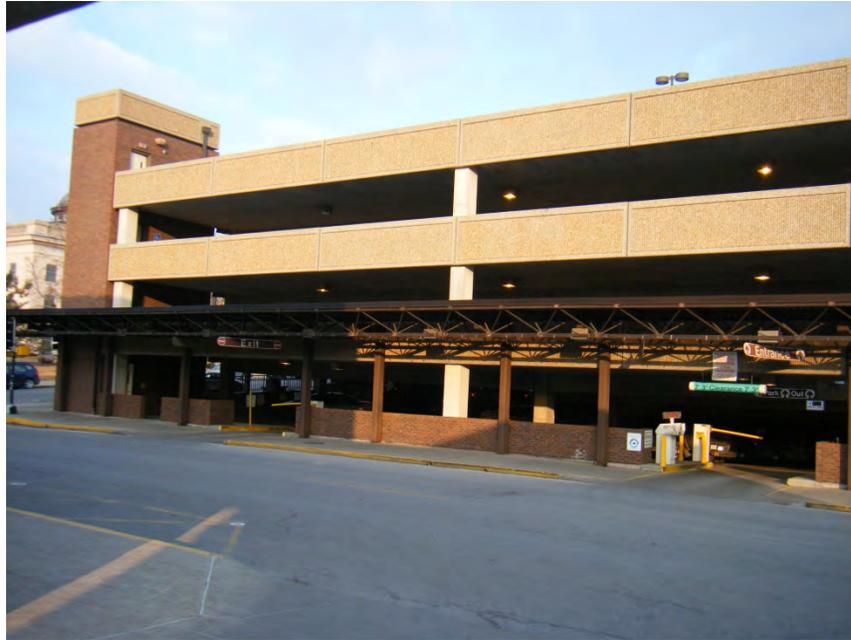
The Parking Plaza structure has four parking levels, all of which are sloped slabs averaging approximately 6%. The parking structure was constructed prior to the 1990 Americans with Disabilities Act and all levels are accessible via two elevators. This structure has a total of 349 parking spaces and therefore, per ADAAG 4.1.2 (5) a. – d., eight total accessible parking spaces are required.

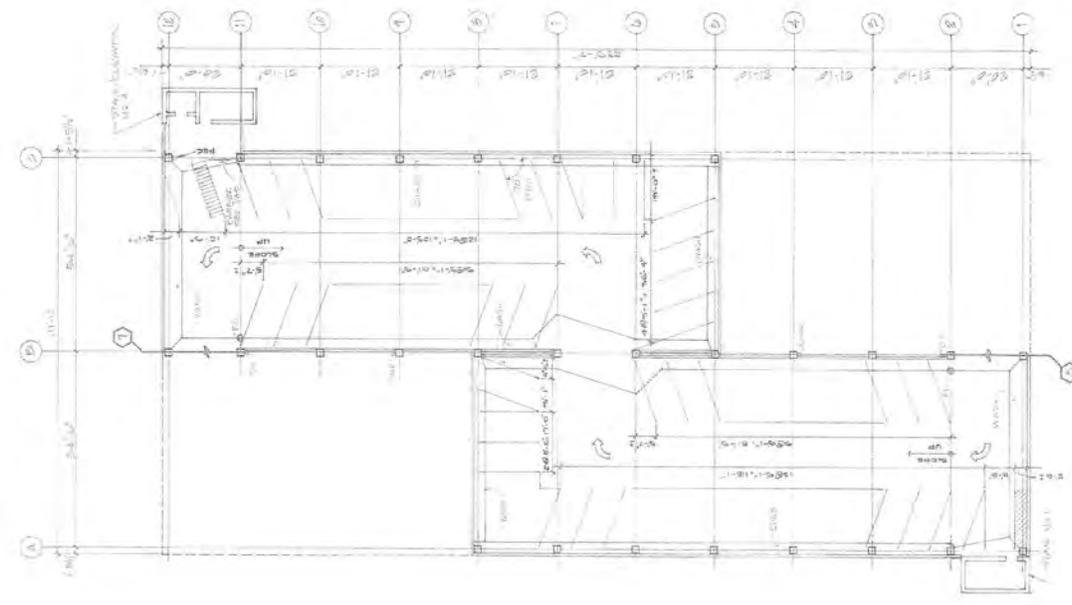
A3

Note: This parking structure was designed with slope slabs throughout which makes it structurally and financially infeasible to make changes that would provide all level parking spaces and access aisles. The slope slabs create an average cross slope at the existing ADA parking spaces of 6% +/- . Additionally, at the slab beams, vertical

clearance gets as low as 88" which is 10" shy of ADAAG 4.6.5 minimum vertical clearance requirement of 98". In a phone conversation on July 11, 2011 with Jim DeJong and Chuck Graham of the Great Plains ADA Center, various options for accessible parking were discussed, including the possibility of removing the existing non-compliant ADA parking in the Parking Plaza and providing those spaces in another City owned parking garage nearby. Jim and Chuck both felt that with the Parking Plaza's heavy use and proximity to various high traffic service, office and government facilities in the area, it would be best to maintain the existing spaces and make any modification deemed feasible to improve those spaces even though they would not be fully ADA compliant. The also recommended that due to the low vertical clearances, signage should be installed indicating that the parking structure is not van accessible and giving directions to the nearest parking structure that has van accessible parking spaces.

- At SW Level 2 elevator landing and SW Level 3 elevator landing, scarify existing concrete beyond the 2' deep level landing to allow for a concrete topping to extend landings to be level out 4' from the elevator entrances and then continue concrete topping out to front edge of accessible parking spaces. Add a contrasting truncated dome detectable warning surface at ramp outlet into the parking area (see Area A & B on plans). **Estimated Cost: \$4,488.00**

- Parking Area 1 (see plans): Restripe two spaces to be minimum 8' wide with a shared min. 5' wide access aisle and raise signs to 72" above grade.
Estimated Cost: \$328.00

- Parking Area 2: Restripe existing space such that a min. 5' wide access aisle is located on the left side of a min. 8' wide parking space and raise parking sign to 72" above grade.
Estimated Cost: \$212.00

- Parking Area 3: Restripe existing space such that a min. 5' wide access aisle is located on the right side of a min. 8' wide parking space.
Estimated Cost: \$288.00

- Parking Area 5: Restripe existing space such that a min. 5' wide access aisle is located on the left side of a min. 8' wide parking space.
Estimated Cost: \$192.00

- Parking Area 6: Restripe existing space such that a min. 5' wide access aisle is located on the left side of a min. 8' wide parking space.
Estimated Cost: \$288.00

- Parking Area 7: Restripe existing space such that a min. 5' wide access aisle is located on the left side of a min. 8' wide parking space and install parking sign on a post to raise to 72" above grade.
Estimated Cost: \$359.00

- Install new curb-cut at parking area 3 & 4 and replace curb-cut at parking area 7:
Estimated Cost: \$7,500.00

- Install a barrier rail meeting ADAAG 4.4.2 at the open underside of four interior stairs (C, D, E & F on the plans). **Estimated Cost: \$670.00**
