# Facility: Stephens Lakes Park

Address: 2001 E. Broadway      Date of Survey: 05/06/10

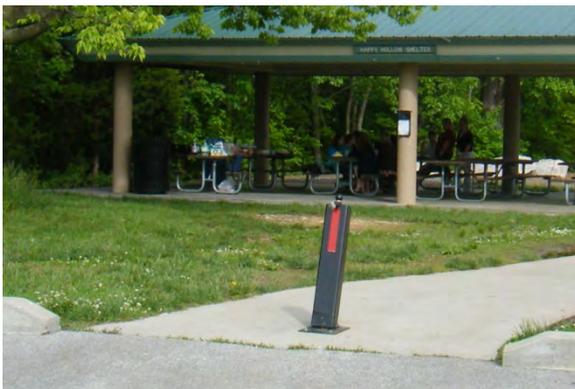
Photo 1

- Refer to site plan included with this report: (A) Patch/fill gap between parking lot and sidewalk that leads to the Happy Hollow Shelter (see photo 1 below).

**Estimated Cost: \$200.00**

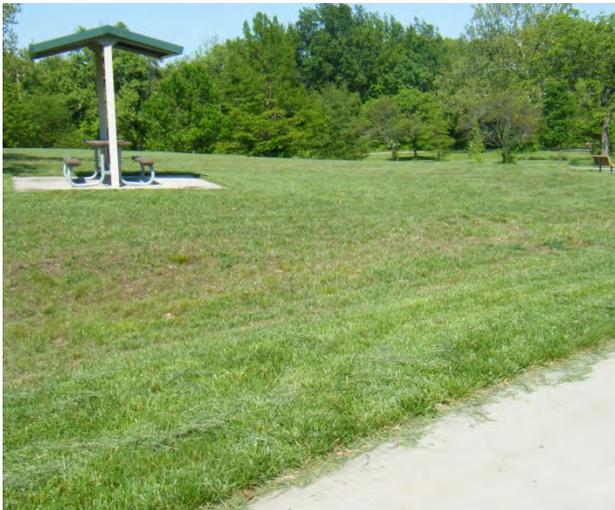
Photo 2

- Refer to site plan included with this report: (C) Install a 4' wide concrete access path to one of the small shelters on site. Path shall have slope not exceeding 5% and cross-slope not exceeding 2% (see photo 2 below). **Estimated Cost: \$1,246.00**

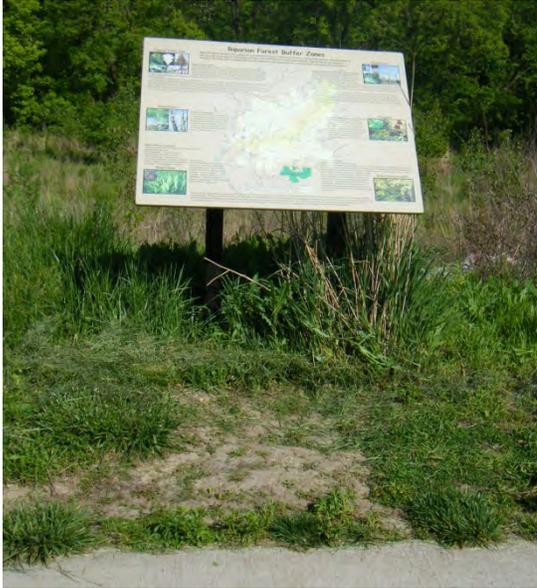
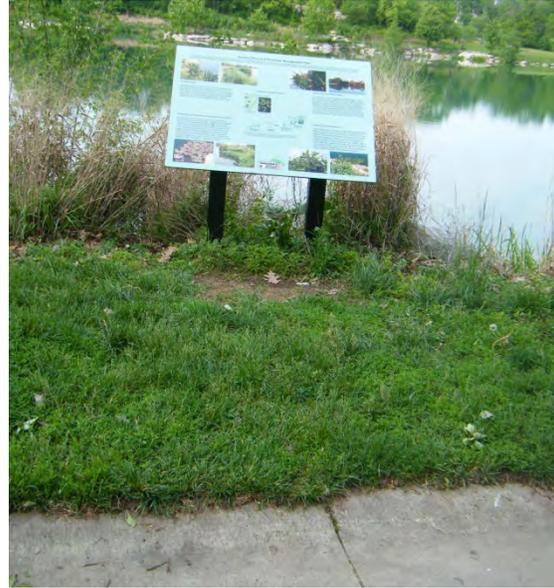
- Refer to site plan included with this report: (D) Install a 5' wide concrete path from the existing sidewalk over to the landscape information signs – path shall have slope no greater than 2% in any direction (see photos 3 & 4 next page). **Estimated Cost: \$1,346.00**

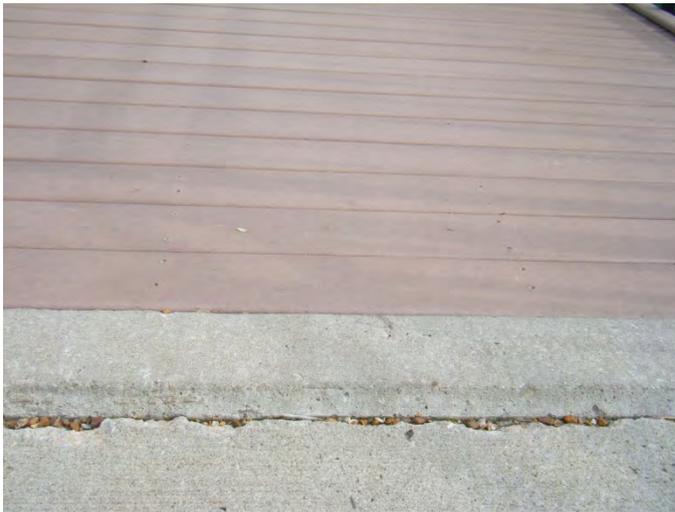
Photo 5

- Refer to site plan included with this report: (E) Two sections of the concrete walk have settled  $\sim \frac{3}{4}$ " - 1" where it connects to the bridge at the lake (see photo 5 below). Replace  $\sim 100$  s.f. of concrete path. **Estimated Cost: \$2,064.00**

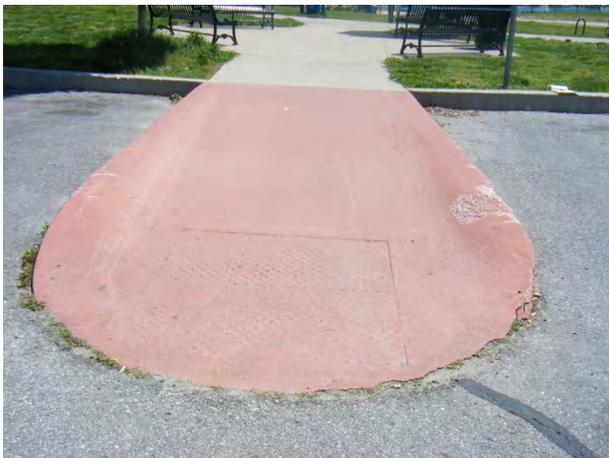
Photo 6

- Refer to site plan included with this report: (F) Replace shallow truncated dome curb ramp surface and patch intersection with asphalt drive (see photo 6 below). **Estimated Cost: \$2,264.00**

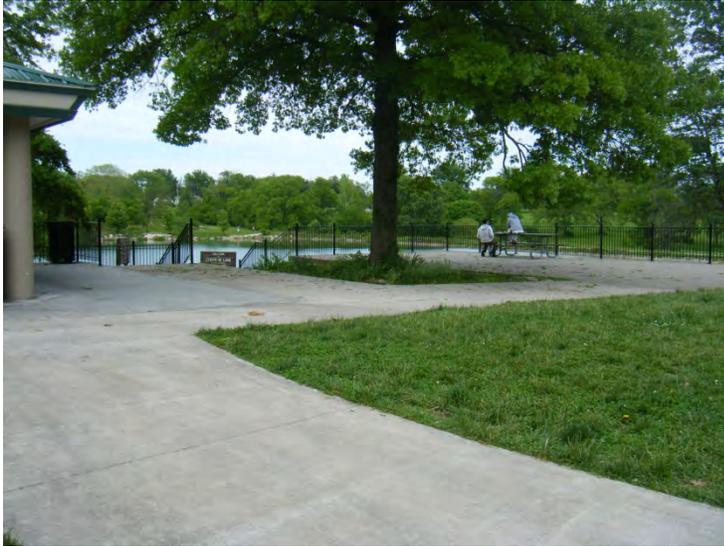
Photo 7

- Refer to site plan included with this report: (H) Add one wheelchair accessible picnic table in the Gordon Shelter and one at the Gordon Shelter outdoor seating area (see photo 7 below for location). **Estimated Cost: \$1,700.00**

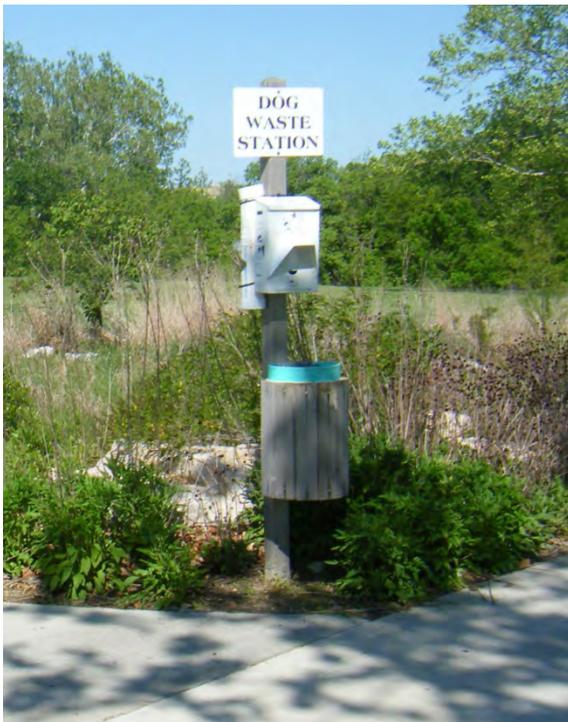
Photo 8

- Lower dog waste station dispenser at three locations so that the highest operable part of the dispenser is no higher than 48" above grade (see photo 8 below).

**Estimated Cost: \$150.00**

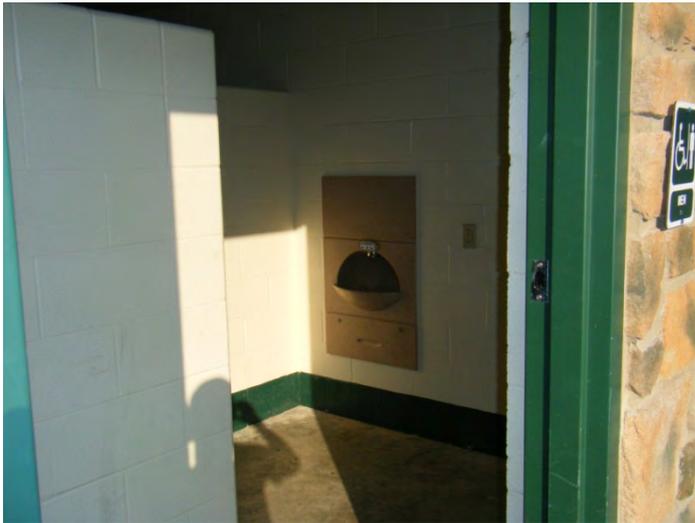
Photo 9

- Refer to site plan included with this report: (M) Existing lavatory in the Men's and Women's Restroom is recessed into wall (see photo 9 on below) and does not meet ADAAG 4.19 requirements for knee space below the lavatory. Options are to remove existing recessed lavatory unit and replace with a new wall-mounted lavatory that meets ADAAG 4.19 or modify the existing lavatories to obtain required knee space below the lavatories (see photo 10 below for example) or leave existing recessed lavatories in place and install an additional wall-hung accessible lavatory next to the existing lavatories. **Estimated Cost: \$3,618.00**

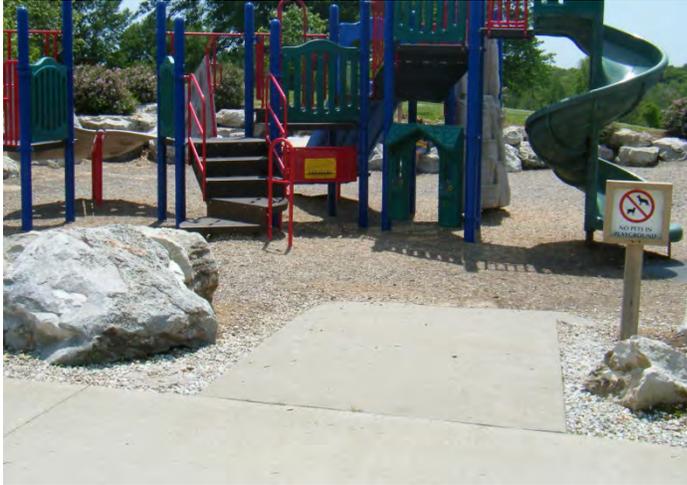
Photo 11

- Refer to site plan included with this report: (R) Supplement/compact existing wood fiber material in the playground just west of the Riechmann Pavilion (~5,983 s.f. area) and build up additional wood fiber surface at the steep concrete ramp into the playground area so that the access is as close to maximum slope of 5% as possible (see photo 11 below). **Estimated Cost: \$4,787.00**
