# Facility: Twin Lakes Recreation Area

Address: 2500 Chapel Hill Road      Date of Survey: 06/04/10

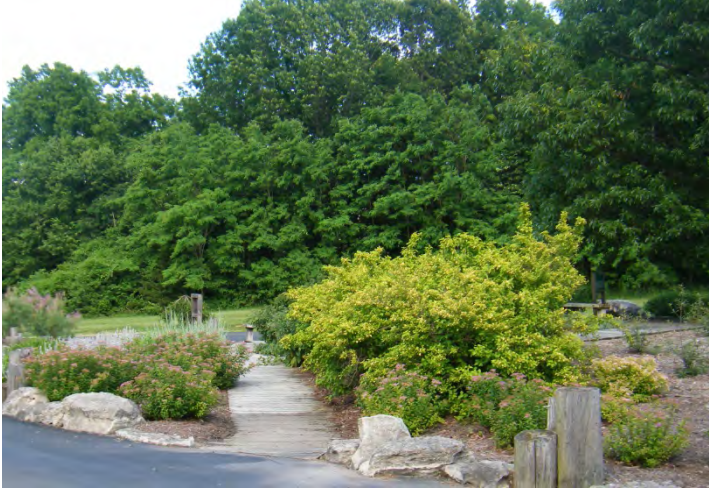
Photo 1

- Refer to site plan included with this report: (C) Replace misc. sections of wood decking at boardwalk within the Xeriscape Demonstration Garden NE of the bathhouse due to cupping and deterioration (see photo 1 below).

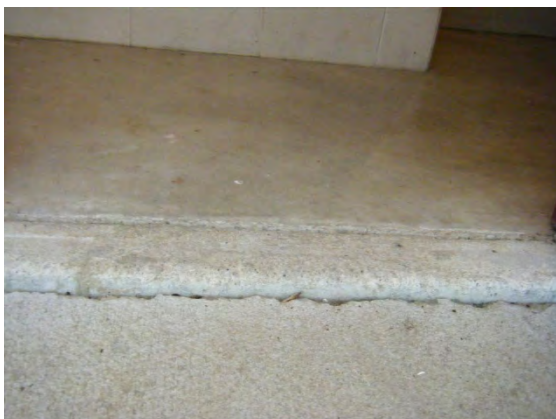
Photo 2

- Refer to site plan included with this report: (F) Remove and replace a 40'x6' section of concrete at the NW Restroom Building entry area due to 1.25" of settlement at doors (see photo 2 below).

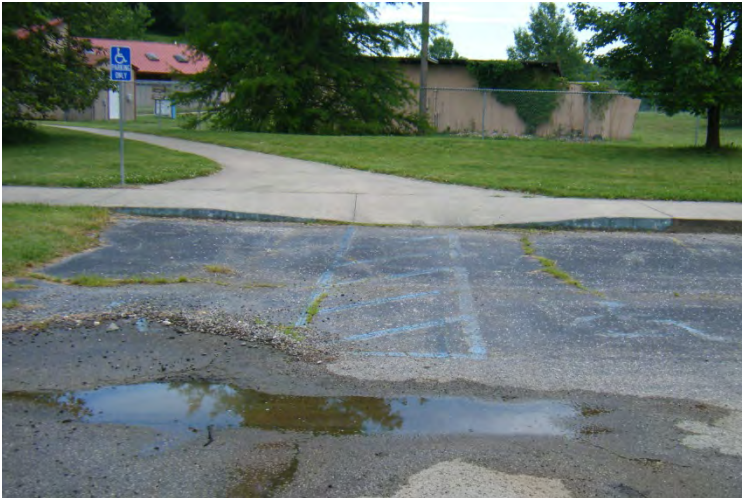
Photo 3

- Refer to site plan included with this report: (1) Existing ADA spaces and access aisle need to be re-striped (blue paint) and one ADA parking sign needs to be added at 72" above grade. **Estimated Cost: \$319.00**
- Refer to site plan included with this report: (2) One of the two existing ADA spaces and the access aisle are less than min. required widths for proper ADA spaces and spaces are in need of asphalt patch and repairs (see photo 3 below). Repair asphalt, re-stripe spaces to be proper sizes (min. 8' wide parking spaces sharing a min. 5' wide access aisle) and add one ADA parking sign installed to be added at 72" above grade. **Estimated Cost: \$1,268.00**

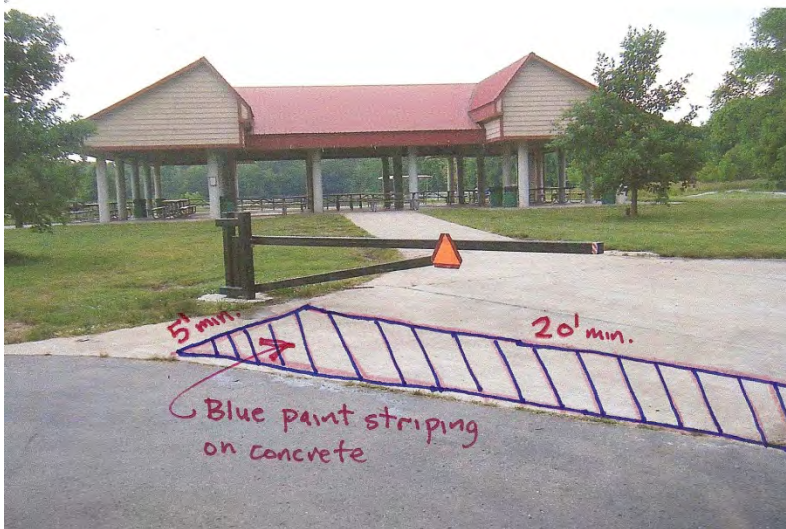
Photo 4

- Refer to site plan included with this report: (5) Due to lack of wheelchair accessible path from the ADA parking spaces in the lower NW parking lot, it is recommended that an accessible drop-off area be added at the large concrete area adjacent to the road near the shelter (see photo 4 below). Stripe (blue paint) a min. 5' wide x 20' long access aisle for the new passenger loading zone to be used for drop-off and pick-up of persons with disabilities who are using the shelter, accessible restrooms, playground or accessible fishing dock. Add an ADA passenger loading zone sign to demark this area.

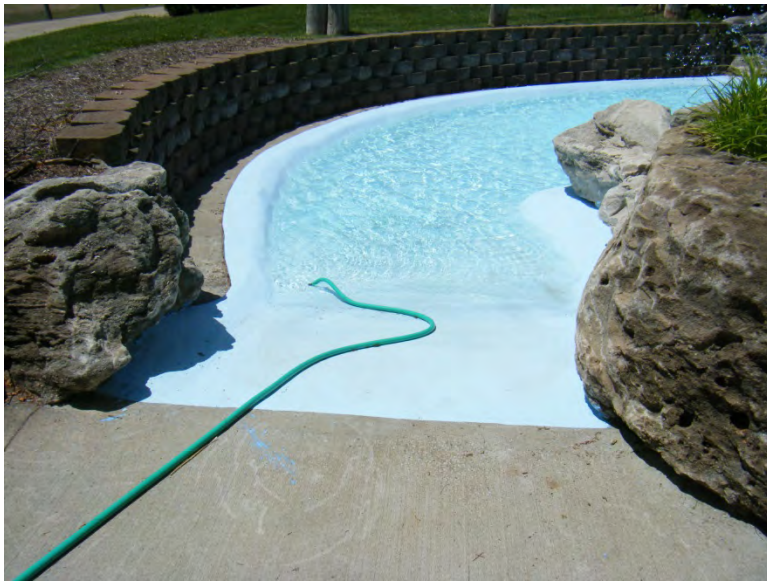
Photo 5

- Refer to site plan included with this report: (H) Install galvanized/painted metal, aluminum or stainless steel handrails (~20 linear feet) on both sides of one of the pool entry ramps at Little Mates Cove water park (see photo 5 below). Handrail system shall meet requirements of ADAAG 4.8.5.

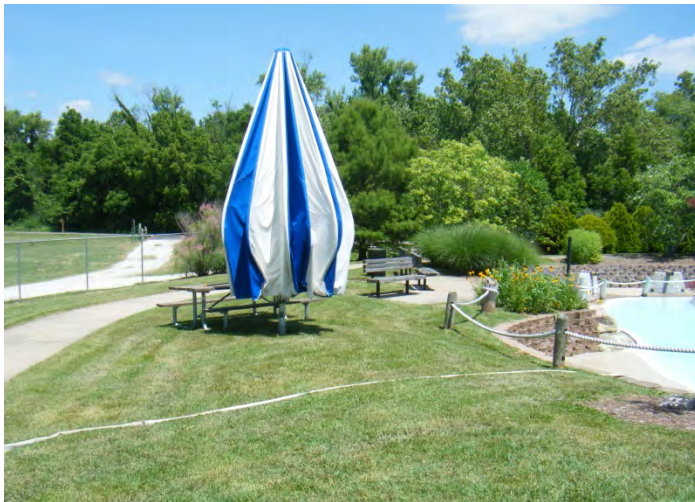
Photo 6

- Refer to site plan included with this report: (I) Add a min. 7'x10' concrete pad directly adjacent and connected to the existing sidewalk for wheelchair accessible picnic table (see photo 6 below for recommended location).  
**Estimated Cost: \$866.00**
- Refer to site plan included with this report: (I) Add one wheelchair accessible picnic table at new concrete to be located near the other picnic tables in the turf area north of Little Mates Cover (see photo 6 below).  
**Estimated Cost: \$795.00**

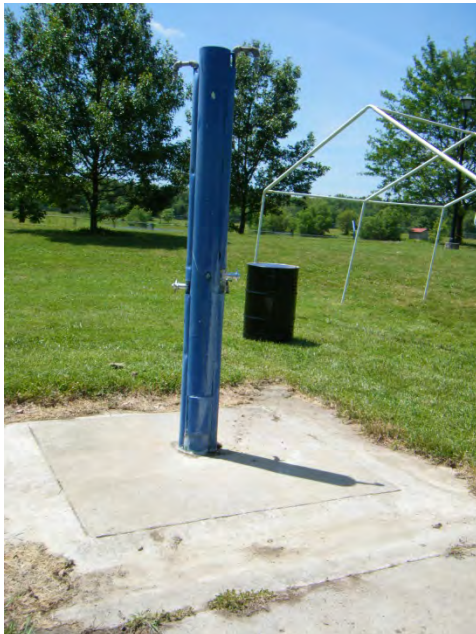
Photo 7

- Refer to site plan included with this report: (N) Add an accessible shower control handle that meets ADAAG 4.27.4 for easy operation and graspability and mounted no higher than 44" above grade at one of the outdoor showers (see photo 7 below). **Estimated Cost: \$300.00**

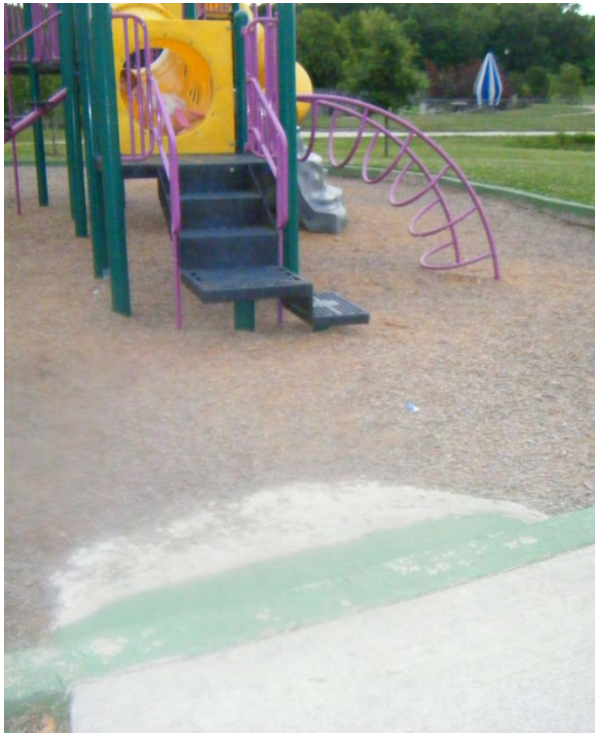
Photo 8

- Refer to site plan included with this report: (O) Supplement/compact existing wood fiber material in the playground area (~2,781 s.f. area).  
**Estimated Cost: \$2,086.00**
- Refer to site plan included with this report: (O) Build up additional wood fiber surface at the steep concrete ramp into the playground area so that the access is as close to maximum slope of 5% as possible (see photo 8 below).  
**Estimated Cost: \$400.00**
