Facility: Blind Boone Historic Home

Address: 10 N. 4th Street

Date of Survey: 01/06/10

The John Williams "Blind" Boone Memorial is a historic two story residence that is listed on the National Register of Historic Places. At the time of this survey, the building was undergoing a renovation/rehabilitation and much of the interior had been gutted.

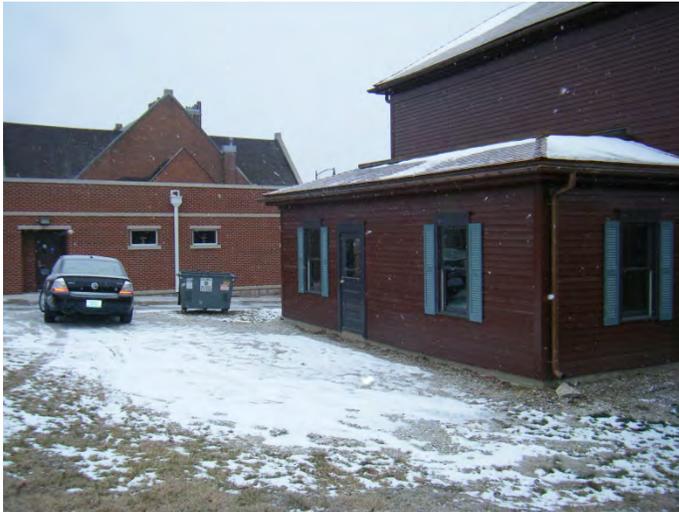
Photo 1

- Refer to site plan included with this report: (B) Install a wood ramp with period appropriate handrails on both sides that meets ADAAG 4.8 (~15 linear feet of ramp plus landing) from the new ADA parking area up to the east building entrance door (see photo 1 below). **Estimated Cost: \$3,900.00**

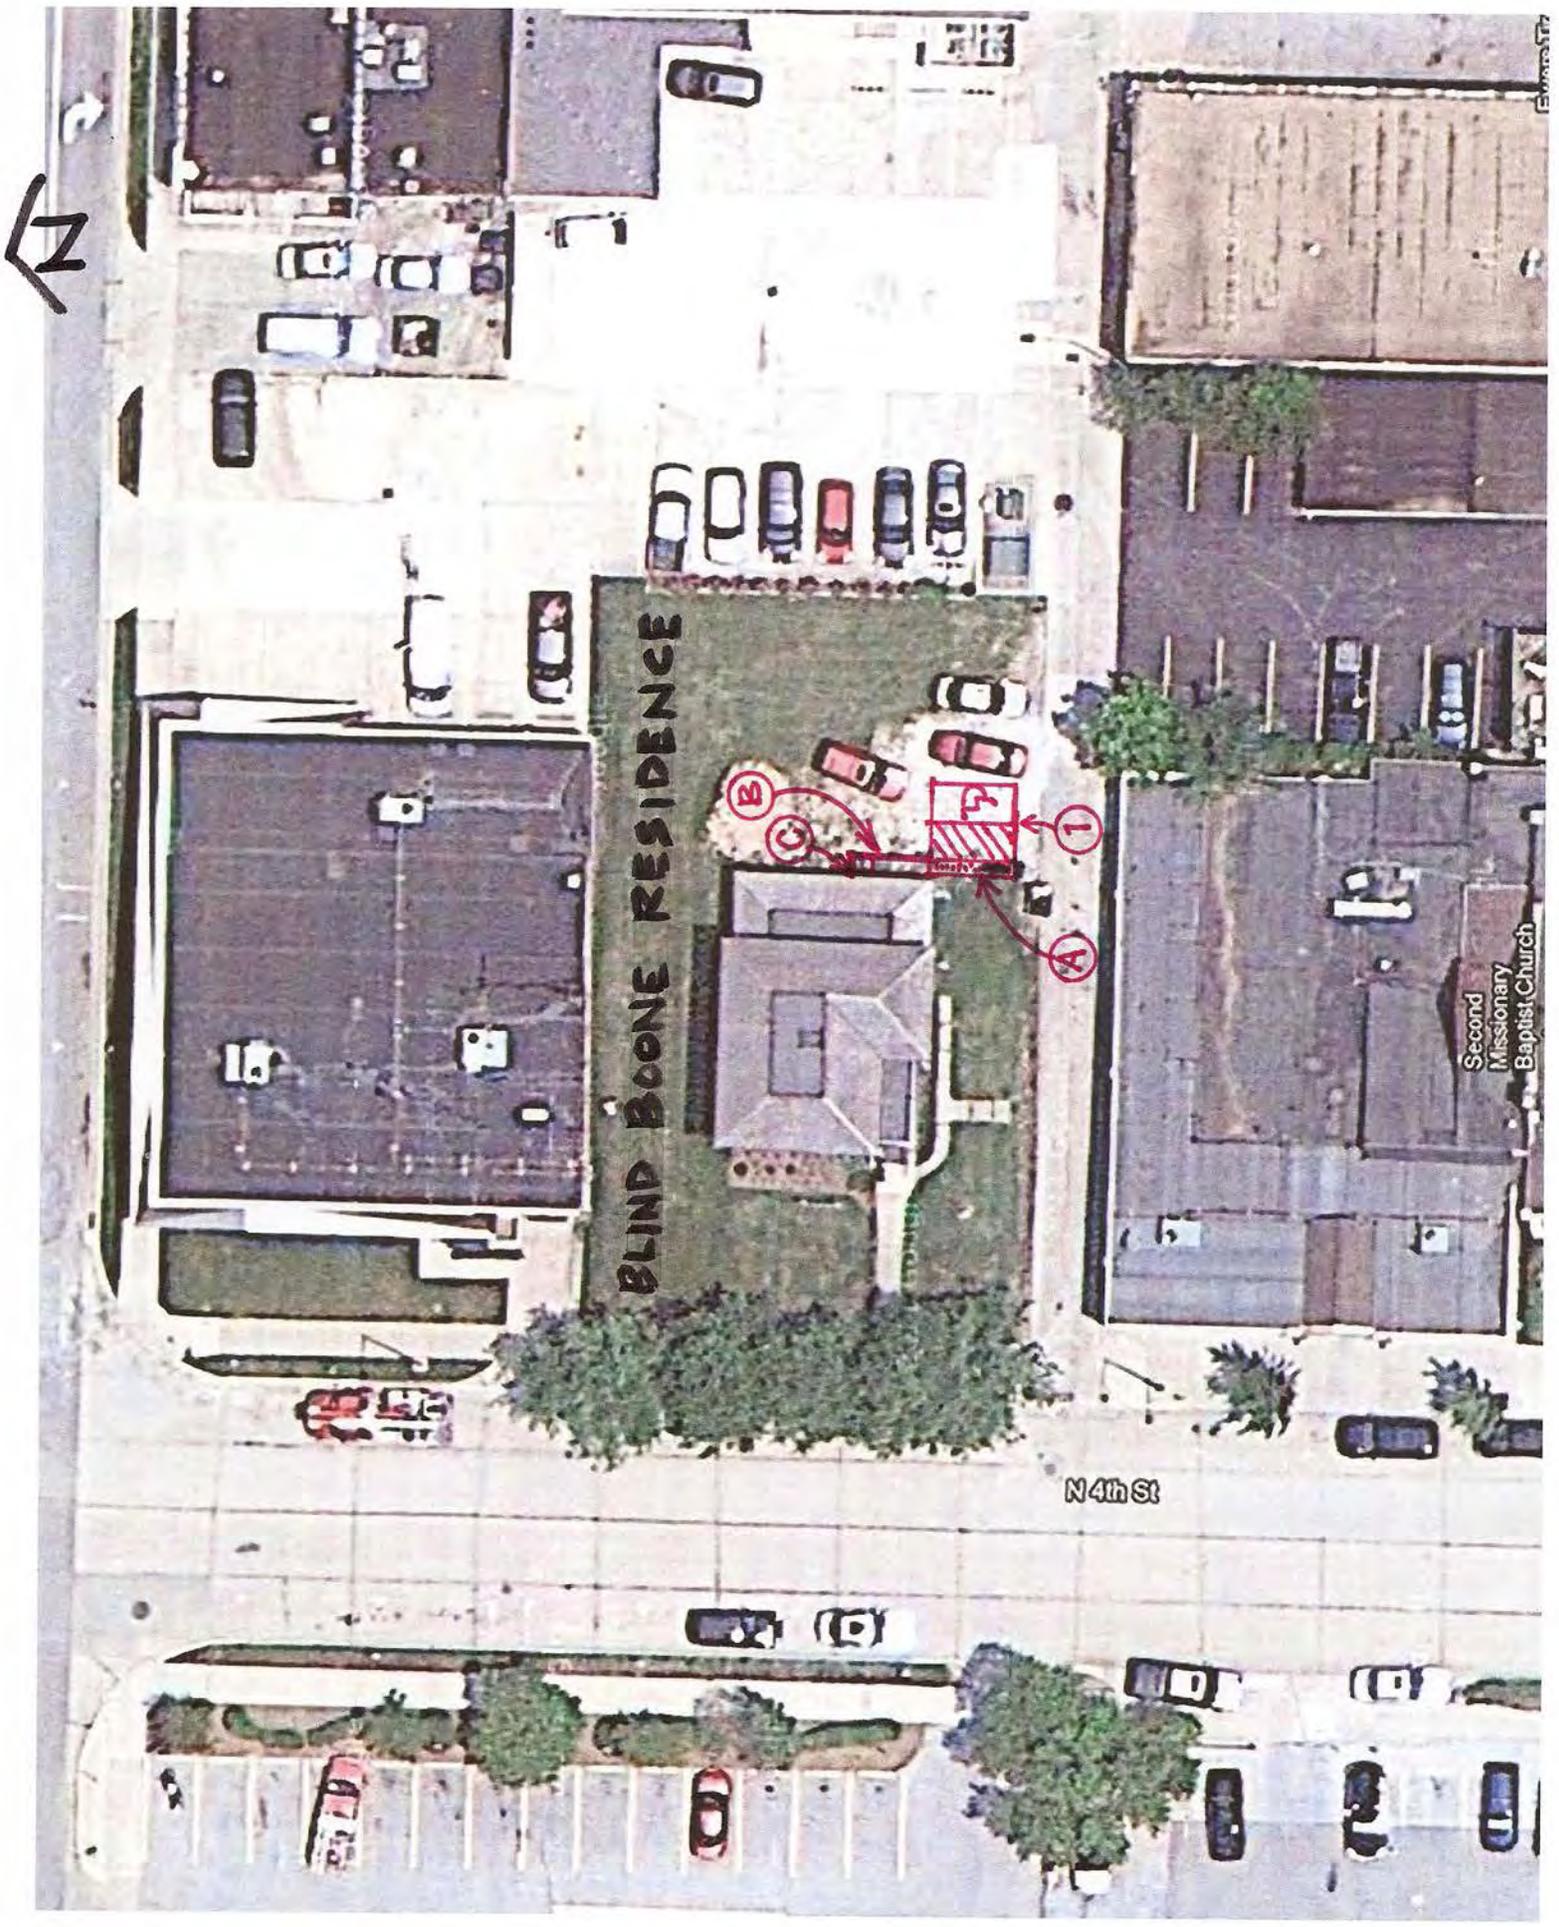
BLIND BOONE RESIDENCE

- Refer to site plan included with this report: (A) Install a min. 4' wide concrete or asphalt access path from new ADA parking space to the new ramp at the east entrance. **Estimated Cost: \$500.00**

- Refer to site plan included with this report: (1) Existing east parking area is gravel only. Install a concrete or asphalt ADA van accessible parking space (min. 8' wide with min. 8' wide access aisle and max. slopes of 2%) with an ADA van access parking sign at 72" above grade. New ADA parking space shall be striped (blue paint). **Estimated Cost: \$2,838.00**

- Refer to site plan included with this report: (C) At east entry door, replace knob with lever. **Estimated Cost: \$305.00**

- Refer to site plan included with this report: (D) Once interior renovation gets back underway, be sure that the new flooring installed in the home is installed such that it is level with the east entrance door sill/threshold for wheelchair access that will be provided via the new ramp recommended in Section 1.4. At time of the survey, there was a ~ 2.5" difference in elevation between the interior sub-floor and the east door sill.

- Refer to site plan included with this report: (E) This is a two story historic property without an elevator. In order to provide wheelchair users or those individuals who cannot use stairs with information about the spaces on the second floor, provide a photo and/or video display detailing the layout and characteristics of the inaccessible second story rooms. This visual display should be placed somewhere on the accessible first floor where it will be easily accessible. **Estimated Cost: \$2,000.00**

- Refer to the building plan included with this report: (F) At the time of this survey, many of the doors and frames inside the home were removed from their original openings. When the renovation project continues, if possible, install “offset” hinges at the doors that provide less than 32” wide clearance so to provide as much clear opening width as possible at these narrow door openings. (G) The existing toilet room has been completely gutted and has no fixtures in place. The existing room is too small to wheelchair accessible. When renovation continues, either enlarge the toilet room to allow for wheelchair access or if that is not possible due to historic restoration requirements, then place an ADA accessible portable toilet on a concrete or asphalt level pad adjacent to the new ADA parking space and/or access path to be installed on the east side of the home.
Contingency for costs unknown due to restoration activities: \$5,000.00
