Facility: Paquin Park

Address: 212 Waugh Street

Date of Survey: 04/15/10

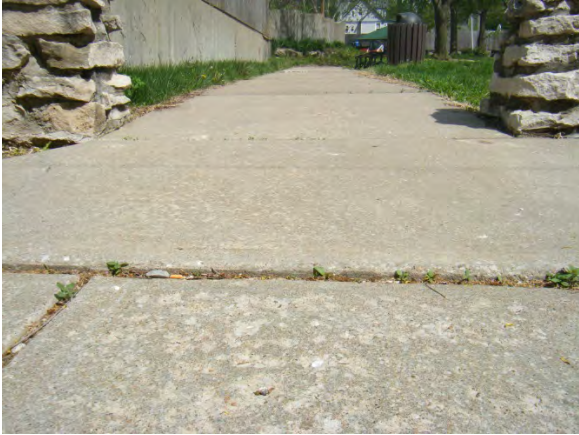
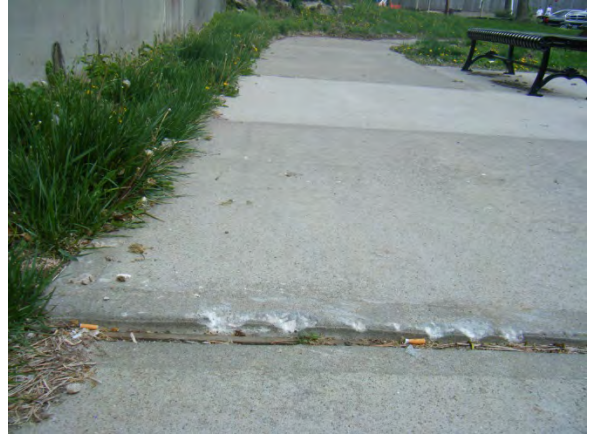
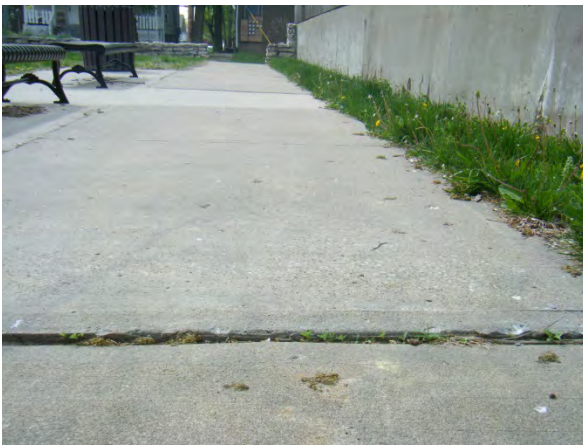
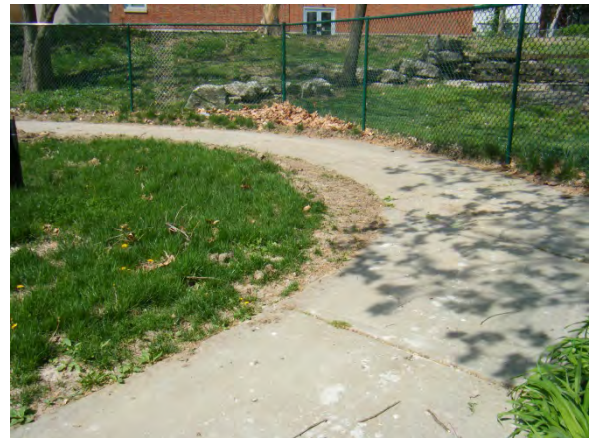
- Refer to site plan included with this report: (A) Remove various sections of settled/heaved/damaged/improperly sloped sidewalk and replace with new concrete sidewalk (hold slope to 5% or less and cross-slopes to 2% or less as much as is feasible) – see photos 1 – 4 next page).

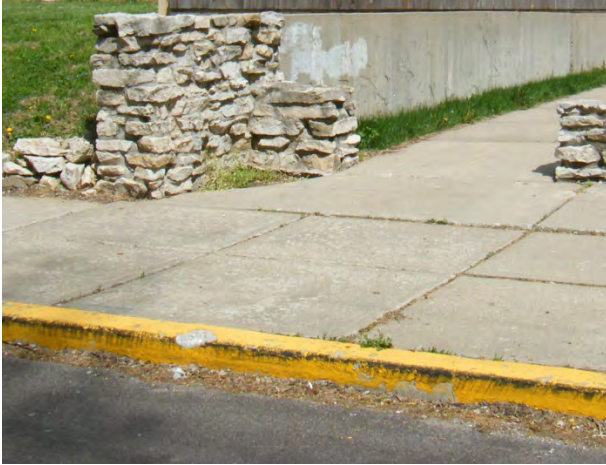
Photo 5

- Refer to site plan included with this report: (B) Recommend the addition of a contrasting truncated dome curb cut at the sidewalk off of Waugh Street (see photo 5 next page).
Estimated Cost: \$2,500.00
- Refer to site plan included with this report: (C) Recommend the addition of a contrasting truncated dome detectable warning surface at the existing SE sidewalk where it connects with the Paquin Tower parking lot.
Estimated Cost: \$1,470.00
