Facility: 8th & Cherry Parking Garage

Address: 801 - 11 Cherry Street

Date of Survey: 02/02/10 & 02/05/10

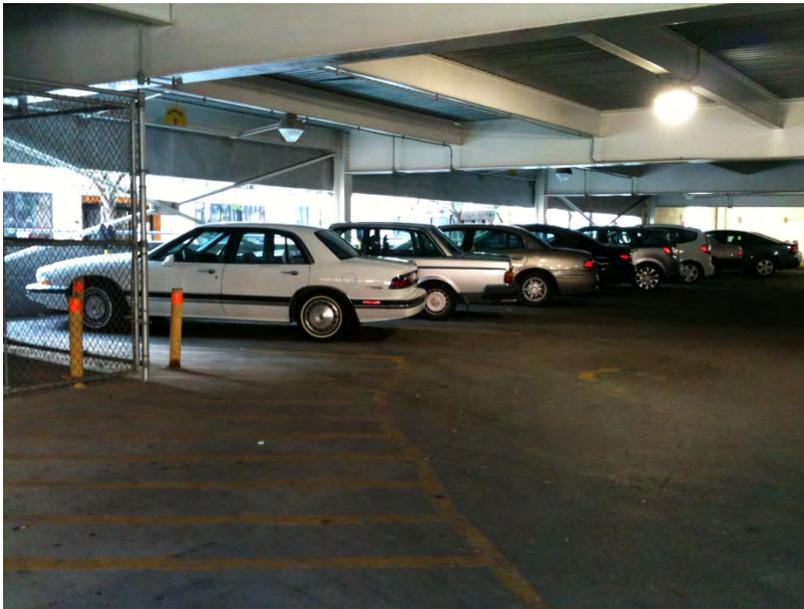
Photo 1

- Existing ADA parking spaces located on each level generally have slopes and cross-slopes that are close to the required 2% maximum slope in any direction, but most areas have at least minor issues with slope or cross-slopes up to 4%. The bigger issue is that the spaces as currently located require the individual with a disability to travel on the vehicular path along the south perimeter of the parking structure to get over to the elevator located in the SW corner of the parking structure. In addition to requiring a wheelchair user to travel an unsafe path, the path typically has excessive cross-slopes of up to 8% which is excessive and non-compliant for an accessible access path. Because of these issues and the existing structural conditions, it would be technically infeasible to completely eliminate these issues in this existing structure. Therefore, I am recommending that the six required ADA parking spaces be relocated to the ground level (Level A) and be placed along the west perimeter of the parking structure (see photo 1) and proposed parking sketch below. The existing slopes and cross-slopes of the parking spaces along the west wall of the garage are mostly acceptable with some up to 3%. The existing spaces can be repaved for maximum 2% slopes, re-striped for proper space markings and sizes and existing parking signs moved to this new location.

Estimated Cost: \$4,911.00

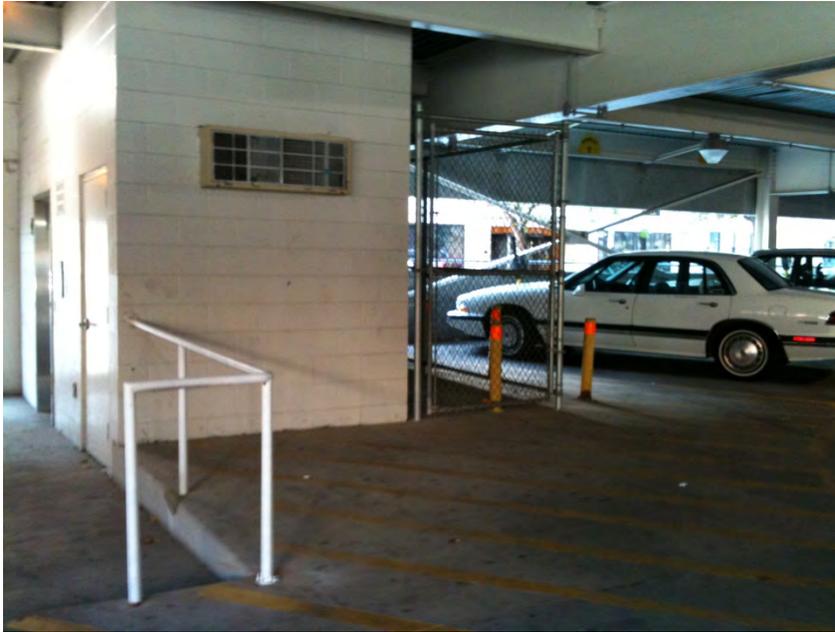
Photo 2

- Rework/level access path from new ADA parking at west side of Level A to the existing concrete landing near elevator and west exit door. This will require the demo of a 4' wide x 15' long section of existing pavement and installation of a maximum 5% slope path (see proposed walk shown in red in the New ADA Parking sketch on previous page and photo 2 below for existing conditions).

Estimated Cost: \$1,642.00.00

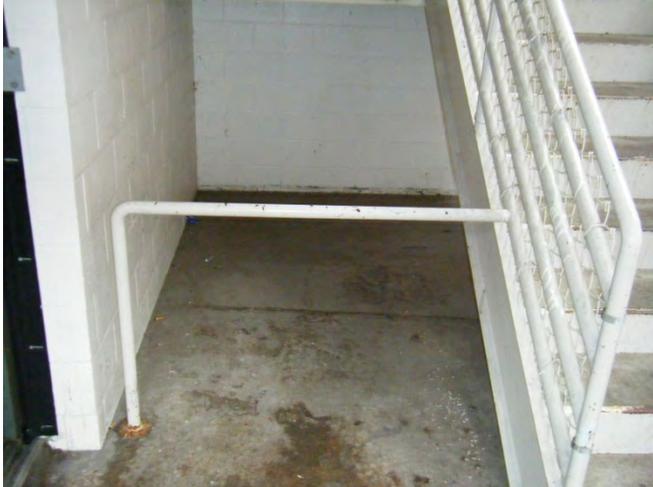
Photo 3

- Install lower horizontal rail for proper cane detection (@ max. 27" a.f.f.) at Level A of SW Stair and Level A of NE Stair (see photos 3 & 4 on next page)

Estimated Cost: \$436.00
