Facility: Water & Light Distribution

Address: 1514 Business Loop 70 East

Date of Survey: 07/05/11

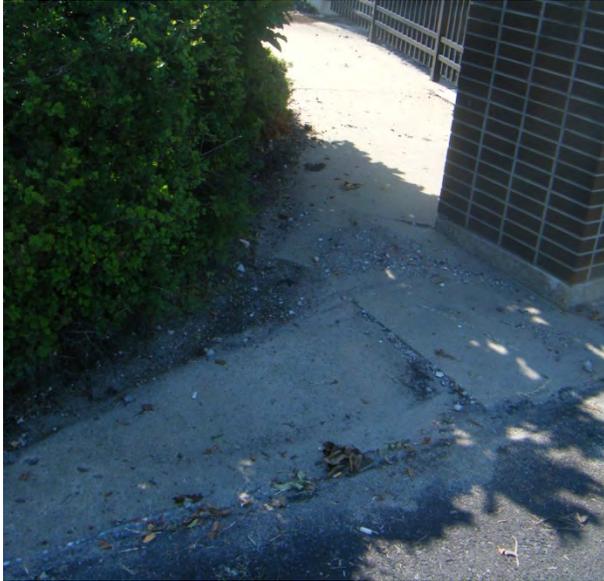
Photo 1

- Refer to site plan included with this report: (A) Stripe (blue paint) a min. 4' wide access path from new ADA parking space to the NW access walk entry point.
Estimated Cost: 100.00
- Refer to site plan included with this report: (B) Repair/replace area of concrete walk (see photo 1 next page) from the parking entrance gate brick masonry pillar to halfway up to the ramp slab (~104 s.f. area).
Estimated Cost: 1,514.00
- Refer to site plan included with this report: (C) Repair/replace three sections of concrete ramp and two sections of access walk leading to the main (north) entrance doors (~96 s.f. area; see photos 2 – 6 next page).
Estimated Cost: 1,454.00

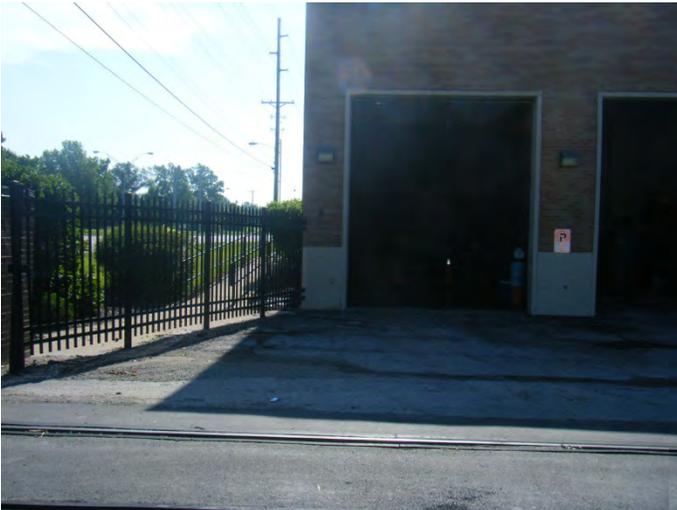
Photo 7

- Refer to site plan included with this report: (1) There are less than 25 total visitor parking spaces. Therefore, ADAAG requires 1 ADA van accessible parking space. Due to the railroad tracks that cross the property drive (see photo 7 below) between the visitor parking area to the west and the concrete sidewalk leading to the main building entry, I recommend installing an ADA van accessible parking space with adjacent access aisle (both parking space and access aisle to be min. 8' wide) near the first (north) open bay door at the west building façade. An ADA parking space was previously existing in this area and according to the building contact, this would likely be the best spot available for an accessible parking space due to the existing conditions elsewhere on the site. Repave the area for proper slopes (no more than 2% in any direction), stripe (blue paint) the new space and install a van access sign at the new space mounted to be 72" above grade. **Estimated Cost: \$2,098.00**
