Agenda Item Number: R 2-15

Re: Public Hearing - Repairs to the Thomas G. Walton Building

Inspection Report

**Energy Conservation Assessment for
Chamber Of Commerce/
Convention and Visitors Bureau/
Office of Cultural Affairs
Thomas Walton Building
300 South Providence Road
Columbia Mo**

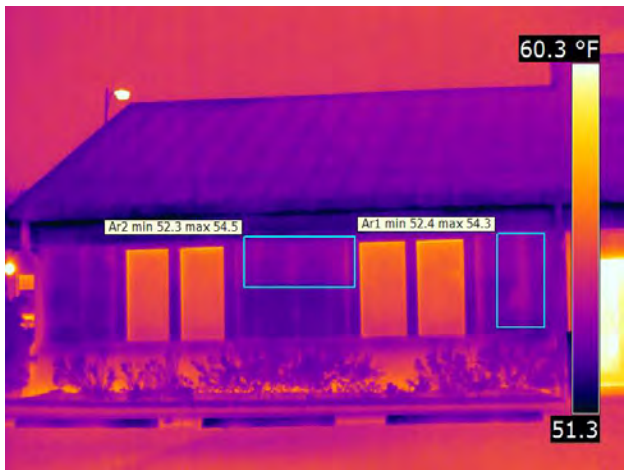
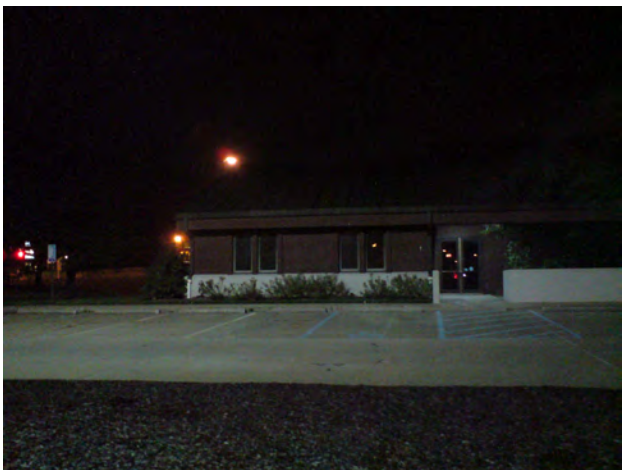
Location: east side of building. Image showing moisure where indicated. See page 2.

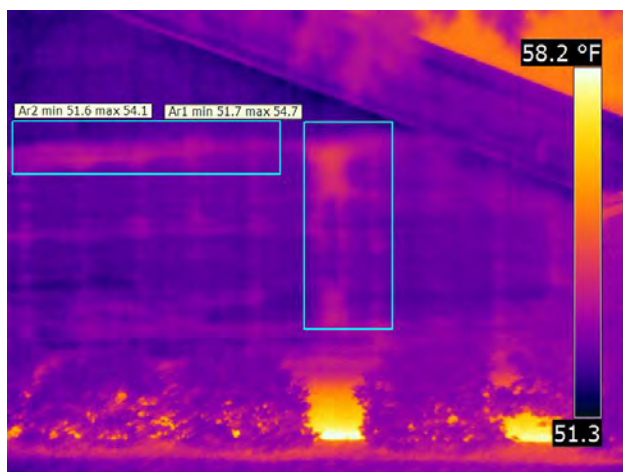
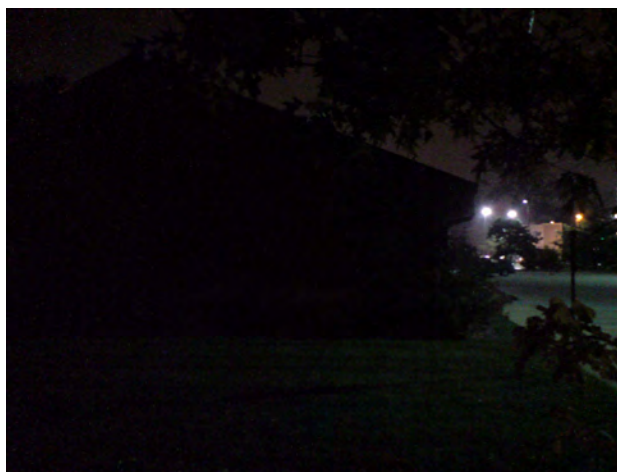
Location: west side of building. Image indicating areas of moisture inside walls. See page 2.

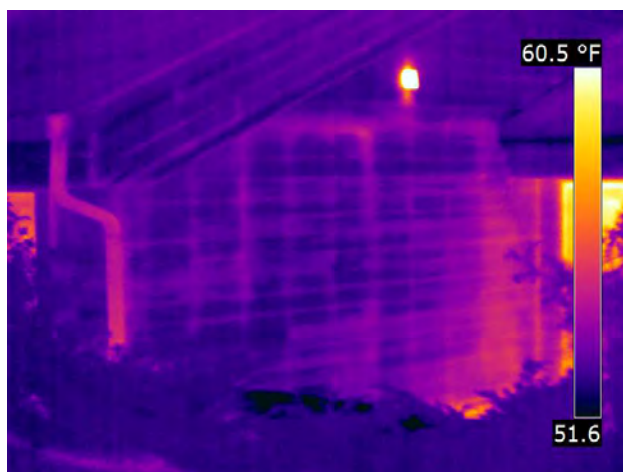
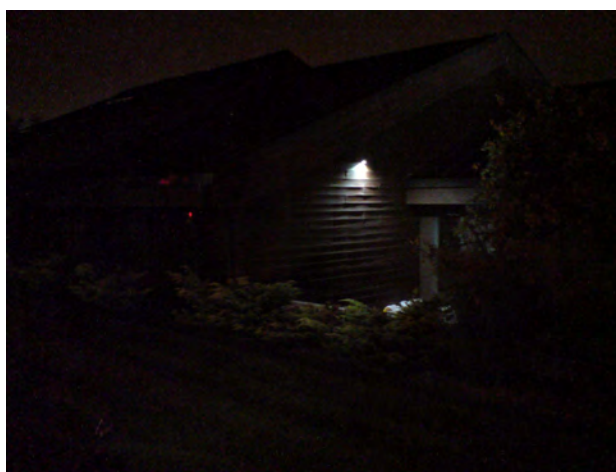
Location: west side of building. Image showing areas with wet insulation.

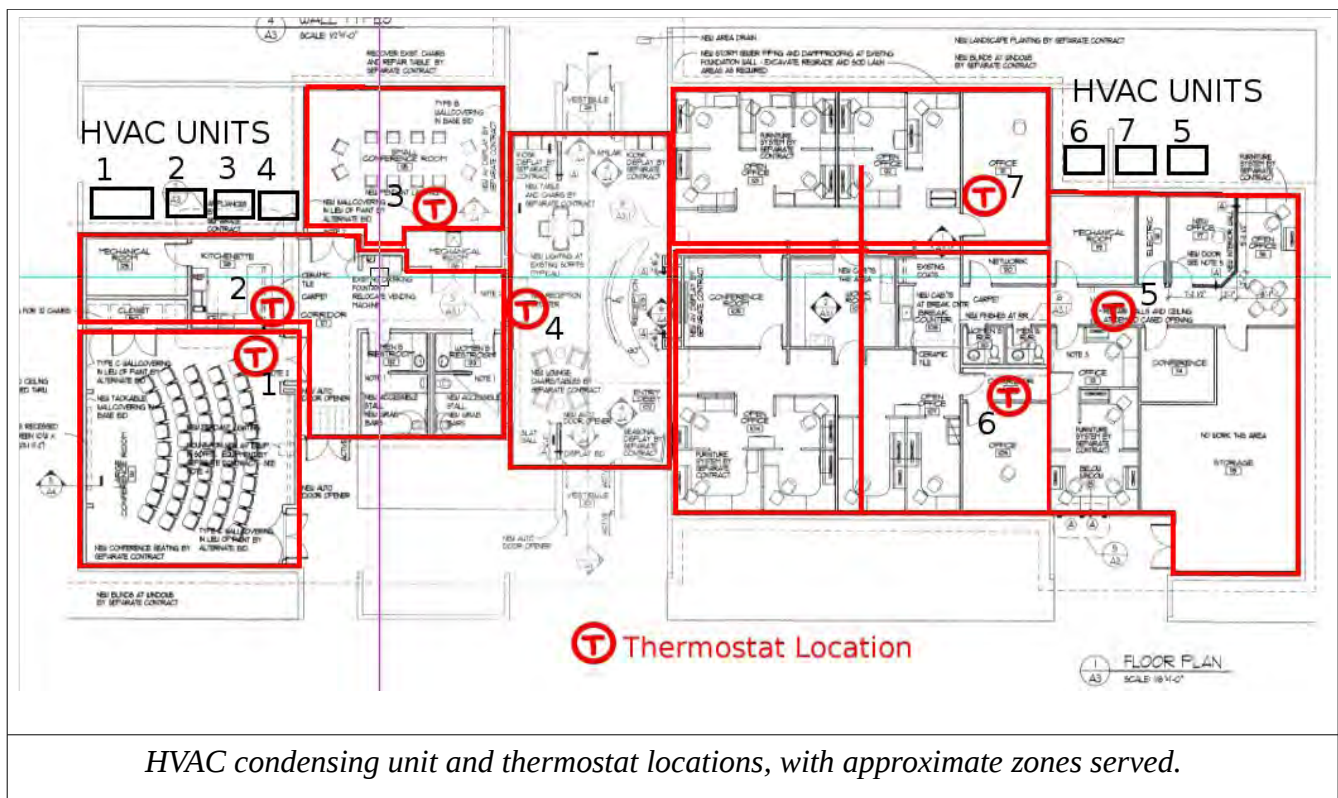
Ms. Ausmus and Ms. Schneider indicated that some parts of the building could feel muggy and that the entry/lobby area could be overheated in summer and cold in winter. It was observed during inspection that significant amounts of insulation are missing from high walls in the attic, which may contribute to the lack of comfort in this room. The height of the room and skylights also contribute to lack of comfort, as skylights can let in excess heat, and height can allow warm air to stagnate in winter.

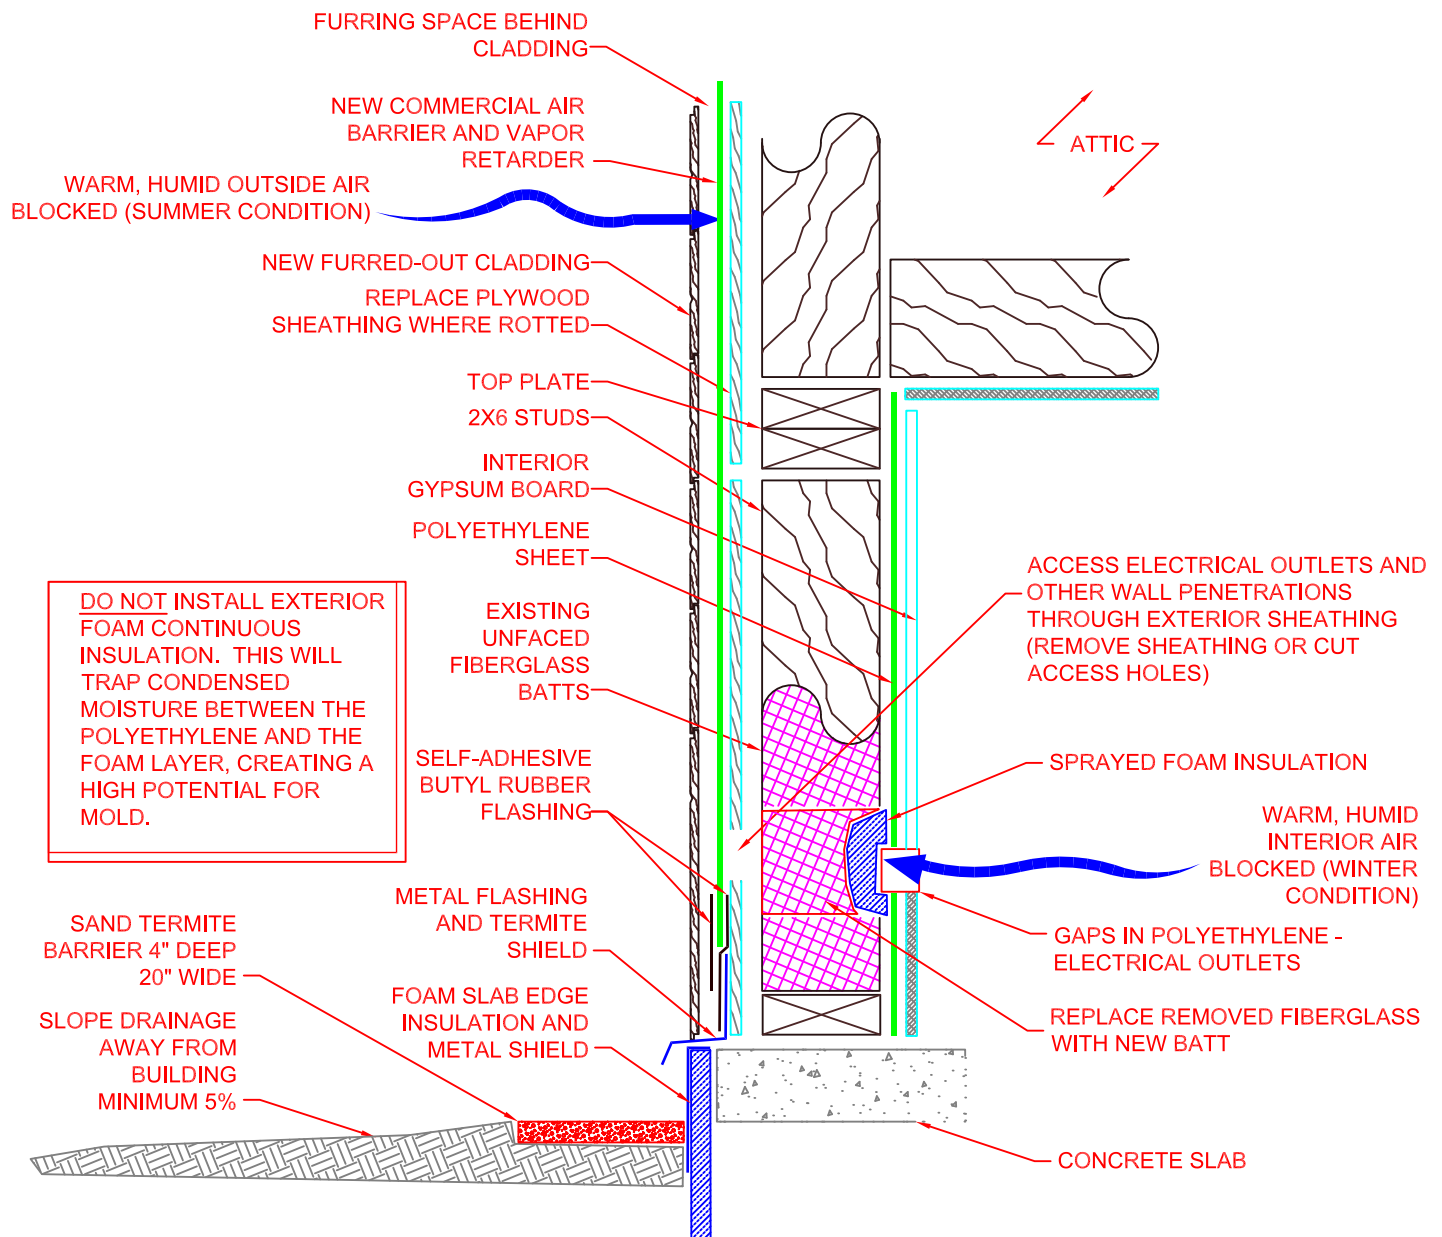
RECOMMENDED EXTERIOR WALL DETAIL

We strongly recommend against installing continuous foam insulation on the outside of the walls under cladding. There is an existing polyethylene barrier on the inside of the walls. This prevents the wall from drying to the interior. An exterior layer with a low permeability will trap moisture between the inner and outer layers. Continuous foam will prevent the wall from drying to the exterior, and increase the likelihood of mold growth within the walls, creating a safety hazard. See ECM #9, below.
