Re: Public Hearing - Repairs to the Thomas G. Walton Building

WALTON BUILDING EXTERIOR RENOVATION DESIGN OPTIONS

Inspection Report

**Energy Conservation Assessment for
Chamber Of Commerce/
Convention and Visitors Bureau/
Office of Cultural Affairs
Thomas Walton Building
300 South Providence Road
Columbia Mo**

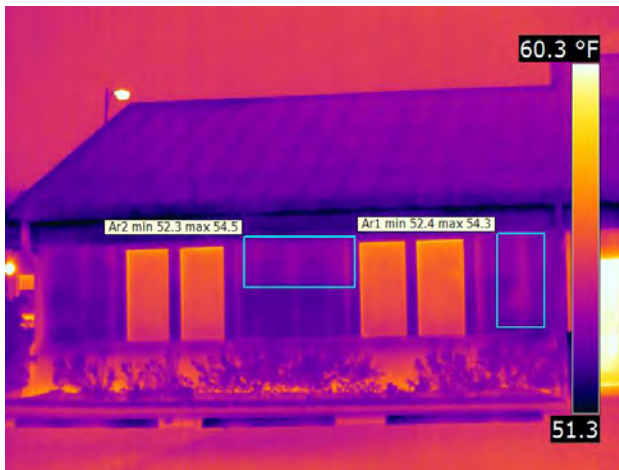
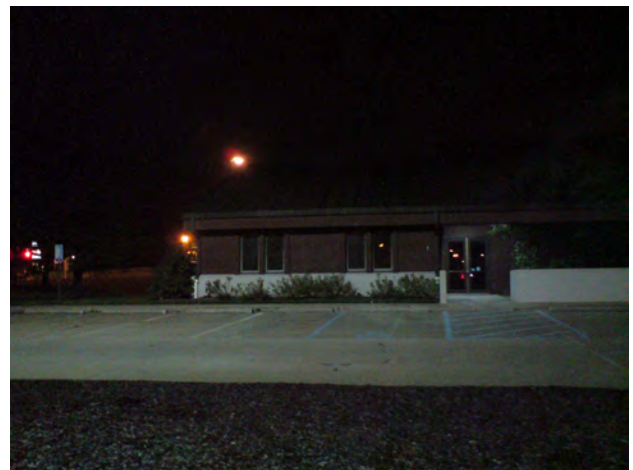
Description
Location: east side of building. Image showing moisure where indicated. See page 2.

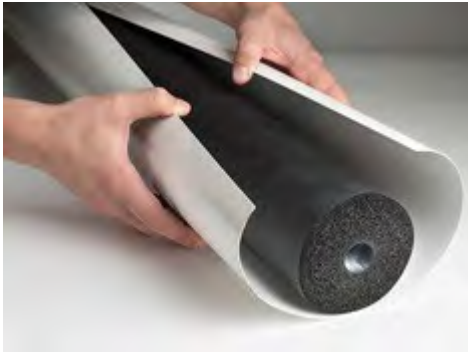
*Adding a sunlight resistant cover to HVAC refrigeration pipe insulation will increase its life. Product shown is Aerocel Saniguard
<http://www.aeroflexusa.com/products/saniguard/>*

It is estimated that about 800 KWHr per cooling season is being wasted by these uninsulated pipes, and they also rob the HVAC of capacity. This means the HVAC cannot deliver full cooling where it is needed. An estimate of the annual energy cost of the uninsulated pipes is about \$87. Repairing the pipes when the serviceman is already on the job doing a seasonal check would cost about \$70, making the payback on this measure 0.8 years or one cooling season. The technician should install a cover on the insulation that will resist sunlight.
