# Facility: Columbia Cosmopolitan Recreation Area

Address: 1615 Business Loop 70W      Date of Survey: 04/19/10 - 05/04/10

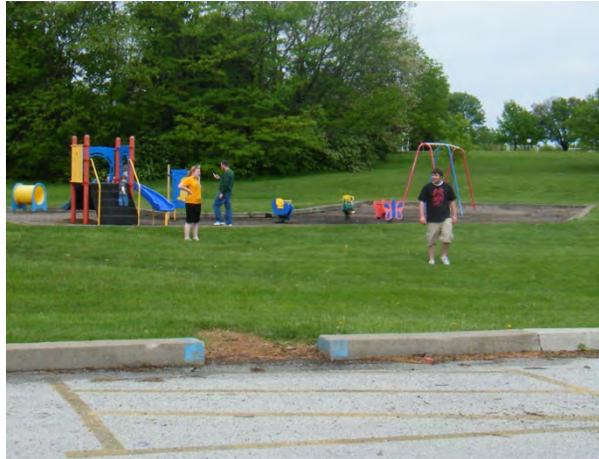
Photo 12

**Estimated Cost: \$1,037.00**
- Refer to site plan included with this report: (15) Install a min. 4' wide concrete or asphalt path (~57 linear feet long) from the existing open curb section (see photo 12 above) to the playground for wheelchair access. New path should have a max. slope of 5% as much as is feasible and a max. cross-slope of 2%.

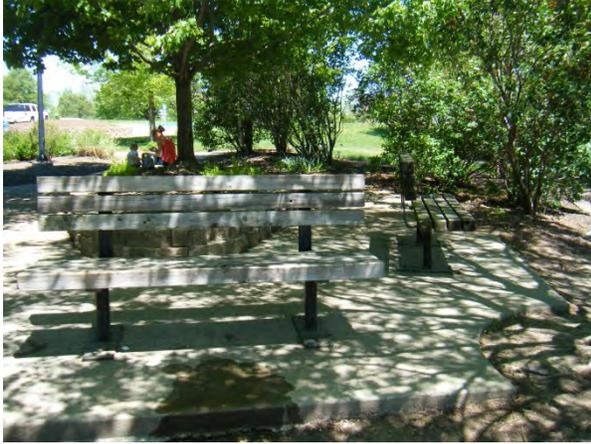
Photo 19

- Refer to site plan included with this report: (23) Extend one corner of the existing concrete pad at the fixed seating area so that a level pad (min. 3'x4') for wheelchair seating is integrated into the seating area (see photo 19 next page). Concrete pad shall have a max. slope and cross-slope of 2%.  
**Estimated Cost: \$546.00**

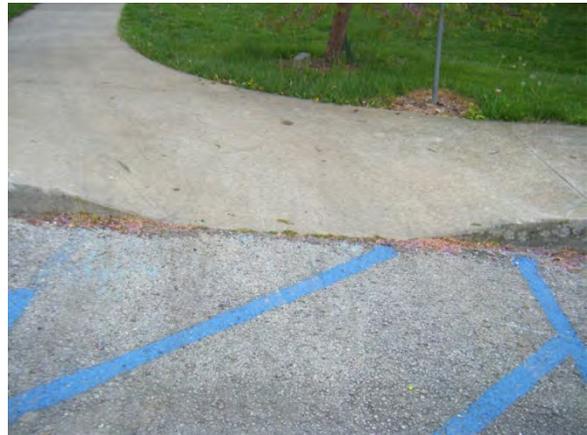
Photo 29

- Refer to site plan included with this report: (28) The existing curb-cut at the access aisle is not tactile or contrasting and flared sides within the sidewalk are greater than ADA maximum slope of 8.33% (see photo 29 above). Replace curb-cut with a contrasting truncated dome ADAAG compliant curb-cut.

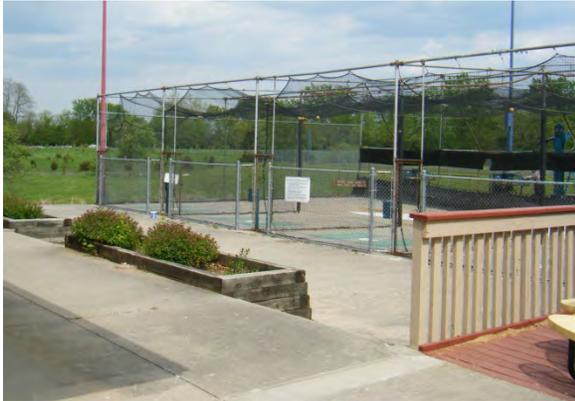
Photo 33

- Refer to site plan included with this report: (32) Install wood ramp with handrails on both sides that meets ADAAG 4.8 for wheelchair access down to the batting cage area (see photo 33 next page). **Estimated Cost: \$6,240.00**
- Refer to site plan included with this report: (33) Install wood handrails that meet ADAAG 4.8.5 on both sides of an existing ~46' long section of concrete leading to the playground area due to slopes between 5.6% - 9.5% at this section of walk (see photo 34 next page). **Estimated Cost: \$3,615.00**

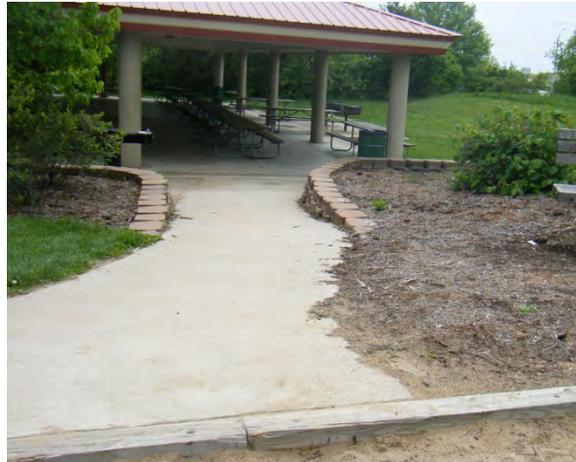
Photo 36

- Refer to site plan included with this report: (35) Install wood handrails that meet ADAAG 4.8.5 on both sides of an existing ~30' long section of concrete leading to the volleyball court due to slopes greater than 5% at this section of walk (see photo 36 above).  
**Estimated Cost: \$2,495.00**
- Refer to site plan included with this report: (36) Install galvanized metal handrails that meet ADAAG 4.8.5 on both sides of an existing ~15' long section of concrete ramp leading to the Harris Shelter due to slopes up to 7.5% (see photo 37 next page).  
**Estimated Cost: \$2,675.00**
