Facility: Douglass Park & Pool

Address: 416 N. Providence Road

Date of Survey: 06/01/10 & 06/02/10

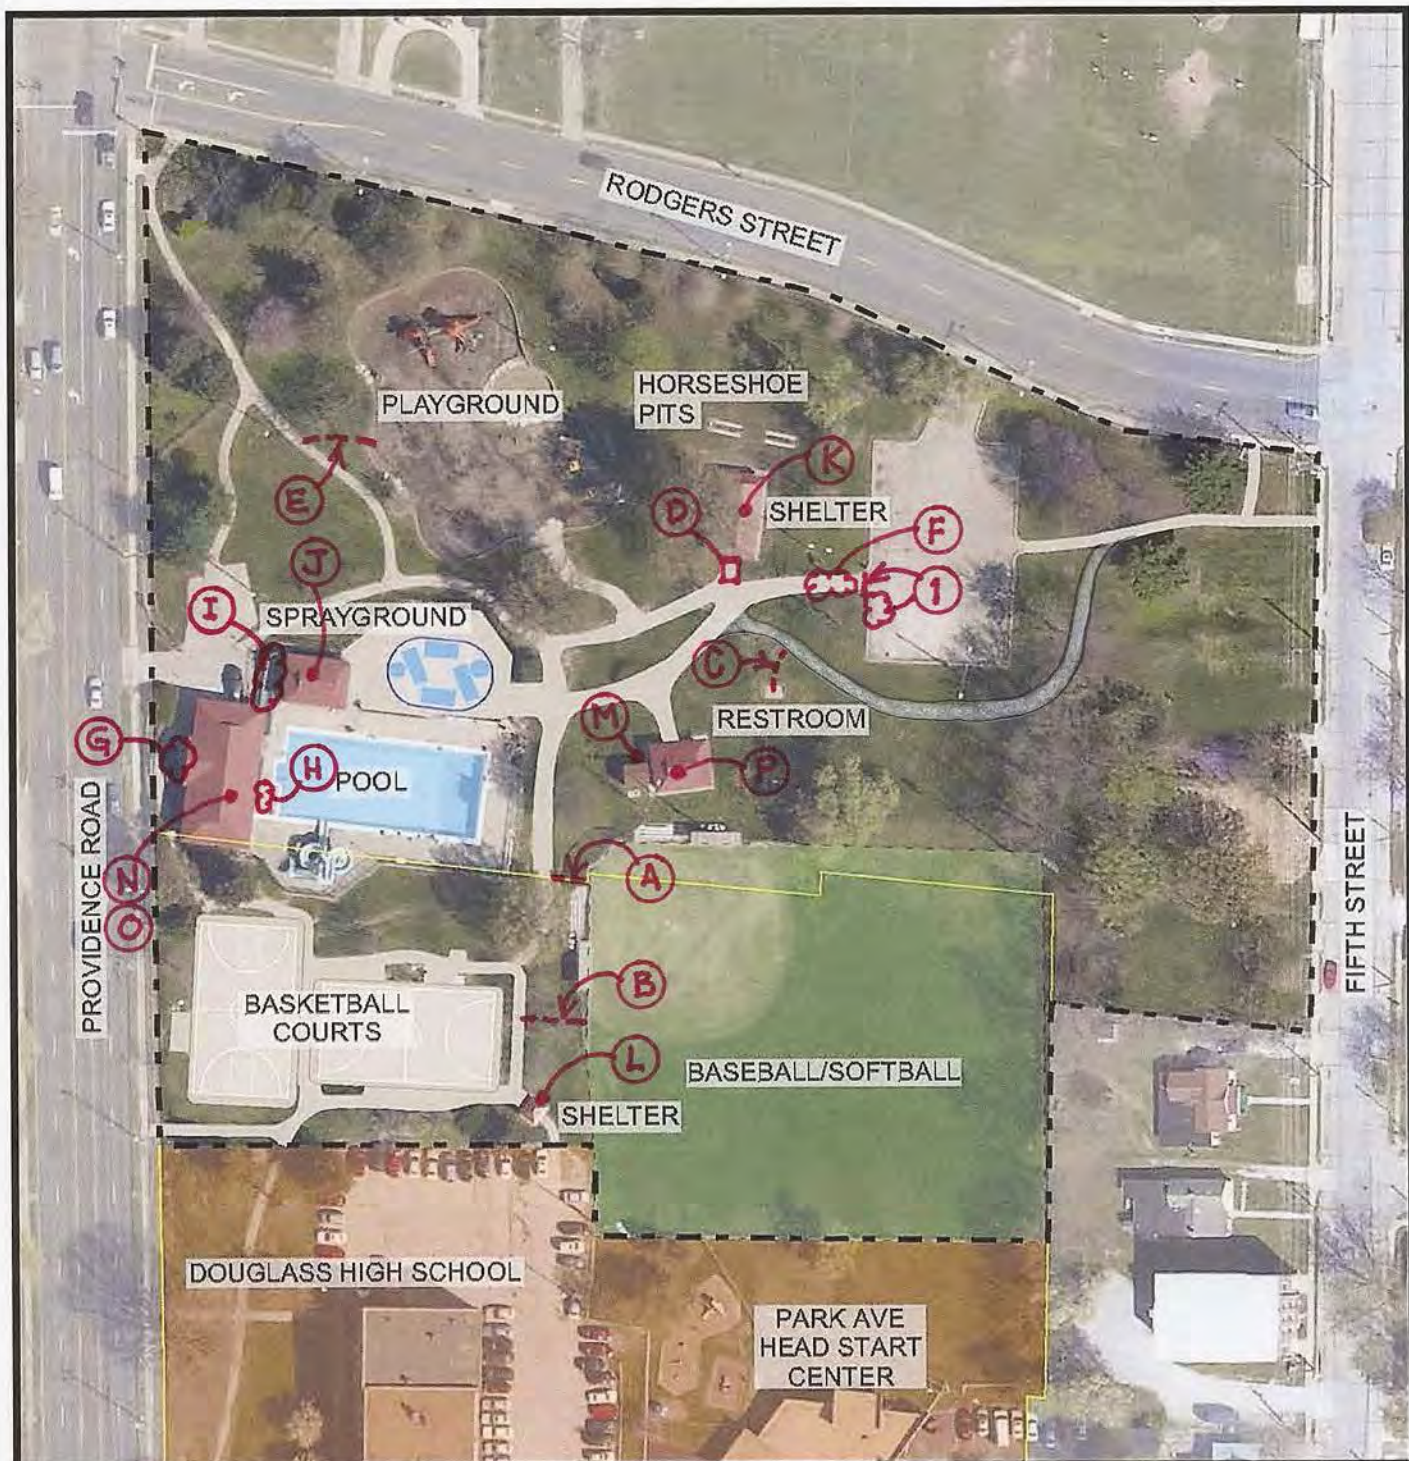
DOUGLASS PARK & POOL FACILITIES

- Refer to site plan included with this report: (A) Add a concrete or asphalt access path from existing sidewalk to ball field seating area (~ 12 linear feet of 4' wide walk with slope no greater than 5% as much as is feasible and cross-slope no greater than 2%).
Estimated Cost: \$758.00
- Refer to site plan included with this report: (B) Add a concrete or asphalt access path from existing sidewalk to one ball field gate (~ 33 linear feet of 4' wide walk with slope no greater than 5% as much as is feasible and cross-slope no greater than 2%).
Estimated Cost: \$1,246.00
- Refer to site plan included with this report: (C) Add a concrete or asphalt access path from existing sidewalk to batting cage area (~ 20 linear feet of 4' wide walk with slope no greater than 5% as much as is feasible and cross-slope no greater than 2%).
Estimated Cost: \$944.00

- Refer to site plan included with this report: (D) Replace existing 16' long walk up to shelter due to slopes up to 7.3% with new longer lower slope (max. 5% slope as much as is feasible and max. 2% cross-slope) access walk (~ 22' long x 4' wide). **Estimated Cost: \$1,140.00**

- Refer to site plan included with this report: (E) Add a concrete or asphalt access path from existing sidewalk to the playground area (~ 40 linear feet of 4' wide walk with slope no greater than 5% as much as is feasible and cross-slope no greater than 2%) due to excessive slope of existing concrete ramp into the playground area. **Estimated Cost: \$1,408.00**

- Refer to site plan included with this report: (F) Repair several sections of damaged concrete walk just west of the accessible parking spaces and install contrasting truncated dome detectable warning surface where concrete walk intersects with parking lot (see photo 1 below). **Estimated Cost: \$2,061.00**

- Refer to site plan included with this report: (G) Existing ramp (see photo 2 below) up to the pool facility entrance door slopes up to 10.7% (ADAAG max. allowed is 8.33%), has no handrails and does not have proper sized landing at the door. Remove existing ramp and install new concrete ramp with galvanized handrail system that meets ADAAG 4.8 (~ 20' long x 6' wide ramp).

- Refer to site plan included with this report: (H) Existing concrete ramp (see photo 3 below) at pool deck does not have handrails mounted between 34" – 38" above grade on both sides of the ramp as required by ADAAG 4.8.5. Install 1.5" diameter galvanized metal handrails on both sides of ramp (~ 28 linear feet of new handrail).

- Refer to site plan included with this report: (I) At existing wood ramp (see photo 4 below) up to pool shelter, replace ~ 5% - 10% of the wood ramp decking due to cupping and deterioration, add a min. 2" high wood curb at each side of the ramp surface (~ 56 linear feet of curbing), install 1.5" dia. wood handrails at 34" – 38" above grade on both sides of the ramp (~ 56 linear feet of railing) and modify the ramp landing to provide ADAAG required 5' square level landing.
