# Facility: MLK Jr. Memorial at Battle Garden

Address: 800 W. Stadium Blvd.

Date of Survey: 04/18/10

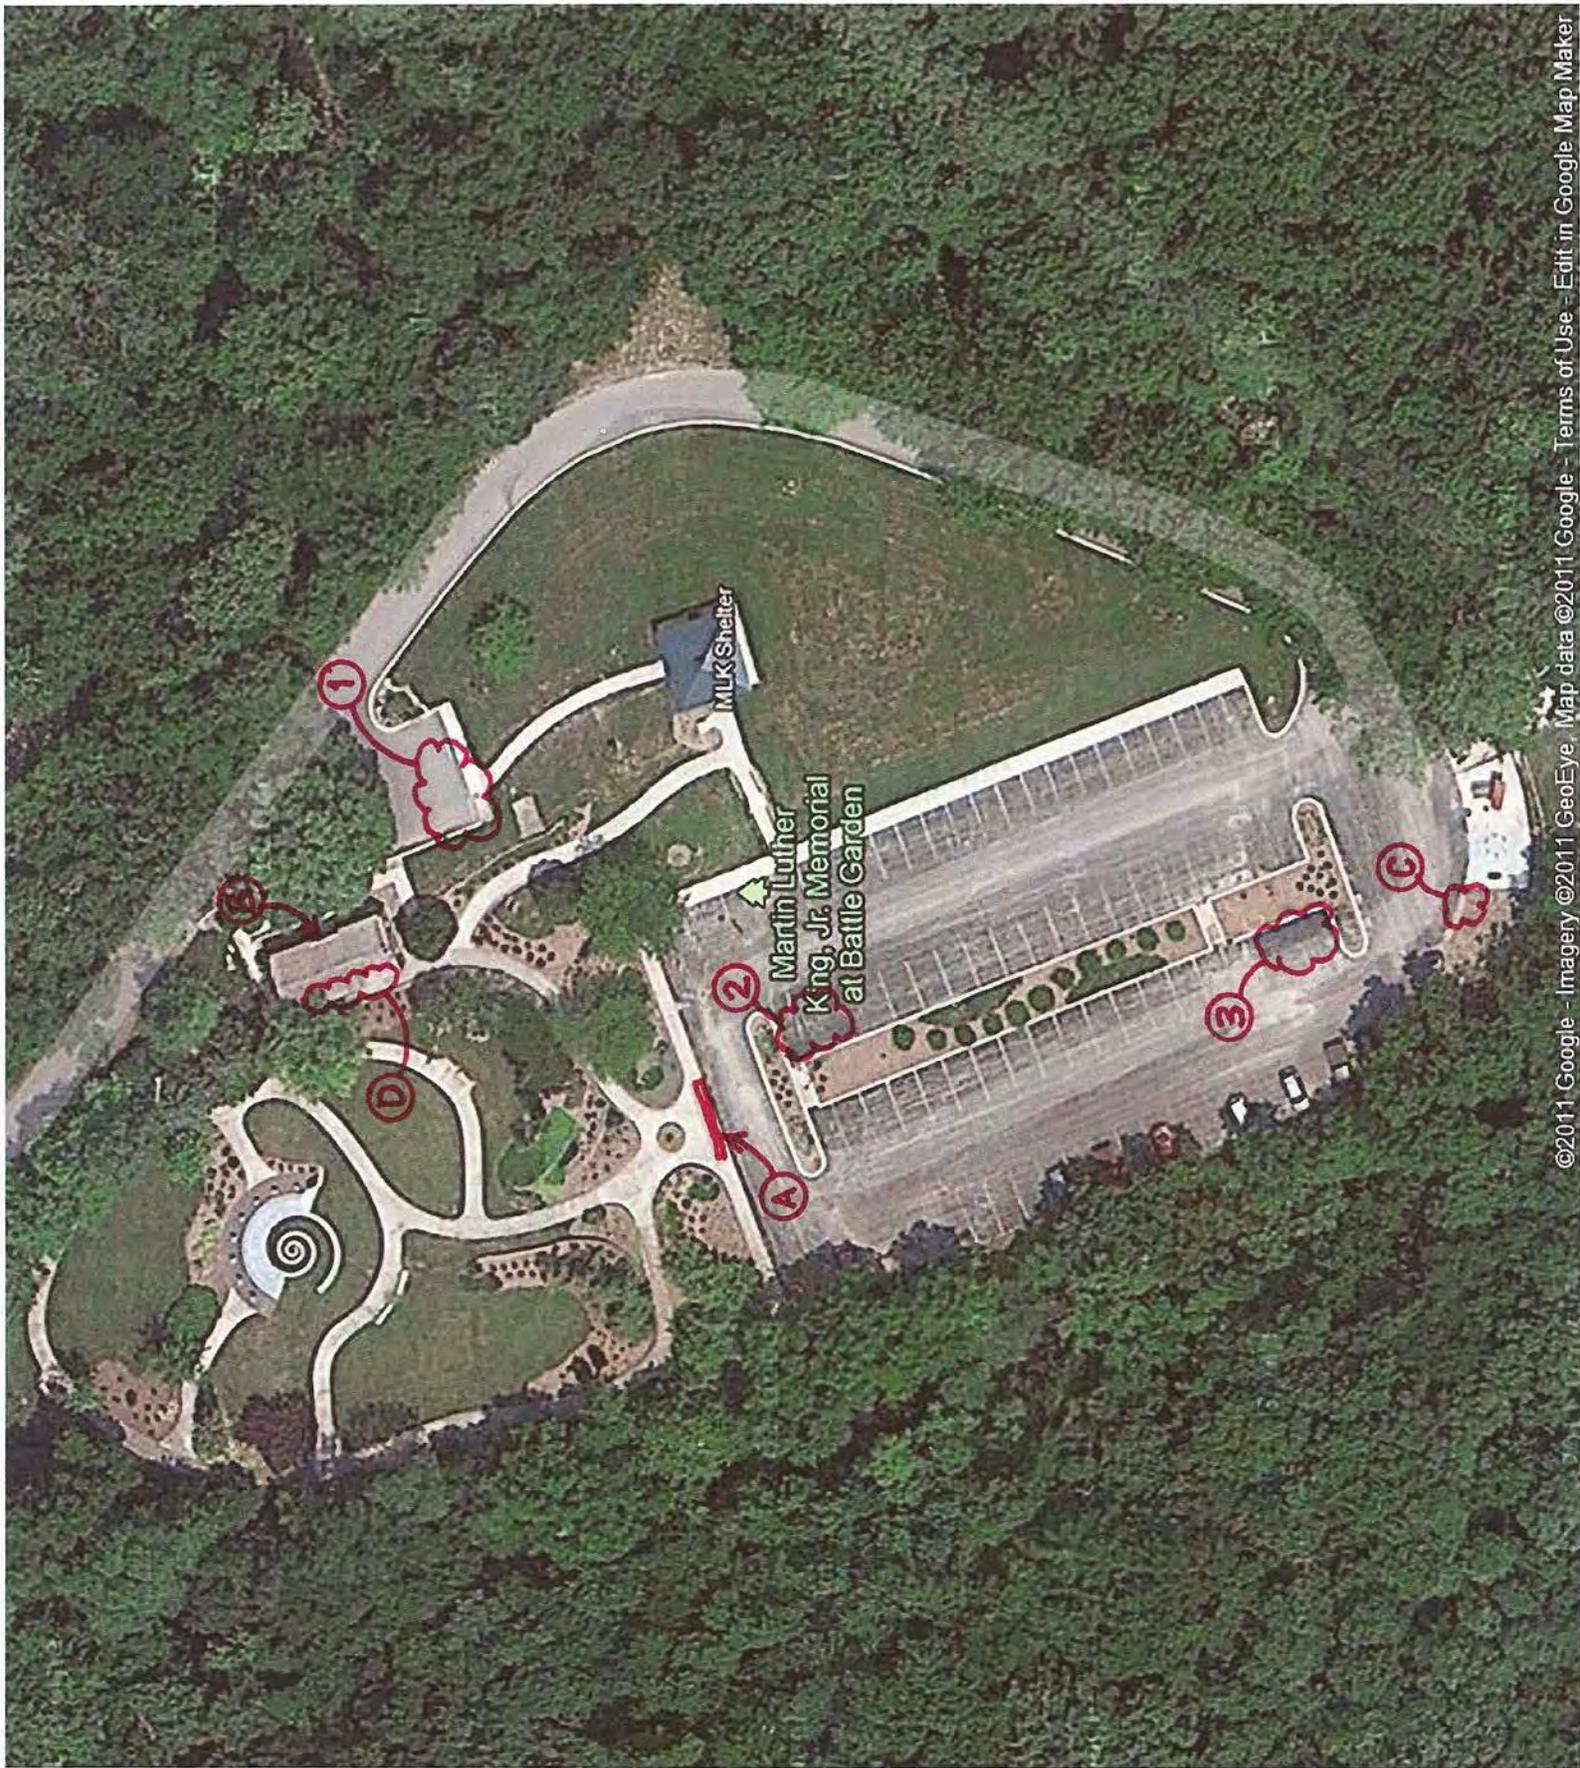
- Refer to site plan included with this report: (1) Two ADA parking spaces in upper lot near the Audubon Society Museum have cross-slopes up to 4%. Repave the spaces for cross-slope not exceeding 2% and restripe.

- Refer to site plan included with this report: (2) Two existing ADA parking spaces are sized properly, but the blue paint striping needs to be re-applied, the existing sign needs to be moved to one ADA space and mounted at 72" above grade and one new sign needs to be added at other ADA space.

- Refer to site plan included with this report: (3) Two existing ADA parking spaces are sized properly, but the blue paint striping needs to be re-applied, the existing sign needs to be moved to one ADA space and mounted at 72" above grade and one new sign needs to be added at other ADA space.

- Refer to site plan included with this report: (A) Install a minimum 3' deep strip of contrasting truncated dome detectable warning surface across the entire width of the sidewalk intersection with the parking lot (see photo 2 below).

- Refer to site plan included with this report: (B) Install wall-mounted handrail on both sides of ramp (existing guardrail does not meet ADAAG 4.8.5 requirements for handrails – see photo 3 below). Handrails shall be 1.5” diameter, be continuous along the gripping surface and mounted between 34” & 38” above the ramp surface. **Estimated Cost: \$1,340.00**

- Refer to site plan included with this report: (C) Replace the non-wheelchair accessible portable toilet unit located at the south end of the main parking lot near the MKT trail access point (cost unknown).

- Refer to site plan included with this report: (D) Men's Restroom in lower level of the Audubon Society Museum Building – Install a braille/tactile ADA restroom sign at 60" a.f.f.at the latch side of the entry door, replace the non-accessible lavatory (see photo 4 next page) with an ADA compliant lavatory mounted no higher than 34" a.f.f. with minimum knee clearances meeting ADAAG 4.19, lower mirror to be no higher than 40" a.f.f. to bottom reflective edge, lower one urinal so that the front lip is no higher than 17" a.f.f., reconfigure the toilet stall to meet ADAAG Fig. 30 (b) 36" wide alternate stall (includes moving and/or lowering the toilet fixture as necessary) and modify shower to meet ADAAG 4.21 and Fig. 35 (b) (lower controls, install an additional fixed shower head at 48" a.f.f. and install proper grab bars). **Estimated Cost: \$4,459.00**

- Refer to site plan included with this report: (D) Women's Restroom in lower level of the Audubon Society Museum Building – Install a braille/tactile ADA restroom sign at 60" a.f.f.at the latch side of the entry door, replace the non-accessible lavatory (see photo 4 next page) with an ADA compliant lavatory mounted no higher than 34" a.f.f. with minimum knee clearances meeting ADAAG 4.19, lower mirror to be no higher than 40" a.f.f. to bottom reflective edge, reconfigure the toilet stall to meet ADAAG Fig. 30 (b) 36" wide alternate stall (includes moving and/or lowering the toilet fixture as necessary and removing a minimum of 2" of the concrete masonry unit stall divider wall to allow for minimum of 42" access path to the toilet stall) and modify shower to meet ADAAG 4.21 and Fig. 35 (b) (lower controls, install an additional fixed shower head at 48" a.f.f. and install proper grab bars). **Estimated Cost: \$4,059.00**
