CONDITION ASSESSMENT REPORT

Well Field, McBaine Water Treatment
Plant, and West Ash Booster Pump
Station

B&V PROJECT NO. 188264

Columbia Missouri Water and Light

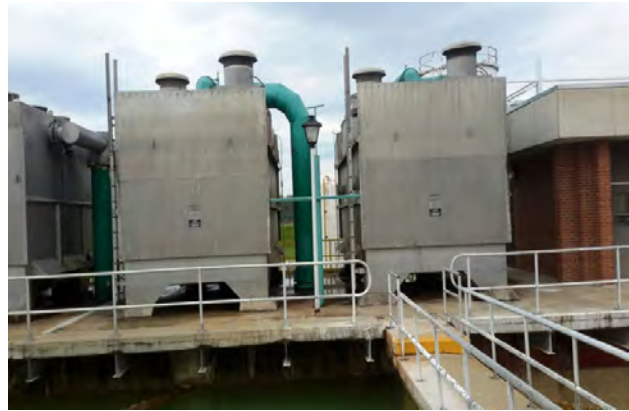
Aerators No. 1 and No. 2

Differences in influent piping configuration between the original two aerators and the aerators installed during the first and second plant expansions result in hydraulic imbalances and inability to distribute flow equally between all in-service units. This reduces aerator performance efficiencies, as a majority of the total flow treated is handled by only two of the four existing units. Internal packing in all aerators has been removed due to fouling problems attributed to excessive deposition of iron precipitates. Fouling of the packing was observed within several weeks after initial installation. While some removal of carbon dioxide (CO₂) is achieved as the water cascades downward through the unequipped aerator shells as indicated by the observed increase in pH between the aerator influent and discharge, it would be expected that performance is less efficient than typically achieved by aerators equipped with well-designed internal baffling and flow distribution.

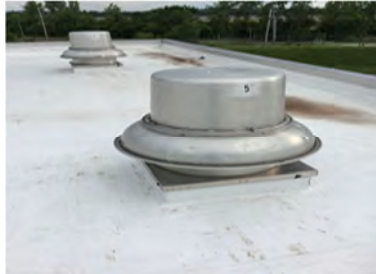
A heat pump unit connected to the Operations Building system serves the 1993 pipe gallery and tunnel. A dehumidification unit was part of the original design for the lower level pipe gallery; modifications appear to have been made by the staff over the years, however only a fan box appears to be functional at present. Portable ductless dehumidification units have been installed by the staff in recent years and appear to be functioning.

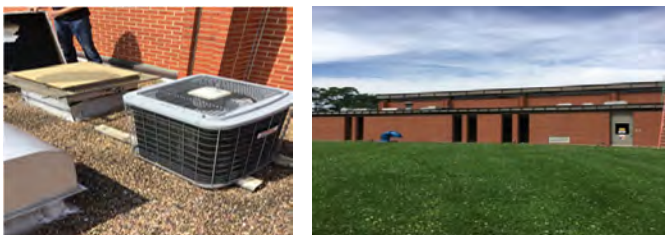
The air conditioning system serves the control room and restroom and consists of an air handling unit suspended overhead in the janitor's room and distribution ductwork. The original unit rejected heat to the pump room; it has been replaced with a traditional DX split system unit with a condensing unit located on the roof. The roof has two levels; the condensing unit is on the lower roof.

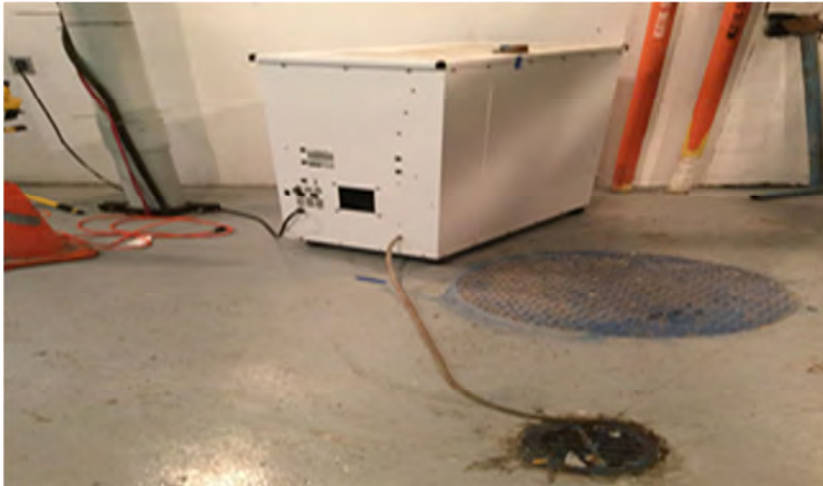
Staff has installed portable ductless dehumidification units on the lower levels of the pump station. One was operational and the other was not.
