Facility: Columbia Regional Airport

Address: 11300 S. Airport Drive Date of Survey: 01/05/10

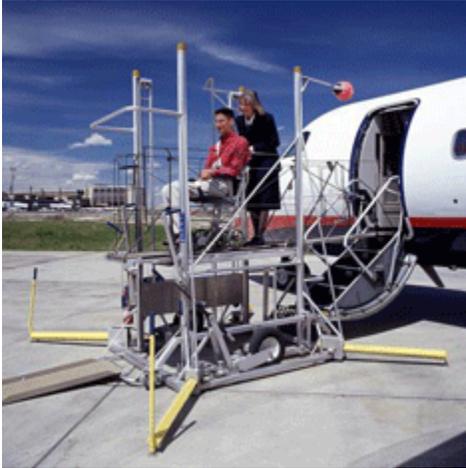
Photo 7

- A means of wheelchair access is required for planes with a seating capacity of 31 or more per Federal Regulations by the DOT (49 CFR Part 27 – Nondiscrimination on the Basis of Disability in Air Travel effective June 04, 2001). Per conversation with Airport management staff, they do provide a mechanical means of access to their aircraft for persons with disabilities. I did not see firsthand the method or equipment used at this airport and the federal regulations are not specific on what would be considered an acceptable means of providing such access, but it is likely that the use of a mechanical lift, portable ramp or accessible jetway structure or boarding bridge would be required and considered to be acceptable. It is recommended that the management staff along with a group of individuals with disabilities review the current means of access to these aircraft to determine if it is acceptable. Should it be determined that the current means of wheelchair access is not ADA compliant, safe and/or user friendly, they may want to consider several other options that would be available. A manually powered wheelchair lift (see photo 7 next page) designed specifically for use on a tarmac and with the type of aircraft that flies in and out of Columbia will cost around \$30,000. A better solution might be a mobile accessible passenger

boarding ramp (see photo 8 below) which costs around \$19,000 - \$24,000 depending on the options required or desired. For the purposes of this survey, I have not figured any costs at this time.

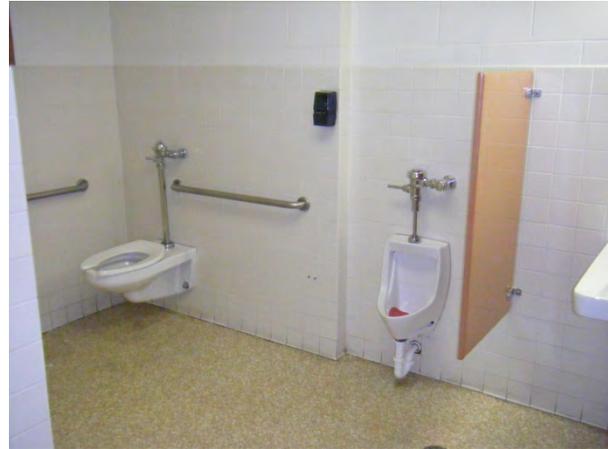
Photo 10

- Refer to building plan included with this report: (I) South Men's Restroom: Relocate the existing braille/tactile ADA restroom sign on the door (or provide a new sign) and mount at the latch side of the door and mounted to be 60" from floor to centerline of the sign, remove the door closer due to the lack of required 12" latch side clearance at corridor side door entry area, install a small section of grab bar on the side of the tall flush valve that has no grab bar at this time in order to meet ADAAG Fig. 29 (a) or lower flush valve so that a single 36" long grab bar can be installed (see photo 10 above), lower the existing urinal at least 1/2" so that the front rim is no higher than 17" a.f.f. and insulate the pipes below the lavatory. **Estimated Cost: \$944.00**
