Facility: Albert Oakland Park & Pool

Address: 1900 Blue Ridge Blvd. Date of Survey: 06/06/10

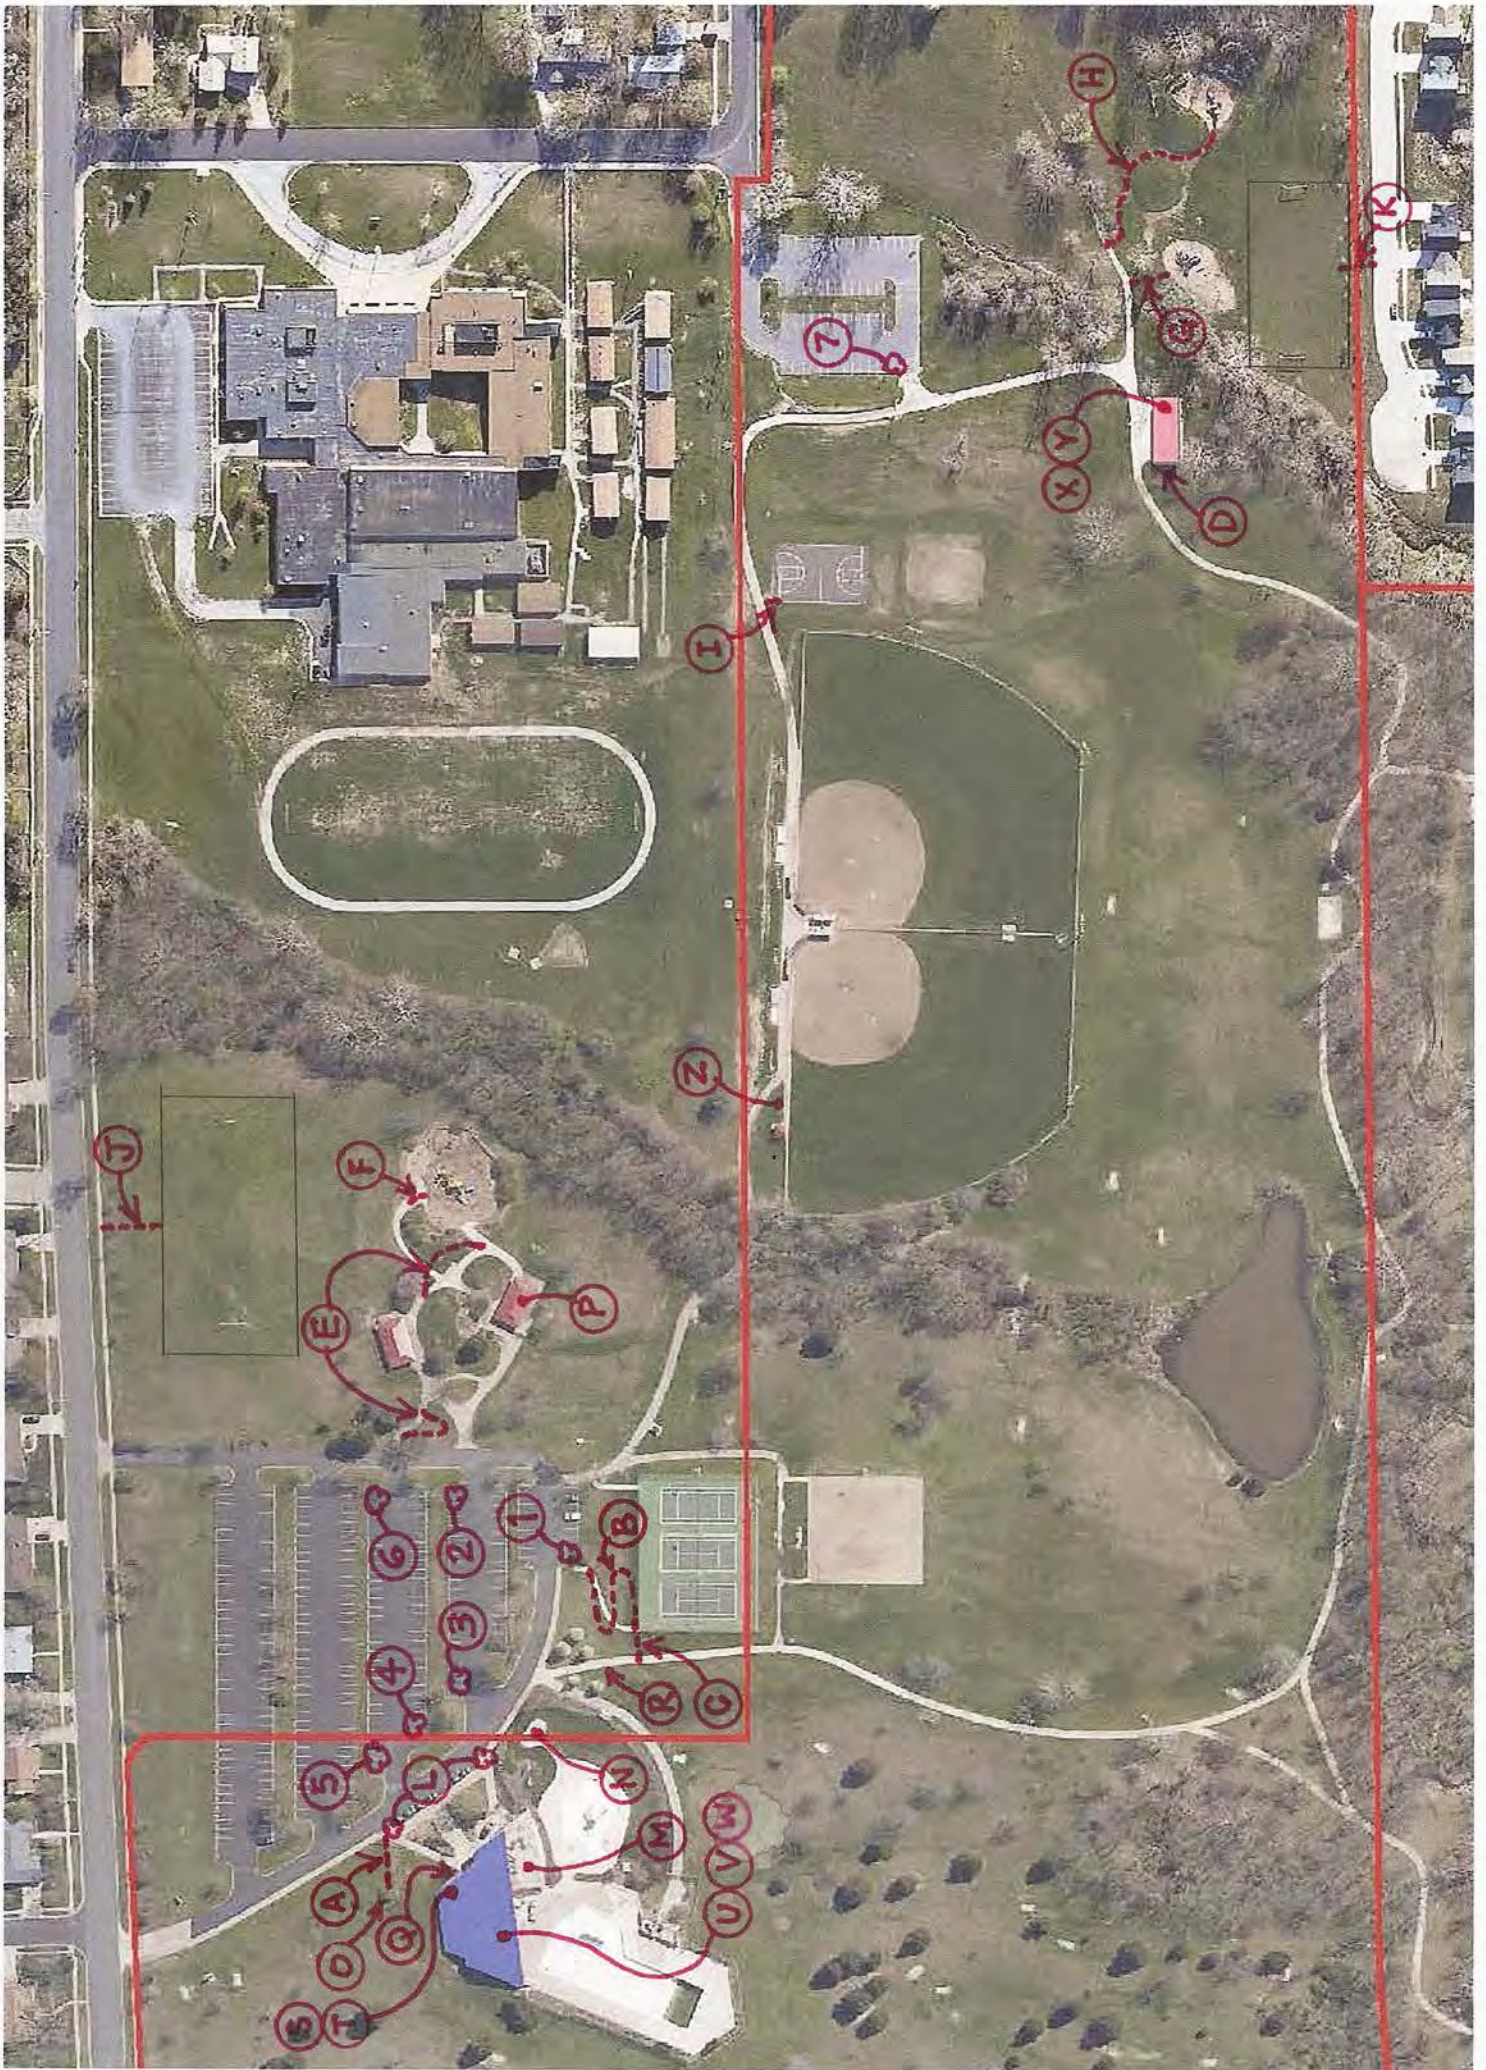
ALBERT OAKLAND PARK

- Refer to site plan included with this report: (A) Add a concrete or asphalt access path from existing sidewalk up to small shelter NW of the pool facility (~ 21 linear feet of 4' wide walk with slope no greater than 5% as much as is feasible and cross-slope no greater than 2%). **Estimated Cost: \$967.00**

- Refer to site plan included with this report: (B) A portion of this existing walk has slopes and cross-slopes exceeding the ADAAG maximums. In order to improve these areas with replacement concrete pathways that have a max. slope of 5% and a max. cross-slope of 2% as much as is feasible due to the existing grades, I have recommended that the trouble areas be removed and installing the new path at 5% or less by installing a longer "switch-back" or "serpentine" walk to allow for shallower slopes leading to the tennis court entrance area . In order to make these areas more accessible and closer to the ADA acceptable slope of 5% and cross-slope of 2% for walks, it is likely that the area will need to be surveyed by a land surveyor to establish the existing topography and determine how best to modify the existing grades to accommodate lesser slopes at the path

- Refer to site plan included with this report: (C) Install a 4' wide concrete access path from the new walk to tennis court over to the existing sidewalk that leads to the volleyball access path. Path shall have slope not exceeding 5% as much as is feasible and cross-slope not exceeding 2%. **Estimated Cost: \$1,130.00**
- Refer to site plan included with this report: (D) Install a min. 4'x6' concrete pad at the Shelter No. 1 BBQ grill for wheelchair access (see photos 1 below). **Estimated Cost: \$620.00**

- Refer to site plan included with this report: (E) There are several areas (as shown on site plan) where the slopes and cross-slopes exceed the ADAAG maximums for an extended length of pathway. In order to improve these areas with replacement concrete pathways that have a max. slope of 5% and a max. cross-slope of 2% as much as is feasible due to the existing grades, I have recommended that the trouble areas be removed and installing the new path at 5% or less by installing a longer "switch-back" or "serpentine" walk to allow for shallower slopes leading to the shelters and playground access walks. In order to make these areas more accessible and closer to the ADA acceptable slope of 5% and cross-slope of 2% for walks, it is likely that the area will need to be surveyed by a land surveyor to establish the existing topography and determine how best to modify the existing grades to accommodate lesser slopes at the path area in question. For these areas, I have estimated that a total of 720 s.f. of 6' wide sidewalk has excessive slope or cross-slope. In order to go back with new paths of lesser slope, I have figures removal and replacement of 1,200 s.f. of sidewalk. **Estimated Cost: \$8,846.00**

- Refer to site plan included with this report: (F) Existing concrete ramp into the playground is up to 12.1% slope which greatly exceeds maximum walk or ramp slopes in ADAAG. Replace existing ramp into playground with new concrete walk extending further into the playground. Walk shall have slope not exceeding

- Refer to site plan included with this report: (3) There are four existing ADA spaces in this parking area, but there is only one access aisle. Slopes of spaces are up to 5.9% and cross-slopes are up to 3.8%. Because of the slope issues, the fact that parking areas 4 & 5 provide accessible parking to the pool facility and because the total amount of ADA spaces in the NW lot well exceeds the minimum required number of spaces per ADAAG, I recommend that these four non-compliant ADA spaces be eliminated and changed over to standard non-ADA parking spaces (re-stripe with white paint). **Estimated Cost: \$92.00**

- Refer to site plan included with this report: (6) There are four existing ADA spaces in this parking area, but there is only one access aisle. Slopes of spaces are up to 5.2% and cross-slopes are up to 4.8%. Because of the slope issues and because the total amount of ADA spaces in the NW lot well exceeds the minimum required number of spaces per ADAAG, I recommend that these four non-compliant ADA spaces be reduced down to two min. 8' wide ADA parking spaces with a shared min. 5' wide access aisle. Repave the two remaining ADA spaces for proper slopes, restripe, and add one additional ADA parking sign mounted at 72" above grade. **Estimated Cost: \$1,074.00**

- Refer to site plan included with this report: (L) Replace two non-compliant curb ramps at the drive near the pool facility (see photos 4 & 5 below) with new contrasting truncated dome curb ramps.
