# Facility: Stephens Lakes Park

Address: 2001 E. Broadway      Date of Survey: 05/06/10

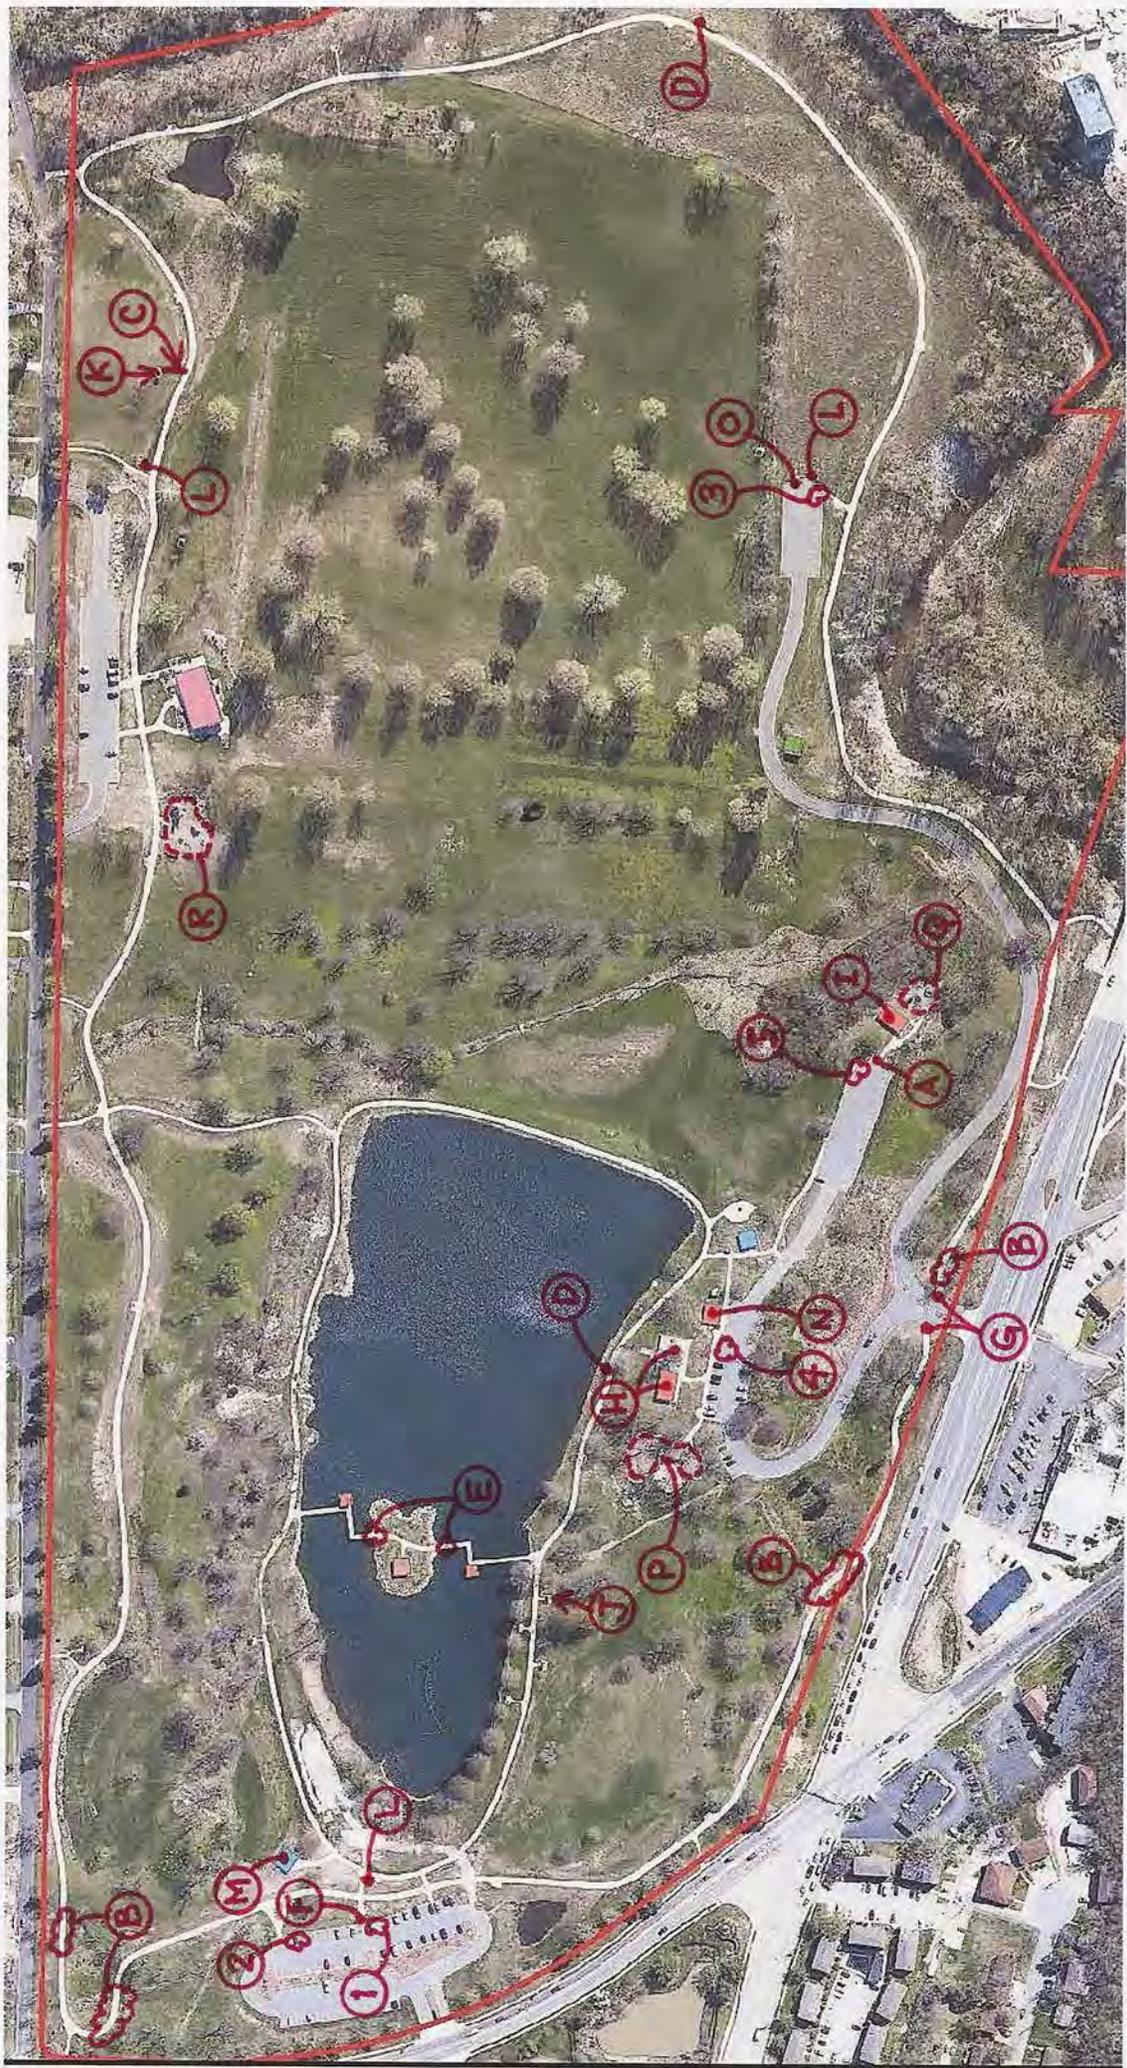
# STEPHENS LAKE PARK

- Refer to site plan included with this report: (A) Patch/fill gap between parking lot and sidewalk that leads to the Happy Hollow Shelter (see photo 1 below).

- Refer to site plan included with this report: (B) A majority of the concrete walking path around the perimeter of the park site has slopes below 5% and cross-slopes below 2%. There are several areas (as shown on site plan) where the slopes and cross-slopes exceed the ADAAG maximums for an extended length of pathway. In order to improve these areas with replacement concrete pathways that have a max. slope of 5% and a max. cross-slope of 2% as much as is feasible due to the existing grades, I have recommended that the trouble areas be removed beyond the excessive slopes so that there is room to make up the additional path needed when it is re-installed at 5% or less. In order to make these areas more accessible and closer to the ADA acceptable slope of 5% and cross-slope of 2% for walks, it is likely that the area will need to be surveyed by a land surveyor to establish the existing topography and determine how best to modify the existing grades to accommodate lesser slopes at the path area in question. For these areas, I have estimated that a total of 3,100 s.f. of 10' wide sidewalk has excessive slope or cross-slope. In order to go back with new paths of lesser slope, I have figures removal and replacement of 4,650 s.f. (3,100 s.f. x 1.5) of 10' wide sidewalk. **Estimated Cost: \$32,840.00**

- Refer to site plan included with this report: (C) Install a 4' wide concrete access path to one of the small shelters on site. Path shall have slope not exceeding 5% and cross-slope not exceeding 2% (see photo 2 below). **Estimated Cost: \$1,246.00**

- Refer to site plan included with this report: (D) Install a 5' wide concrete path from the existing sidewalk over to the landscape information signs – path shall have slope no greater than 2% in any direction (see photos 3 & 4 next page). **Estimated Cost: \$1,346.00**

- Refer to site plan included with this report: (E) Two sections of the concrete walk have settled  $\sim \frac{3}{4}$ " - 1" where it connects to the bridge at the lake (see photo 5 below). Replace  $\sim 100$  s.f. of concrete path. **Estimated Cost: \$2,064.00**

- Refer to site plan included with this report: (F) Replace shallow truncated dome curb ramp surface and patch intersection with asphalt drive (see photo 6 below). **Estimated Cost: \$2,264.00**
