Facility: MKT Trail Recreation Area

Address: 3662 Scott Blvd. Date of Survey: 05/25/10

1 ACCESS TO THE SITE AND/OR FACILITY

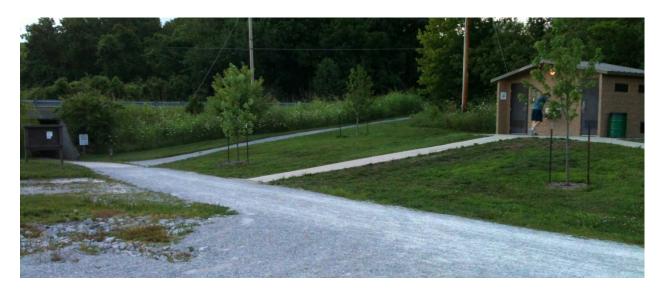
Photo 1 Photo 2

Refer to site plan included with this report: (A) Install ~ 126 l.f. of new 4' wide concrete or asphalt access path from the existing sidewalk east of the restroom building (see photo 1 below) over to the existing paved trail access point west of the restroom building (see photo 2 below).
 Estimated Cost: \$3,403.00
