Facility: Park Management Center

Address: 1507 Business Loop 70 West Date of Survey: 07/01/11

PARK MANAGEMENT CENTER

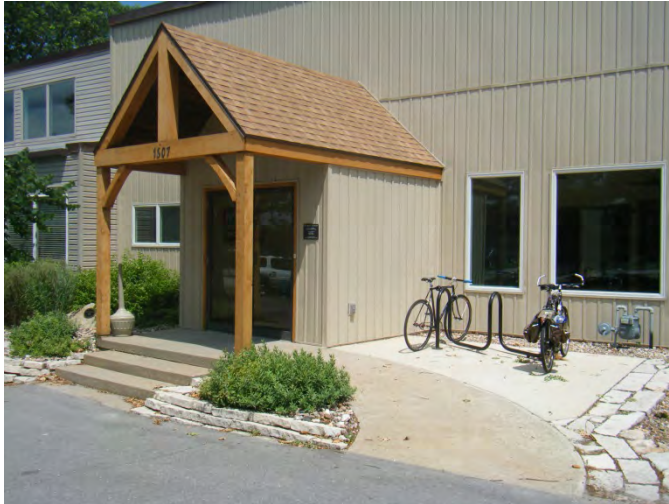
Photo 1

- Refer to site plan included with this report: (B) Install min. 3' deep x entire width ADA compliant contrasting truncated dome detectable warning surface at ramp where it intersects with the south drive (see photo 1 below).

Estimated Cost: \$1,272.00

- Refer to site plan included with this report: (A) Install galvanized metal handrails that meet ADAAG 4.8.5 on both sides of the existing ramp (~16 linear feet of ramp run) from the south drive up to the building entrance stoop (see photo 1 above).

Estimated Cost: \$2,797.00

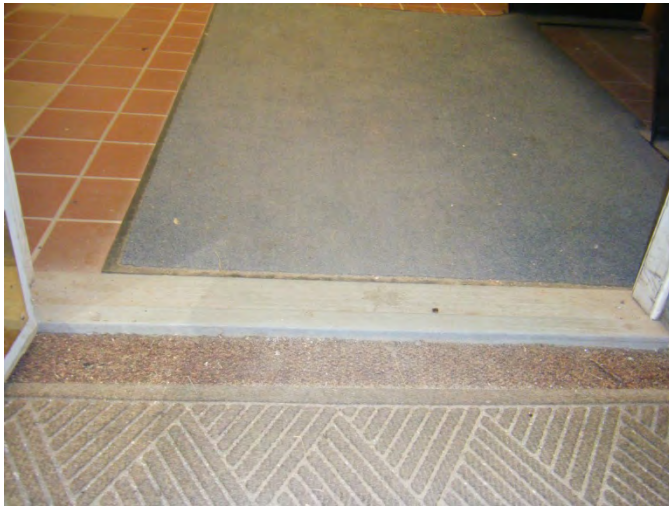
Photo 2

- Adjust the two vestibule door closers so that they operate with 5 lbs. force or less, replace door knob with a lever at the small conference room just east of the reception desk and replace the non-compliant threshold at the corridor leading to the large meeting room (see photo 2 below). **Estimated Cost: \$564.00**

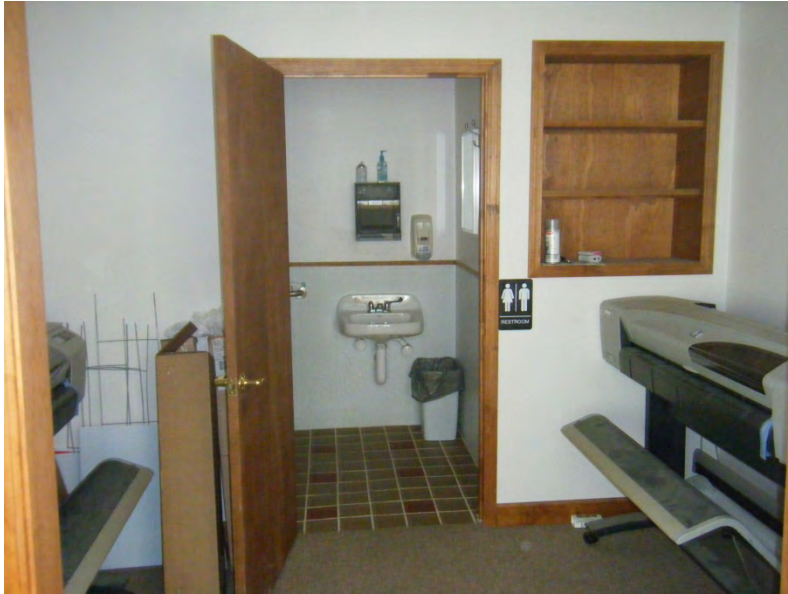
Photo 3

- Existing Unisex ADA Restroom (see photo 3 next page) is too small for wheelchair access. In order to obtain required min. 5' radius wheelchair maneuvering space inside the restroom, the south wall (with door) will need to be pushed out at least 1'-0" further to the south. Additionally, the lavatory needs to be raised to allow ADAAG min. required 27" high knee clearance beneath the lavatory bowl, the existing mirror needs to be lowered such that the low reflective surface of the mirror is no higher than 40" a.f.f., the paper towel dispenser needs to be lowered such that the highest operable part of the dispenser is no higher than 48" a.f.f., relocate or add another toilet paper dispenser to meet location requirements of ADAAG Fig. 29 (b), install a braille/tactile Unisex accessible restroom sign with the symbol of accessibility included (sign should be on the latch side of the door and mounted at 60" from the

floor to the centerline of the sign. It is likely that the plotter just outside of the restroom door will need to be relocated in order to obtain required latch side clearance at the door per ADAAG 4.13.6 and Fig. 25.

Estimated Cost: \$1,574.00

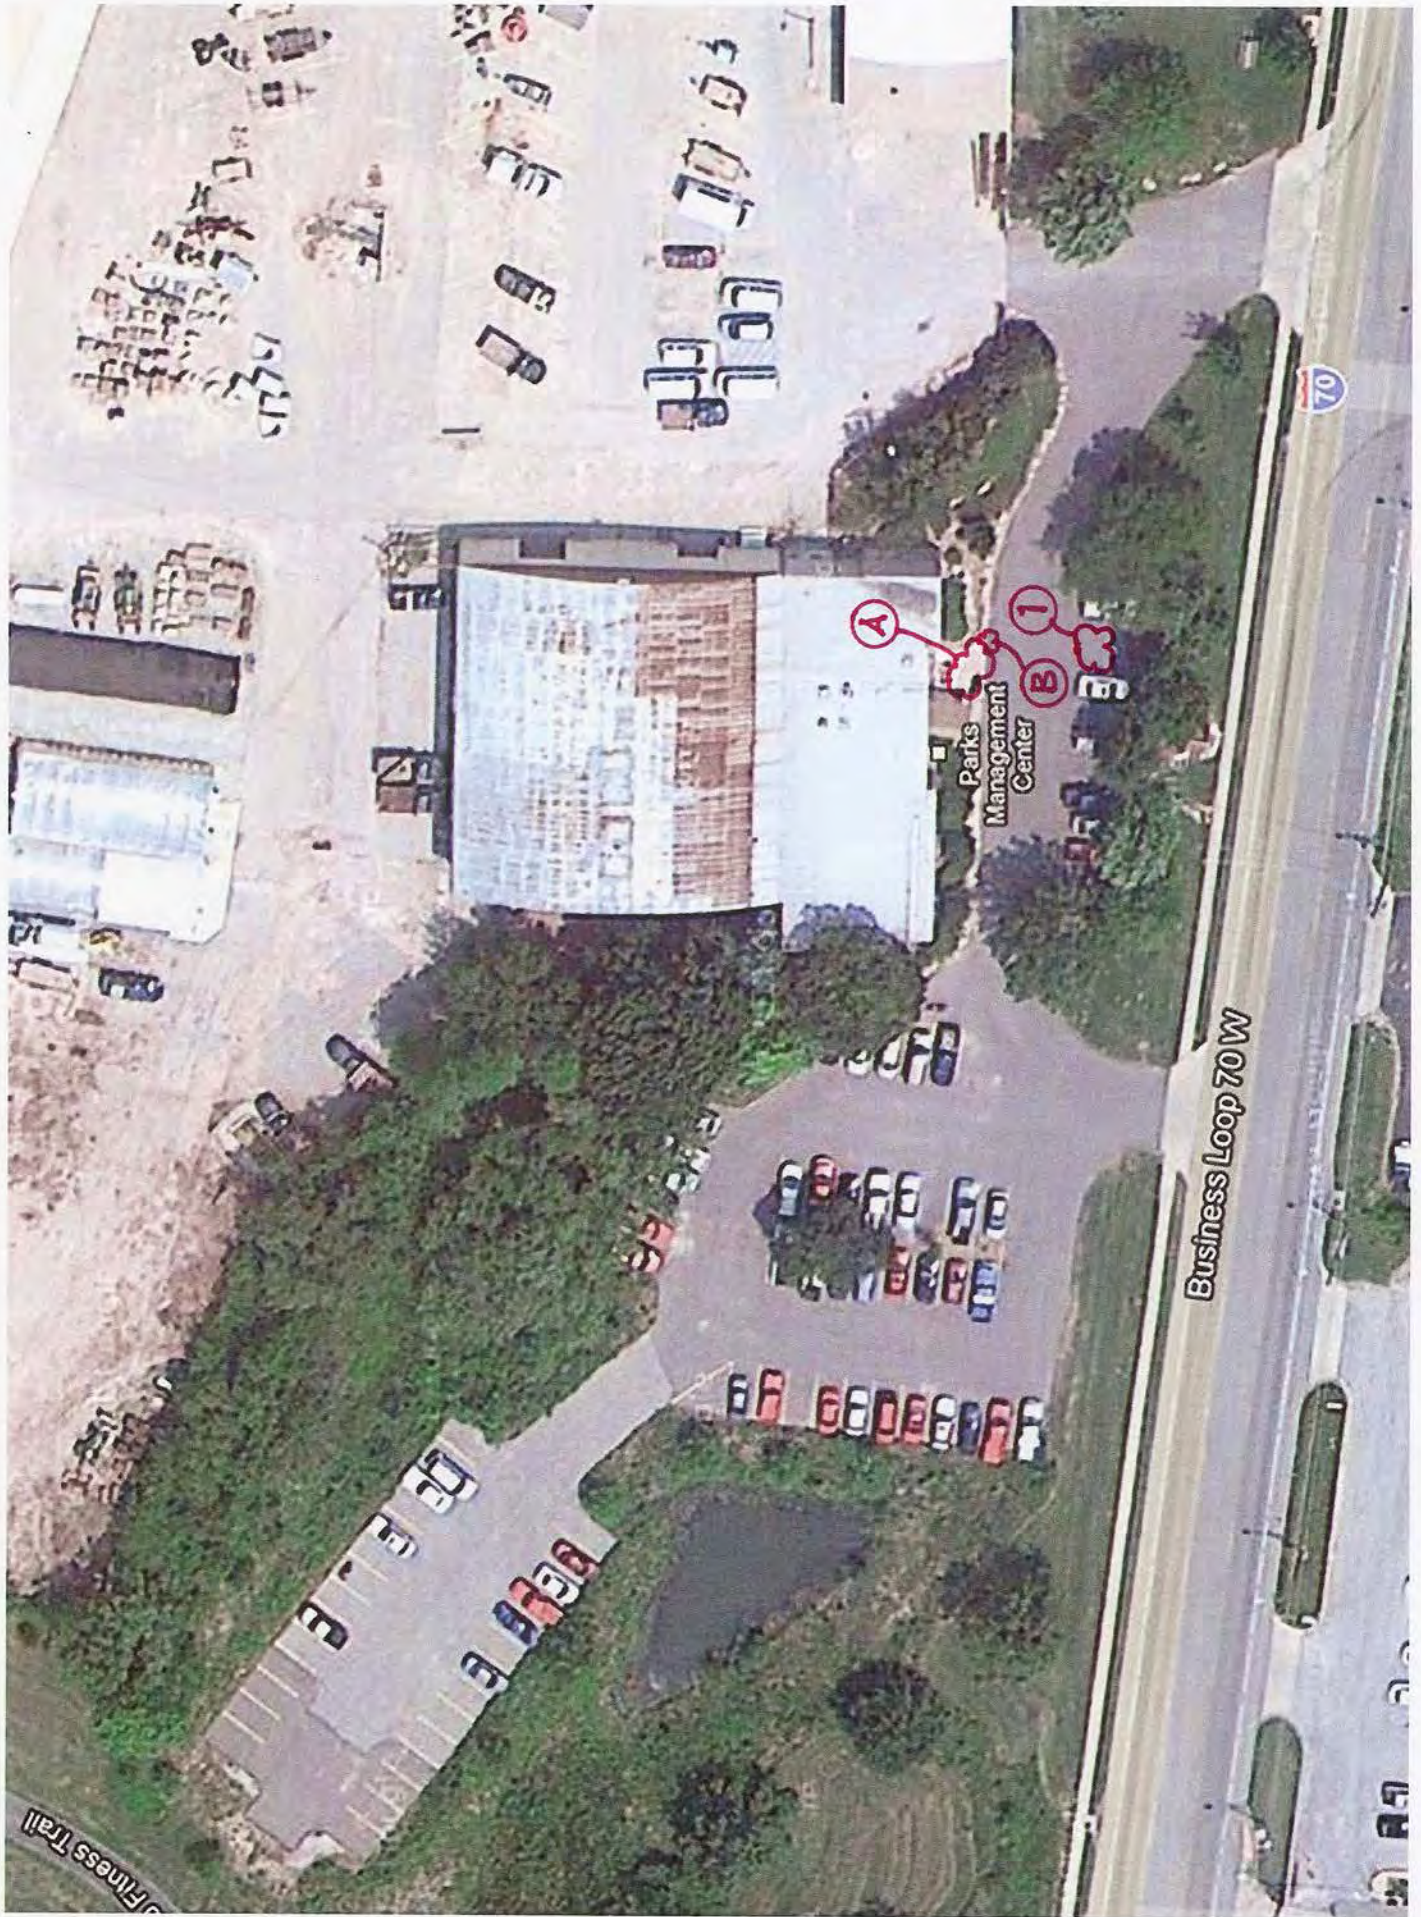
- Refer to site plan included with this report: (1) With a total of ~ 77 visitor and employee parking spaces (11 south of building and 66 west of the building), ADAAG 4.1.2 requires 4 accessible parking spaces with a minimum of one of those required spaces being van accessible. Only the van accessible space has been provided at this time. The existing space has no sign, so install an ADA van access parking sign at 72" above grade at this location. Add one more ADA parking space (min. 8' wide with min. 5' wide access aisle and max. slopes of 2%) in the south parking lot and add two more ADA spaces in the west lot as close to the building as is feasible. New spaces shall be striped (blue paint) and have ADA parking signs installed. **Estimated Cost: \$748.00**
