# Facility: Fairview Park

Address: 1001 Fairview Road Date of Survey: 05/04/10

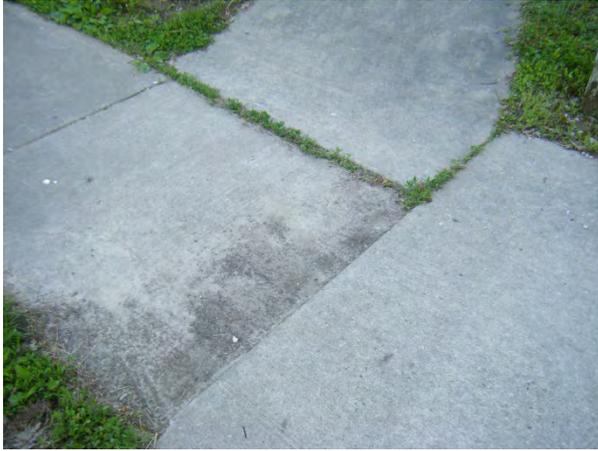
Photo 1

- Refer to site plan included with this report: (A) Remove ~ 50 s.f. section of concrete walk that has settled near the intersection of the main sidewalk along Fairview with the sidewalk leading up to the shelter (see photo 1 next page) and replace with new concrete (max. slope of 5% and max. cross-slope of 2%) walk section (B) Remove ~ 100 s.f. section of concrete walk that has settled at the sidewalk leading up to the shelter (see photo 2 next page) and replace with new concrete (max. slope of 5% and max. cross-slope of 2%) walk.

**Estimated Cost: \$2,588.00**

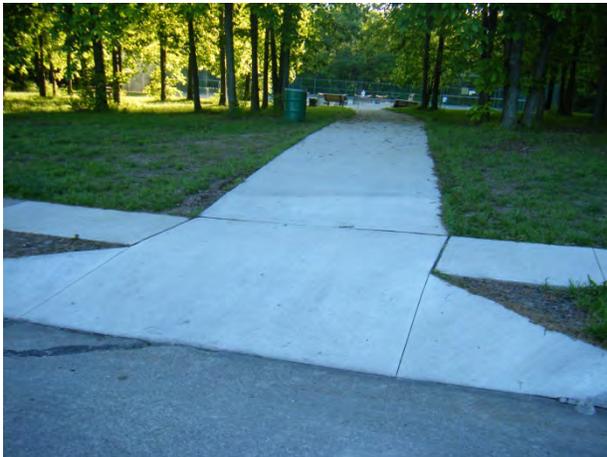
Photo 3

- Refer to site plan included with this report: (C) Install contrasting truncated dome detectable warning surface at walk/drive intersection (see photo 3 below) with Fairview Road.  
**Estimated Cost: \$1,634.00**

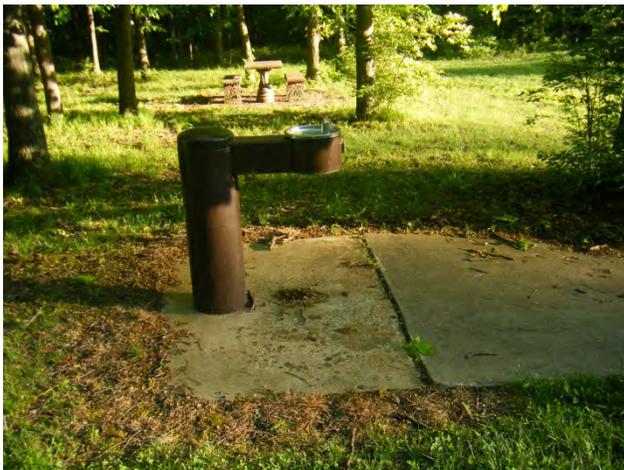
Photo 4

- Refer to site plan included with this report: (D) Remove and replace ~ 33 s.f. of settled concrete at the drinking fountain (see photo 4 below) to eliminate change in elevation at the slab; pad should have maximum slope in any direction of 2%.

**Estimated Cost: \$251.00**

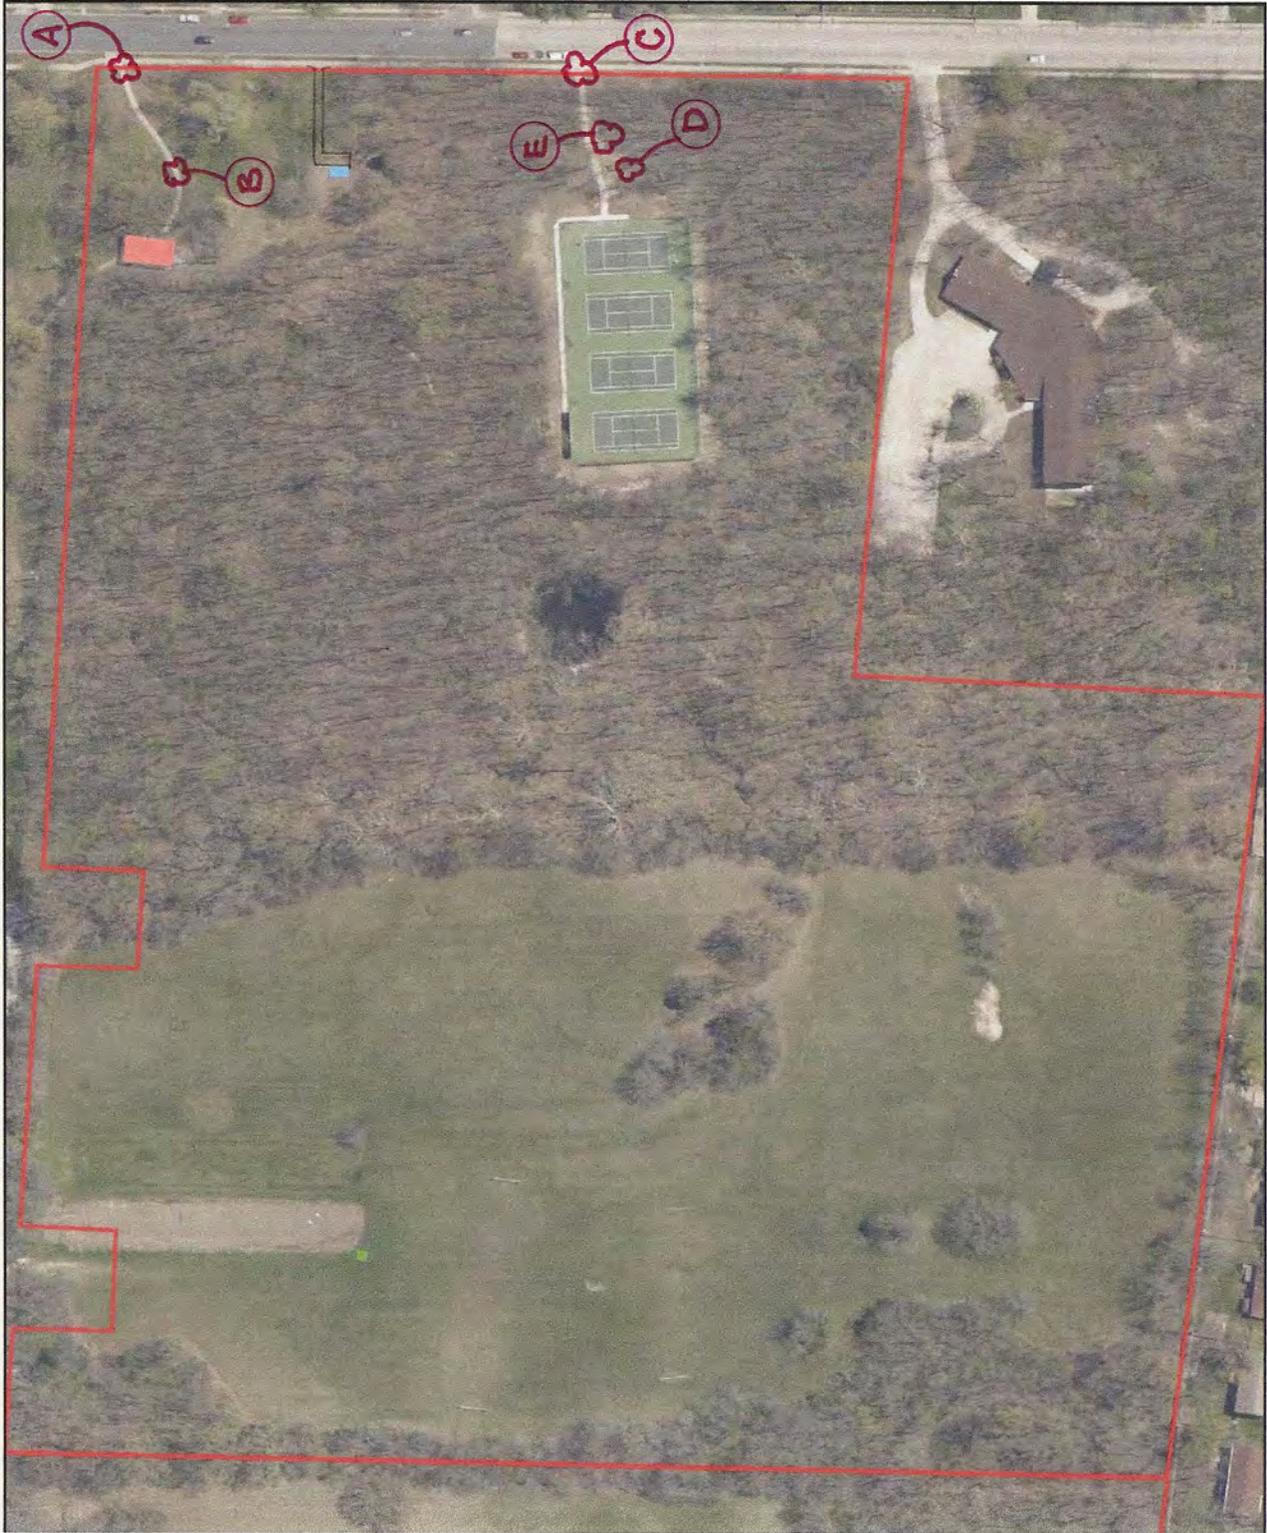
# Fairview\_Park

- Refer to site plan included with this report: (E) Install a min. 8'x8' concrete pad directly off of the existing sidewalk near the tennis courts for installation of a wheelchair accessible picnic table. Concrete pad to have slopes in any direction not exceeding 2%. **Estimated Cost: \$1,628.00**
