Facility: Indian Hills Park

Address: 5009 Aztec Blvd.

Date of Survey: 05/31/10

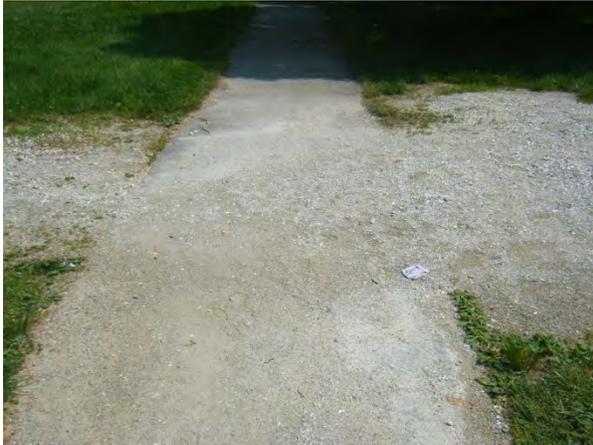
Photo 1

- Refer to site plan included with this report: (A) Remove gravel from concrete sidewalk just north of the parking lot and install some means of stopping the gravel from washing down onto the sidewalk (landscape timber extending just slightly above grade or pvc landscaping edging material, etc.); see photo 1 next page (B) Install a concrete or asphalt access path (max. 5% slope & max. 2% cross-slope whenever possible) from the shelter to the north playgrounds and basketball court (C) Install a concrete or asphalt access path (max. 5% slope & max. 2% cross-slope whenever possible) from shelter to volleyball field and continuing around and over to the restroom building; existing concrete walks up to the restroom building have slopes up to 10% which is excessive (D) Install a concrete or asphalt access path (max. 5% slope & max. 2% cross-slope whenever possible) from new volleyball access walk over to one dugout at the ball field (E) Install a concrete or asphalt access path (max. 5% slope & max. 2% cross-slope whenever possible) from the existing sidewalk adjacent to the south playground over to the south swing play area (I) Remove section of existing walk that exceeds 5% and the steep ramp into the playground area and replace with walk that has 5% max. slope and a 6' long ramp (no rails) with max. slope of

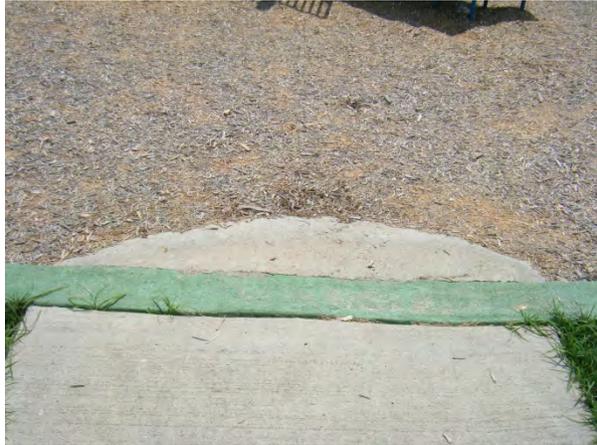
Photo 2

8.33% into the playground area; see photo 2 below.

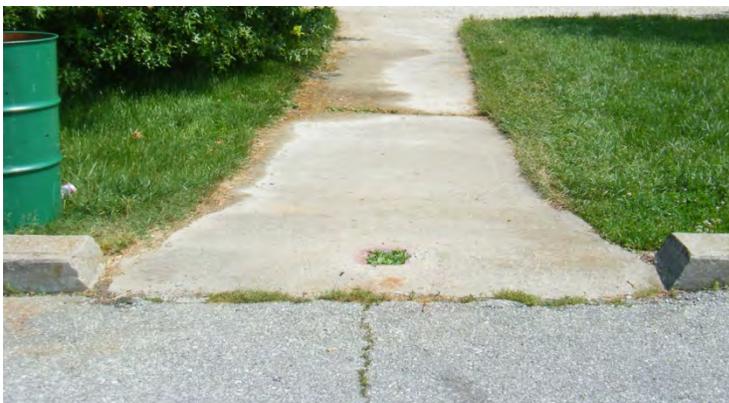
Photo 3

- Refer to site plan included with this report: (F) Install contrasting truncated dome detectable warning surface at the concrete walk adjacent to the parking lot (see photo 3 below).

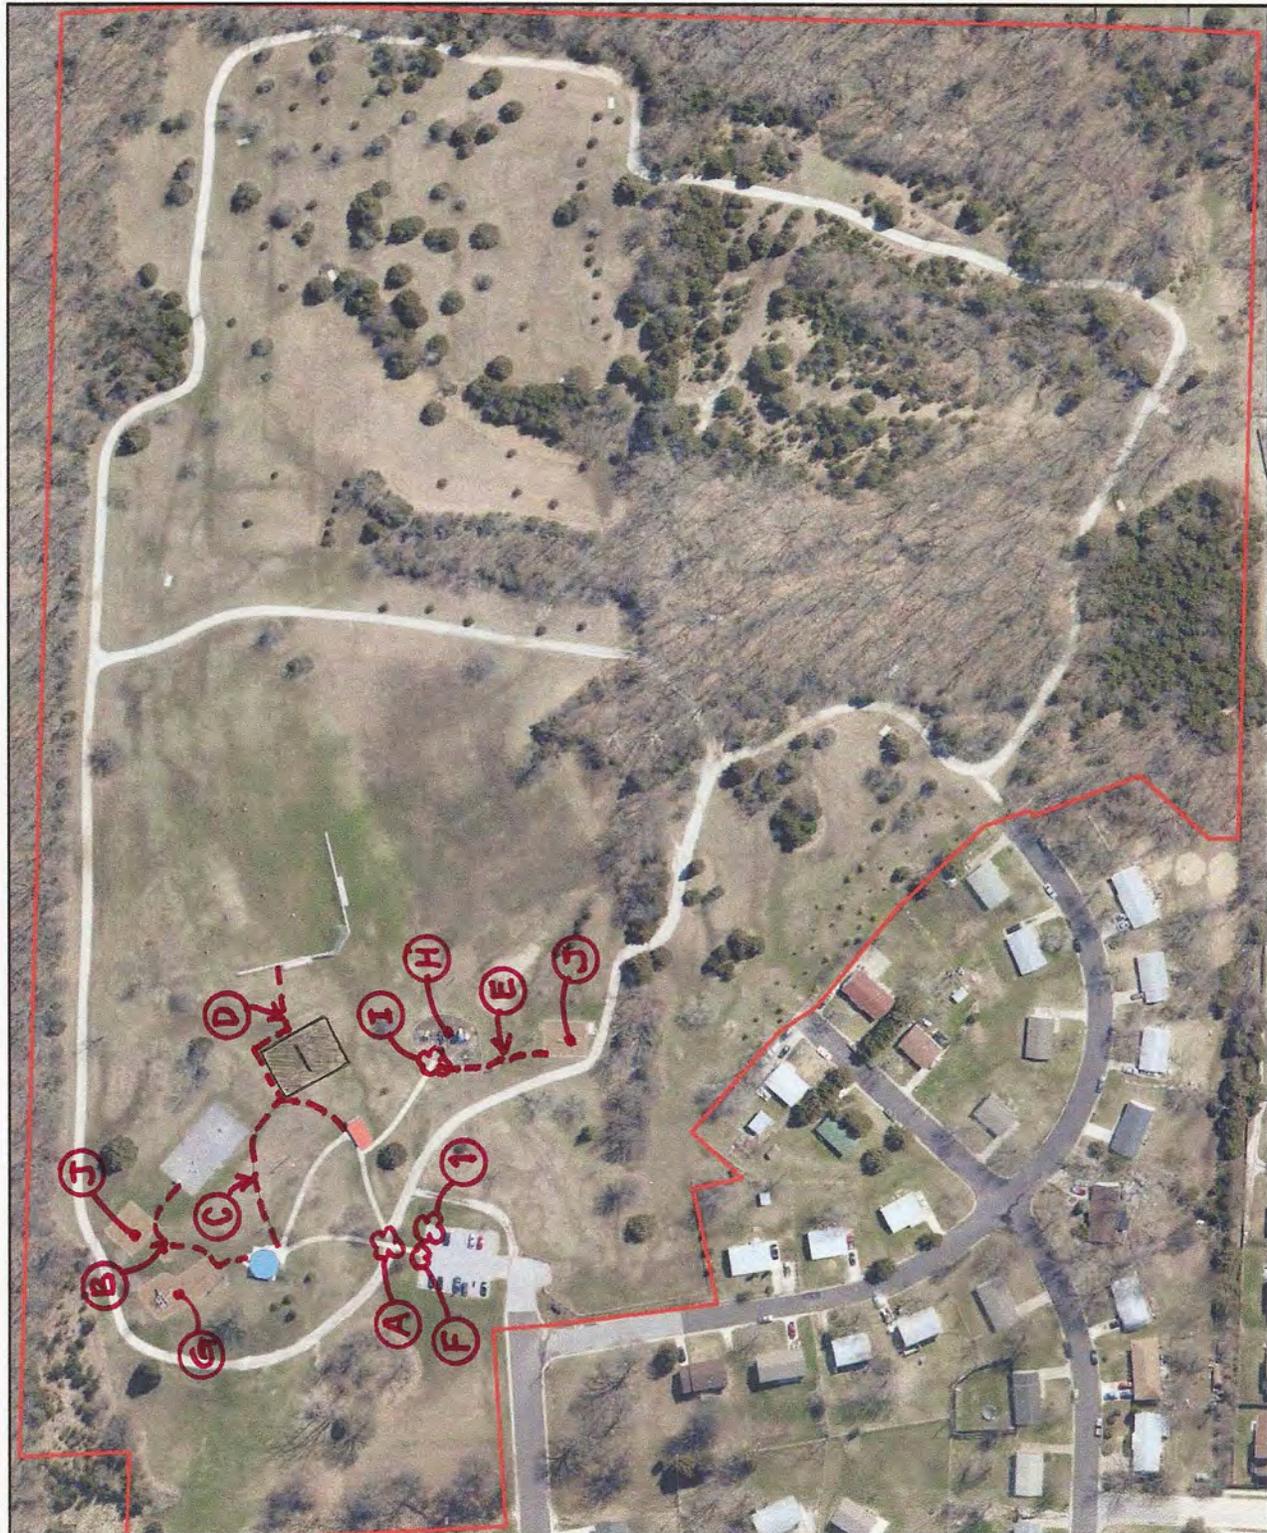
Indian_Hills_Park

- Refer to site plan included with this report: (1) Parking lot has a total of 18 parking spaces. Therefore, ADAAG requires one ADA parking space which is van accessible. One van accessible parking space exists, but the existing slopes and cross-slopes are up to 4.4% which exceeds ADAAG required max. of 2% slopes. Raise existing ADA parking sign to 72" above grade, repave spaces for proper slopes and restripe.

- Refer to site plan included with this report: (G) Remove pea gravel play surface and install compacted wood fiber surface at the playground north of the shelter (~ 2,590 s.f. area). **Estimated Cost: \$9,065.00**
- Refer to site plan included with this report: (H) Supplement and compact existing wood fiber play surface at the playground south of the restroom building (~ 2,450 s.f. area). **Estimated Cost: \$1,838.00**
- Refer to site plan included with this report: (J) Remove pea gravel play surface and install compacted wood fiber surface at the two swing play areas (~ 2,800 s.f. area). **Estimated Cost: \$9,800.00**
