# Facility: Orr St. Fire Station & Administration

Address: 201 Orr Street

Date of Survey: 05/14/10

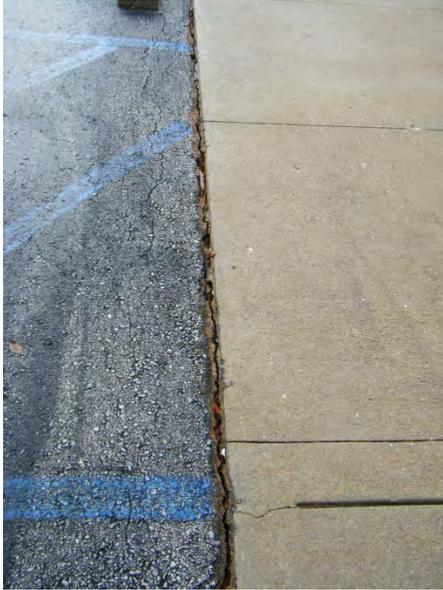
Photo 1

- Refer to site plan included with this report: (A) Fill/patch 1" wide gap between accessible parking spaces and sidewalk (see photo 1 next page).

**Estimated Cost: \$100.00**

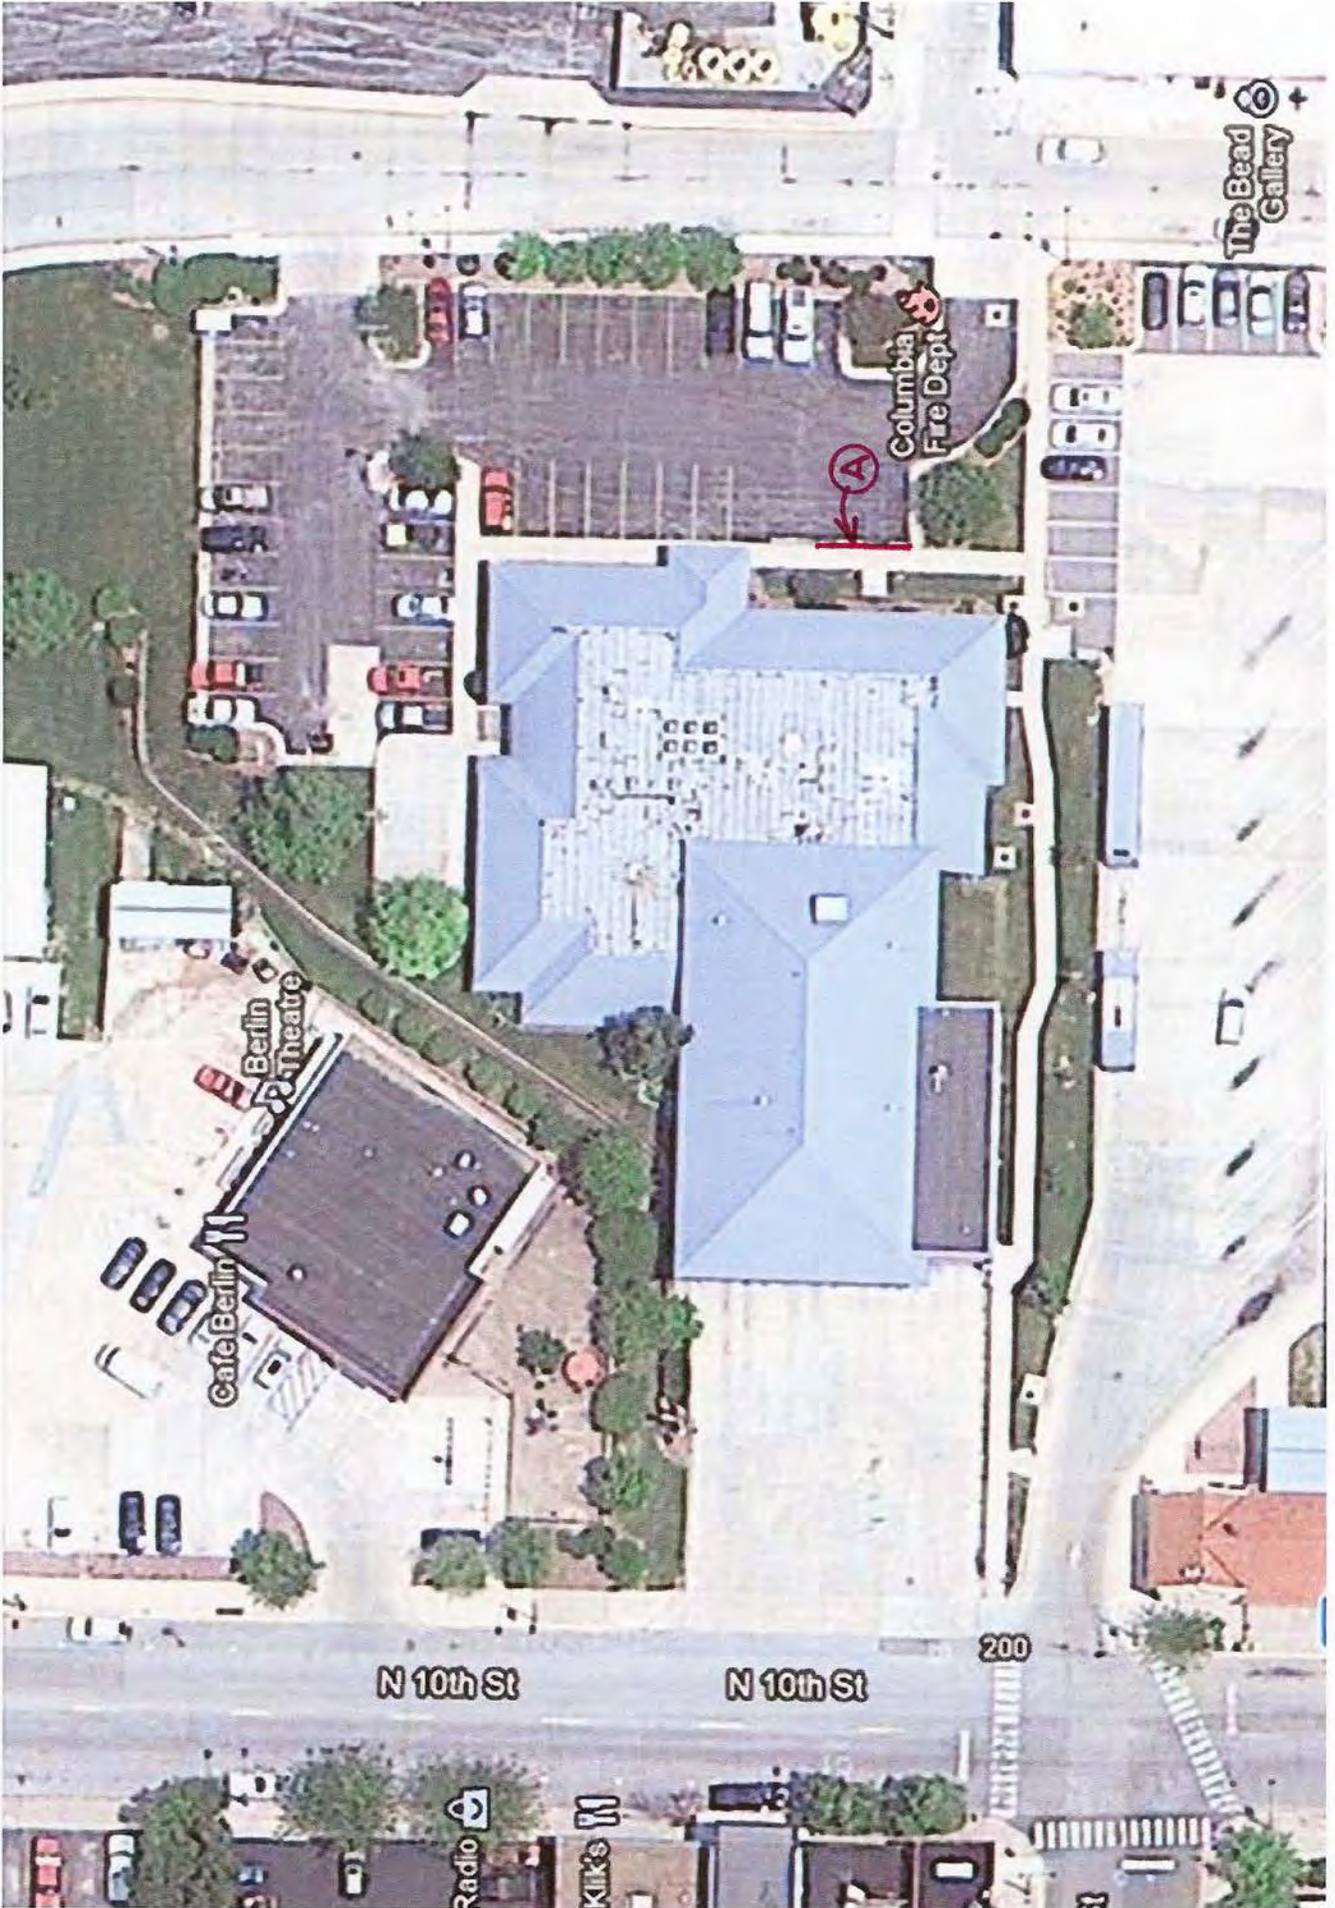
ORR ST. FIRE STATION / ADMINISTRATION

- Refer to building plan included with this report: (B) Adjust the closers on three doors so that they open with 5 lbs. of force or less.

- Refer to building plan included with this report: (C) Men's Public Restroom: Install a braille/tactile ADA restroom sign on the latch side of the door mounted at 60" from the floor to the centerline of the sign, lower the mirror so that the lowest reflective surface is no higher than 40" a.f.f. and lower the paper towel dispenser so that the highest operable part of the dispenser is no higher than 48" a.f.f.

- Refer to building plan included with this report: (D) Women's Public Restroom: Install a braille/tactile ADA restroom sign on the latch side of the door mounted at 60" from the floor to the centerline of the sign, lower the mirror so that the lowest reflective surface is no higher than 40" a.f.f. and replace the 30" long rear grab bar with the ADAAG min. required 36" long grab bar.
