Facility: City Landfill

Address: 5700 Peabody Road Date of Survey: 07/01/11

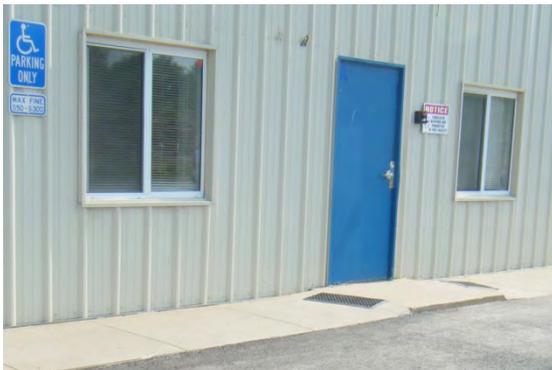
Photo 1

- Refer to building plan included with this report: (A) Increase the size of the existing level concrete landing (shown in blue ink in sketch on next page) at the south entry door into the Landfill Operation Center (see photo 1 below) to obtain the ADAAG required wheelchair clearances at the door with a larger landing (shown in red ink in the sketch on the next page).

Estimated Cost: 1,458.00

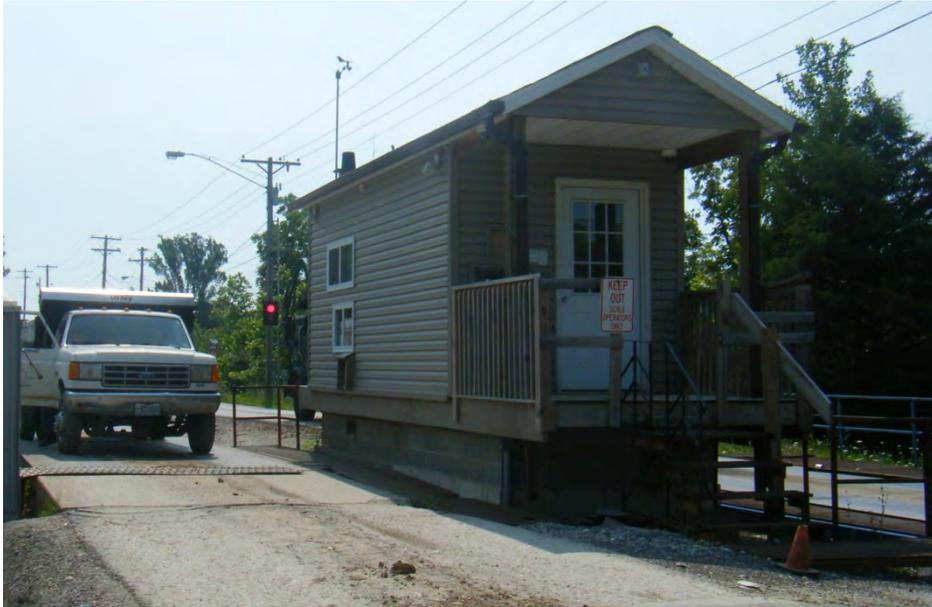
Photo 2

- Refer to the building plan included with this report: (B) Install some type of sliding tray at the weigh station/pay booth for access from vehicles (see photo 2 below and example of sliding transaction tray included with this report).

Estimated Cost: \$1,825.00

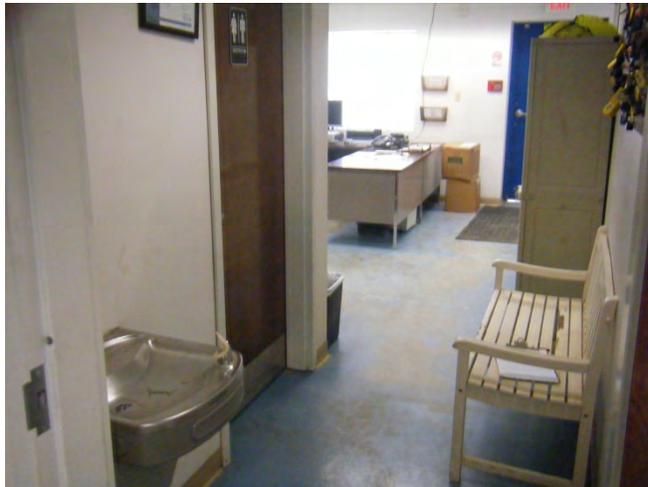
Photo 3

- Refer to building plan included with this report: (C) Public-Use Unisex Restroom in the Landfill Operation Center: Move the bench in the corridor that blocks proper wheelchair clearance at the restroom door (see photo 3 below), install a braille/tactile ADA restroom sign on the latch side of the door and mounted to be 60” from floor to centerline of the sign, fur out wall with a half wall to get to 18” from the side wall to the centerline of the toilet fixture, replace the lavatory with a lavatory that meets the requirements of ADAAG 4.19, install a mirror with low reflective surface no higher than 40” a.f.f., relocate the paper towel dispenser so that it is wheelchair accessible and no higher than 48” a.f.f. and install rear and side grab bars to meet ADAAG 4.16.4. **Cost Estimate: \$3,574.00**

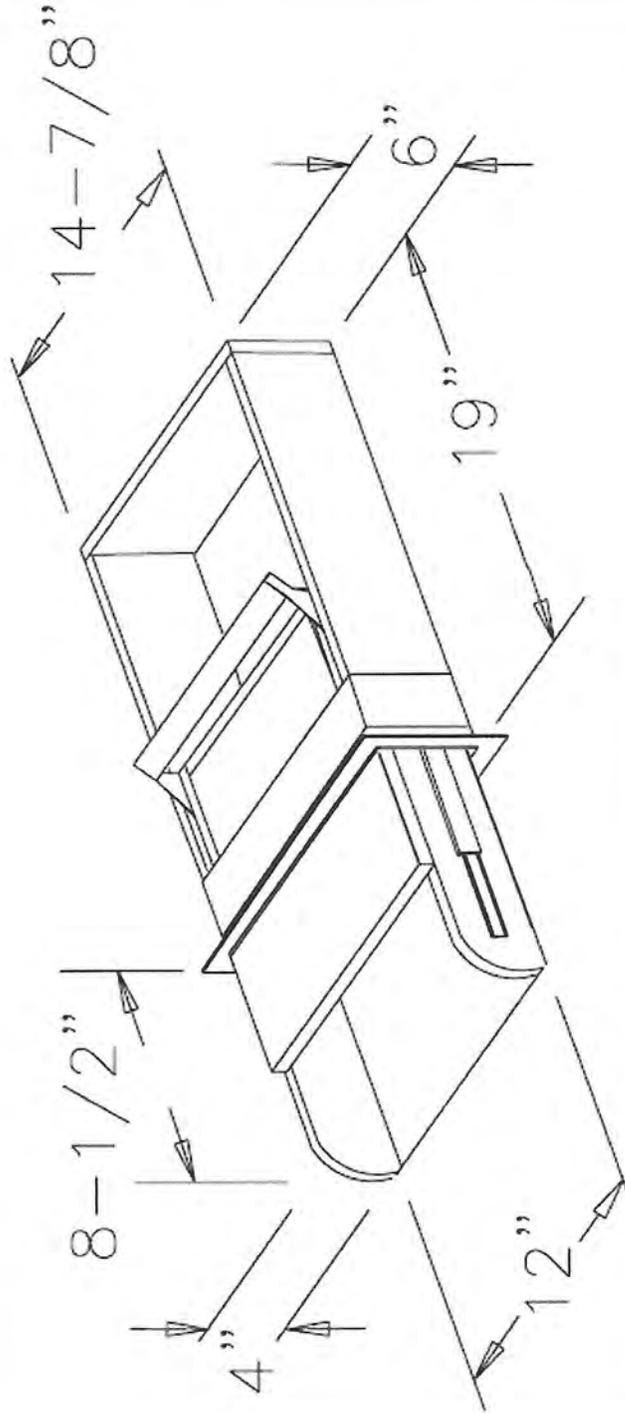
QST-619-DT MAIN VIEW
Submitted By: BRIAN COBLE
Date: 12/23/2005
Sheet: DD26

Rough Opening: 15-1/4" (W) X 6-3/8" (H)
Actual Dimension 14-7/8" (W) X 6" (H)
